January 8, 2022

**2021 ANNUAL INSPECTION REPORT
PLANT CRISP ASH POND
CRISP COUNTY POWER COMMISSION**

This letter report summarizes the observations and resulting recommendations from our annual inspection of the Plant Crisp Ash Pond performed on Wednesday, November 10, 2021.

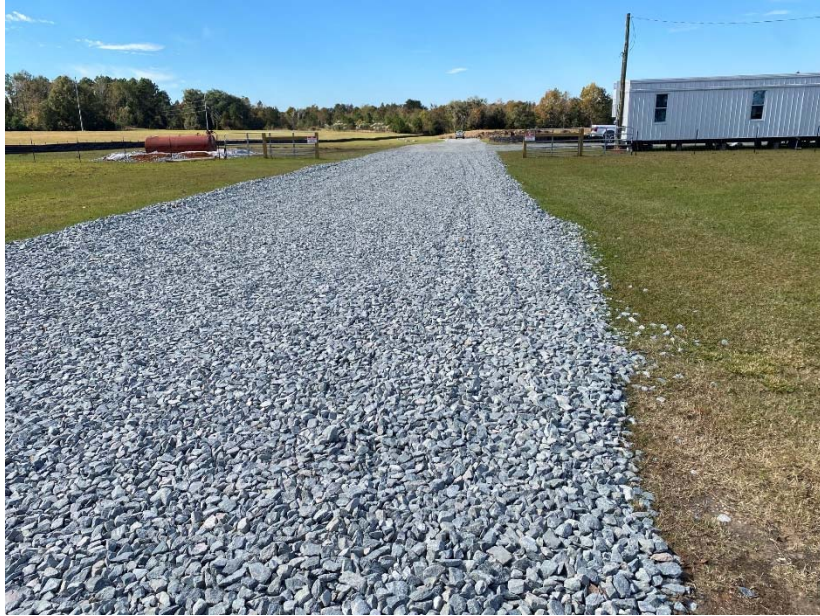
Photograph No. 01

closure construction were mostly installed at the time of the inspection (Photographs 01, 07, 08, 12, and 13).

Description:
Construction
Entrance and Initial
Best Management
Practices

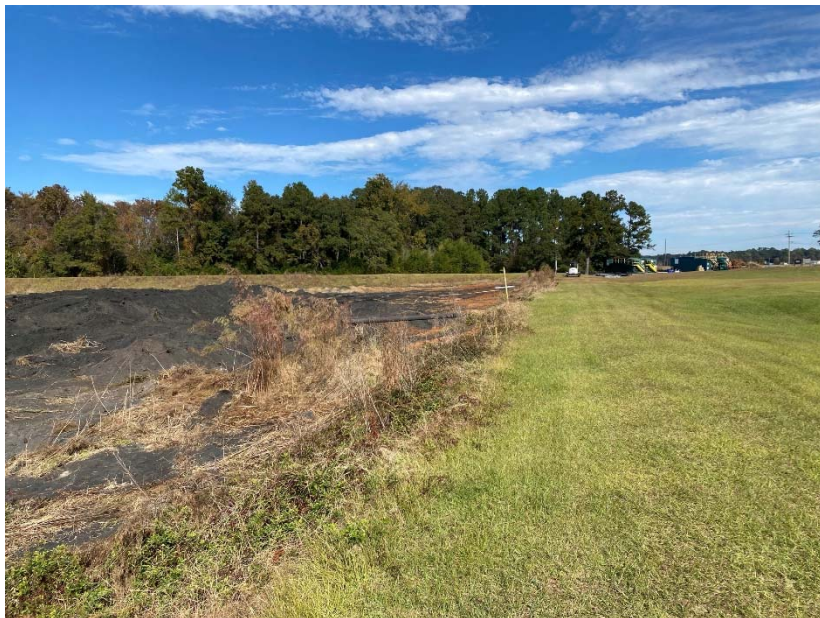
Photograph No. 02

Description: East
Embankment

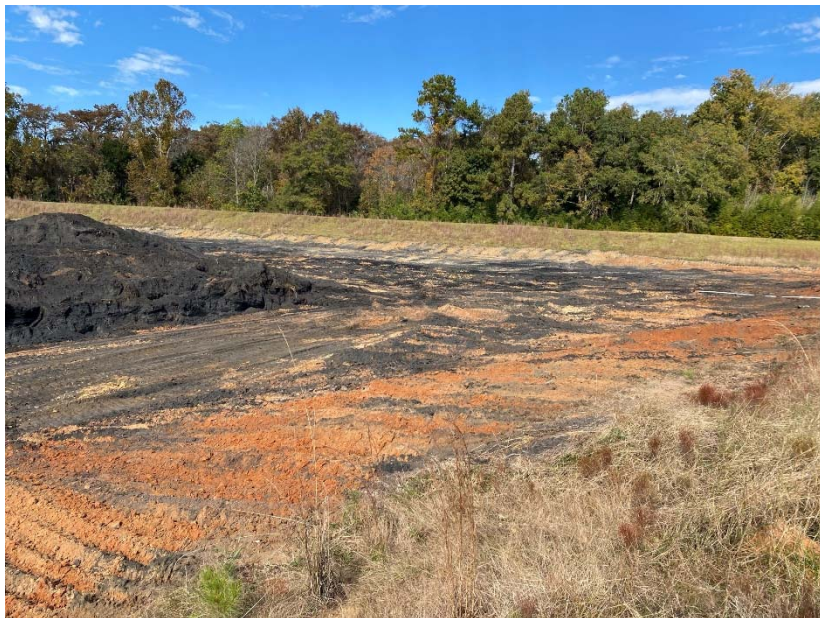
Photograph No. 04

Description: Initial
ash removal
activities within the
ash pond

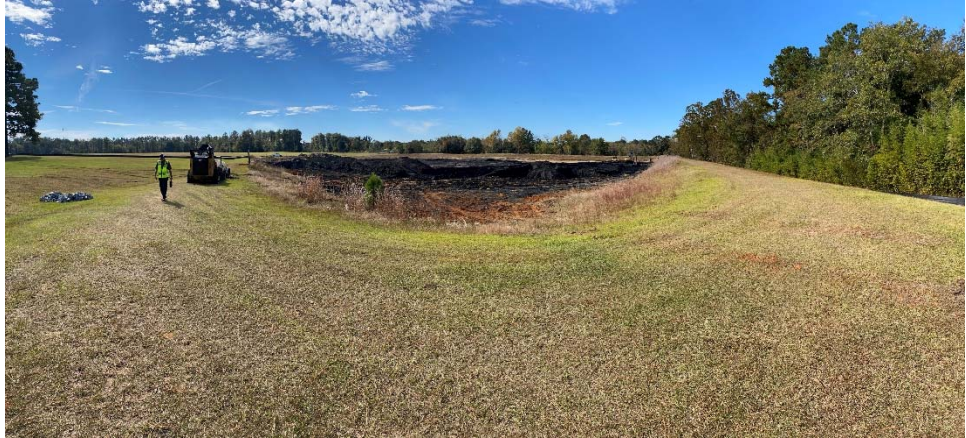
Photograph No. 05

Description:
Panorama of the ash pond from its northeast corner

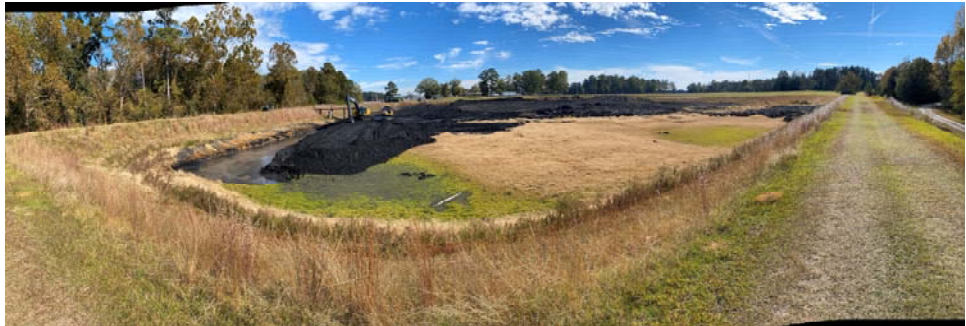
Photograph No. 06

Description:
Panorama of the ash pond from its northwest corner

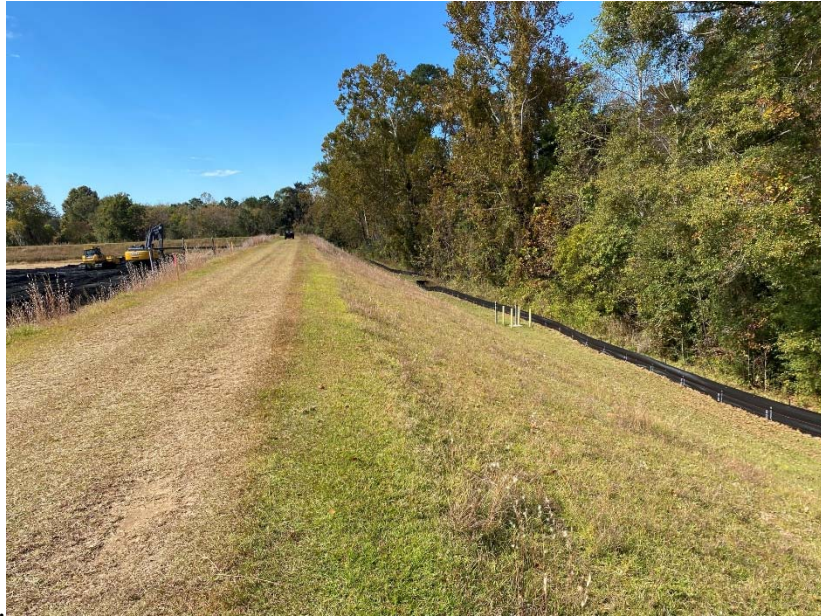
Photograph No. 07

Description: North Embankment and external slope at crest

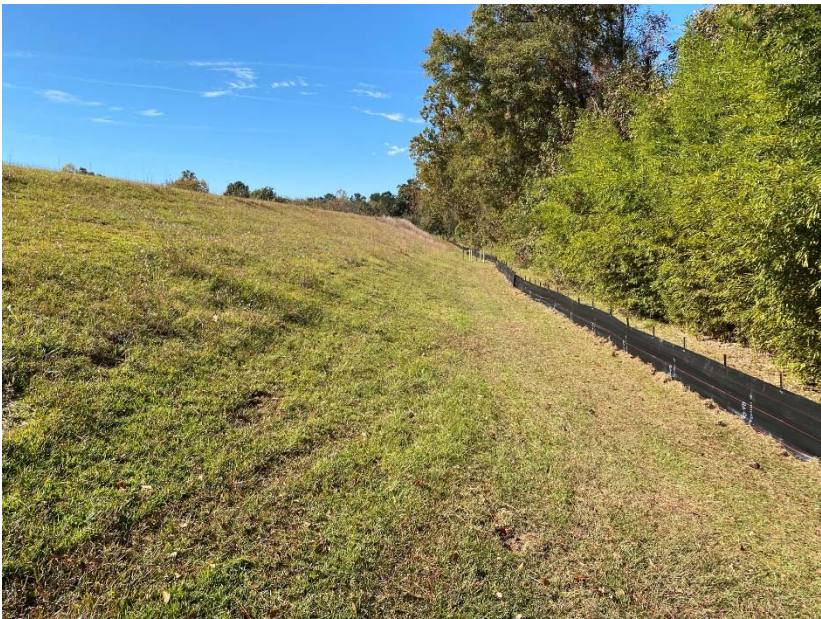
Photograph No. 08

Description: North Embankment and external slope at toe

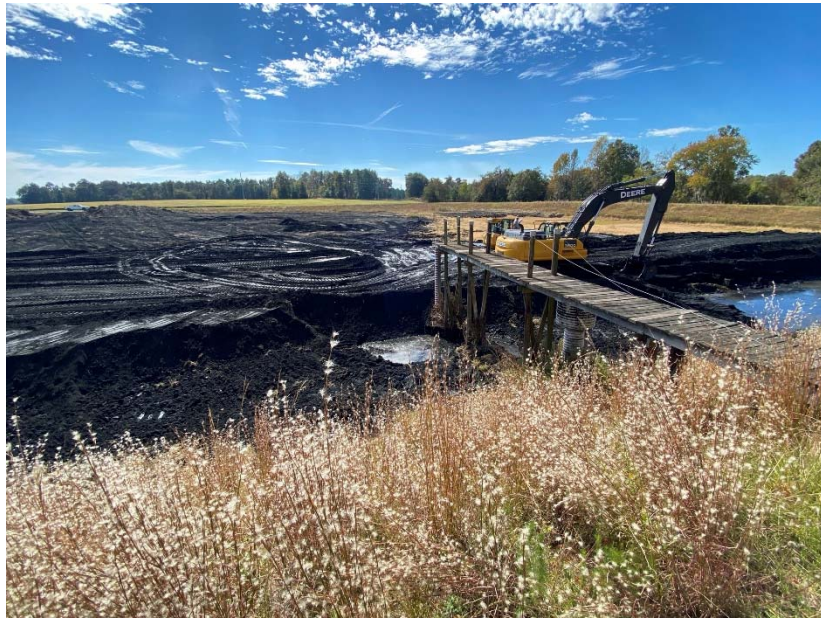
Photograph No. 09

3. Overall grass cover on the embankment slopes is acceptable, with grass heights generally less than six inches on the external slopes. A small area on the external slope of the Western Dike and majority of the internal slopes had overgrown vegetation approximately 6 to 12 inches (Photographs 09, 11, and 12). CCPC indicated that the overgrown vegetation will be mowed as part of the continued maintenance activities. It is noted that the ash pond is already in the process of closure with an ongoing construction where the water levels are and will continue to be maintained as low as possible to facilitate ash removal. Following removal of the ash, the dikes will be lowered and breached.

Description: Internal slope of North Embankment, boardwalk, 12-in spillway riser with 24-in trash screen, and staff gauge

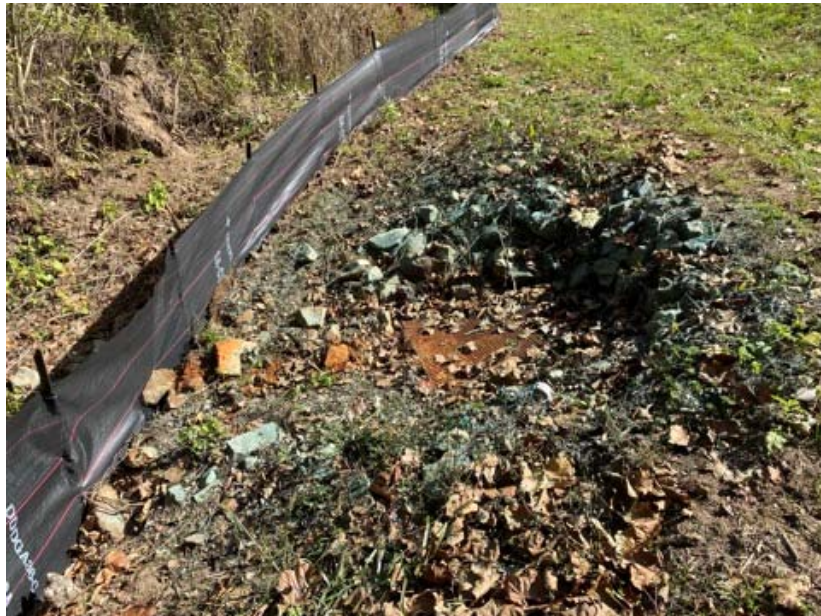
Photograph No. 10

4. The spillway outfall area was clear of vegetation and appeared to be dry (Photograph No. 10).
5. Some of the historical inspections reported a wet area in the vicinity of monitoring well MW-D3, near the toe of the north embankment [Rizzo, 2019; Geosyntec, 2020b]. However, this area appeared to be dry during this inspection (Photograph No. 13), consistent with the previous annual inspection. Additionally, the groundwater level reading on 10/26/2021 at monitoring well MW-D3 was measured to be approximately 3.3 ft below ground surface.

Description: Spillway outlet (installed with a protective grate for animal control); no flow/discharge observed

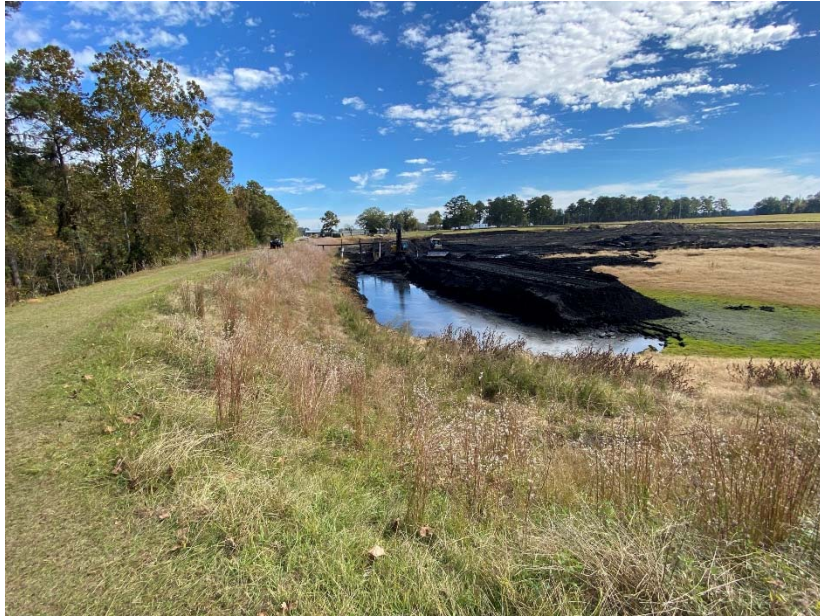
Photograph No. 11

Description: A small puddle along the internal slope toe of the North Embankment

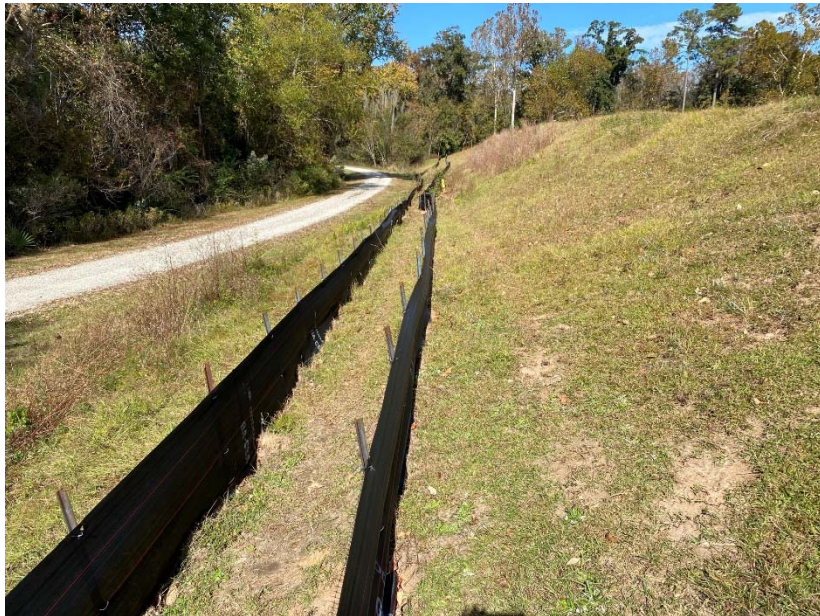
Photograph No. 12

2. Hummocky areas and minor soil erosion with missing grass cover was observed at a few locations on both internal and external slopes of the AP embankments (Photograph 12).

Description: Hummocky areas and minor surface erosion on the external slope of the West Embankment

- **Recommendation No.1:** Continue monitoring the areas of minor erosion at both internal and external slopes during weekly inspections. If any changes are observed that indicate further degradation of the slopes, CCPC should repair these areas locally to prevent further erosion.
- **Recommendation No.2:** Continue mowing the external and internal slopes of the embankments periodically to discourage overgrowth and facilitate inspection.
- **Recommendation No.3:** Continue monitoring the vicinity of monitoring well MW-D3 for wetness, signs of general slope instability, or embankment distress such as sloughs, tension cracks, bulges.

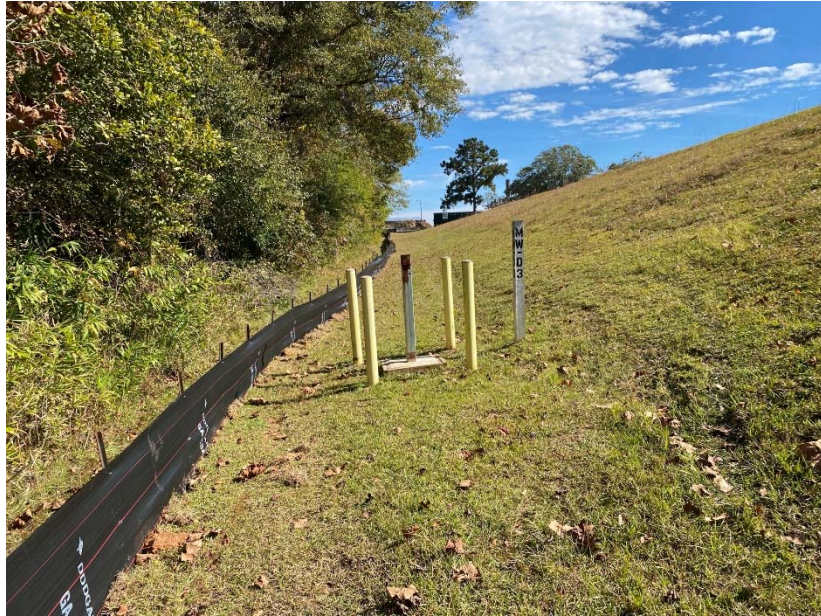
Photograph No. 13

Description:
External slope of
North Embankment;
groundwater
monitoring well
MW-D3
