**2020 ANNUAL INSPECTION REPORT**  
**PLANT CRISP ASH POND**  
**CRISP COUNTY POWER COMMISSION**

This letter report summarizes the observations and resulting recommendations from our annual inspection of the Plant Crisp Ash Pond performed on Monday, December 28, 2020.

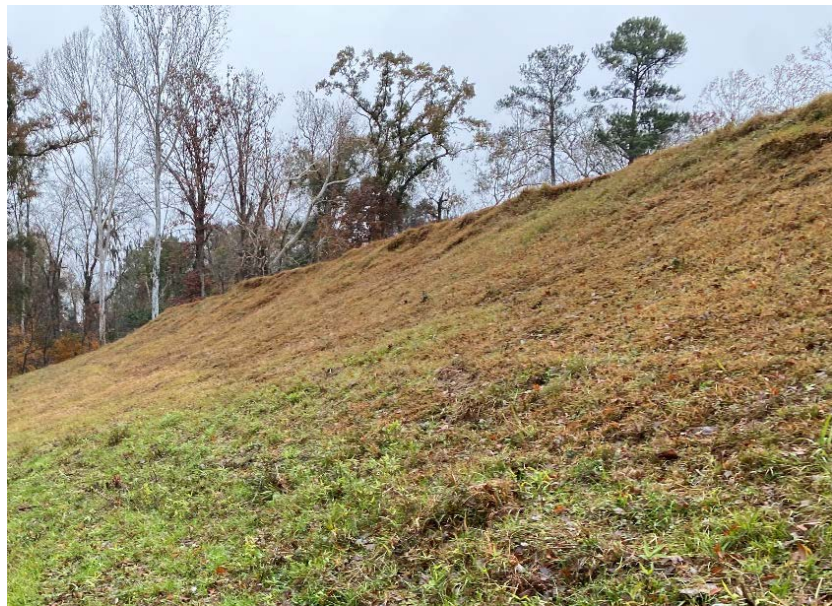
Photograph No. 06

1. Hummocky areas and minor soil erosion with missing grass cover was observed at several locations on both internal and external slopes of the AP embankments.
2. The latest mowing of the slopes was conducted in July 2020. Overall grass cover on the embankment slopes is acceptable, with grass heights

Description: Hummocky areas and minor surface erosion on the external slope of the west embankment

- **Recommendation No.1:** Continue to monitor the areas of minor erosion at both internal and external slopes during weekly inspections. If any changes are observed that are pointing to further degradation of the slopes, CCPC should repair these areas locally to prevent further erosion.
- **Recommendation No.2:** Continue to mow the external and internal slopes of the embankments and the outfall area to discourage overgrowth. Remove small volunteer trees as early as practical. Trees allowed to grow and develop root systems in the slopes of dams can create preferential seepage pathways and potential instability.
- **Recommendation No.3:** Continue to monitor the vicinity of monitoring well MW-D3 for wetness, signs of general slope instability, or embankment distress such as sloughs, tension cracks, bulges.

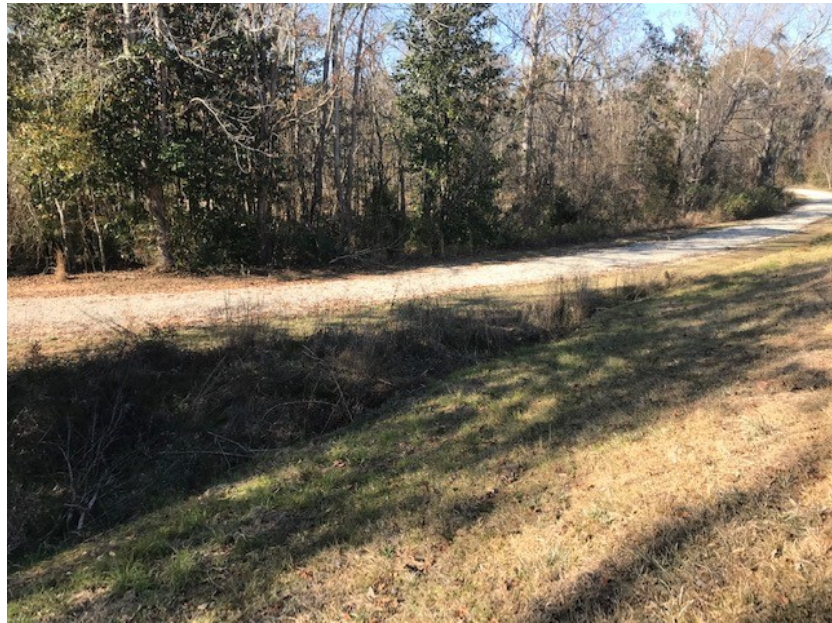
Photograph No. 08

Description: Documentation of Maintenance - External slope of the north embankment after the short trees in Photograph No. 07 were removed

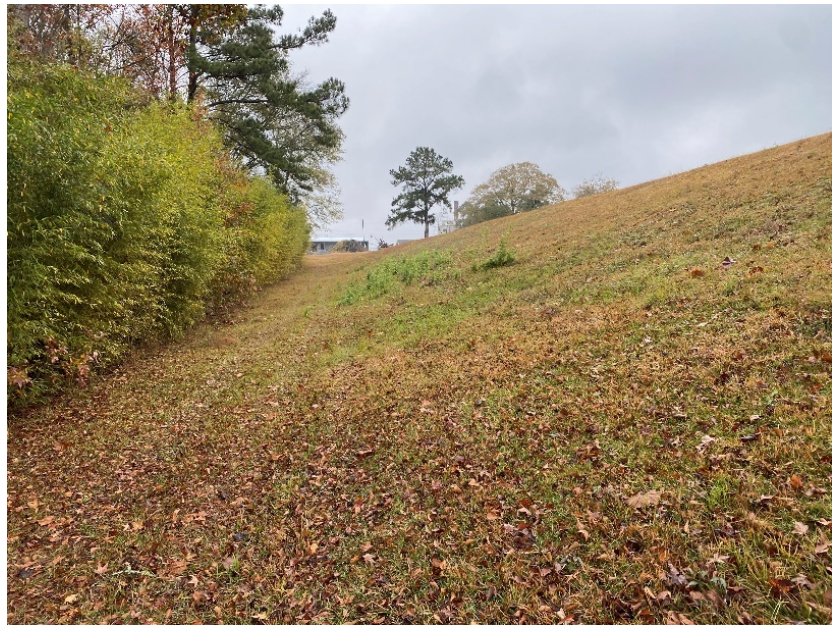
Photograph No. 09

generally less than six inches. A small area on the external slope of the Northern Dike had overgrown vegetation taller than 6-inches, which appeared to consist of bamboo saplings (Photograph No. 09). Following the inspection, CCPC mowed the overgrown vegetation, which is documented on Photograph No. 10.

Description: External slope of north embankment with bamboo saplings on the slope

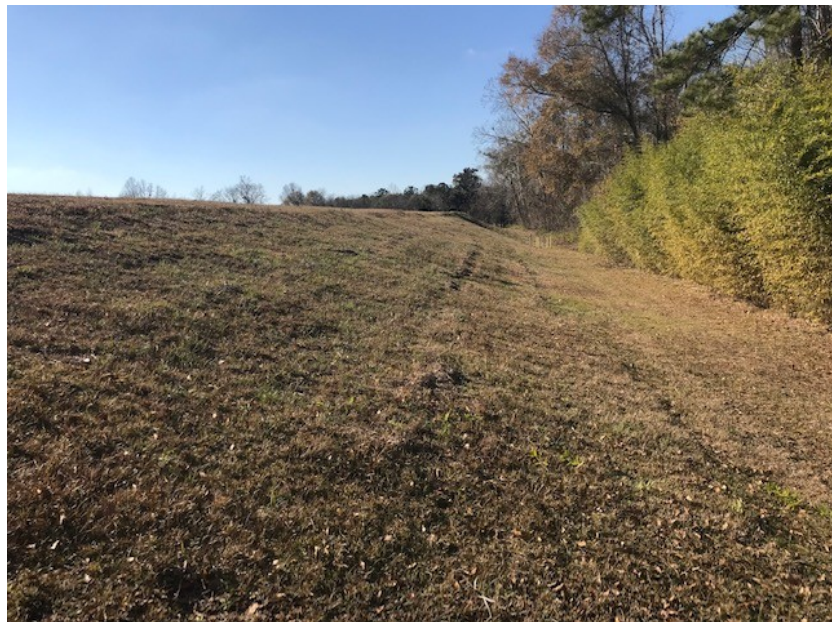
Photograph No. 10

Description: Documentation of Maintenance – External slope of north embankment after the bamboo saplings on Photograph No. 09 were removed

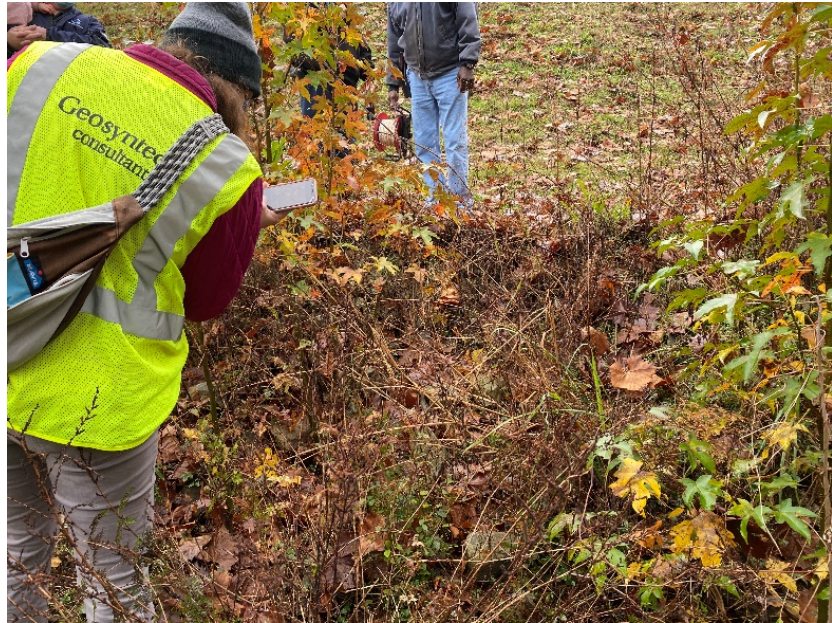
Photograph No. 11

4. The spillway outfall area was covered with overgrown vegetation which impeded visual inspection of the outlet pipe and would obstruct flow if discharge were to occur from the AP (Photograph No. 11). The inspectors carefully removed the vegetation locally and observed the outfall area to be dry. Following the inspection, CCPC trimmed the vegetation and cleared the area, which is documented on Photograph No. 12.

Description: Spillway outlet (installed with a protective grate for animal control) covered by overgrown vegetation; no flow/discharge observed

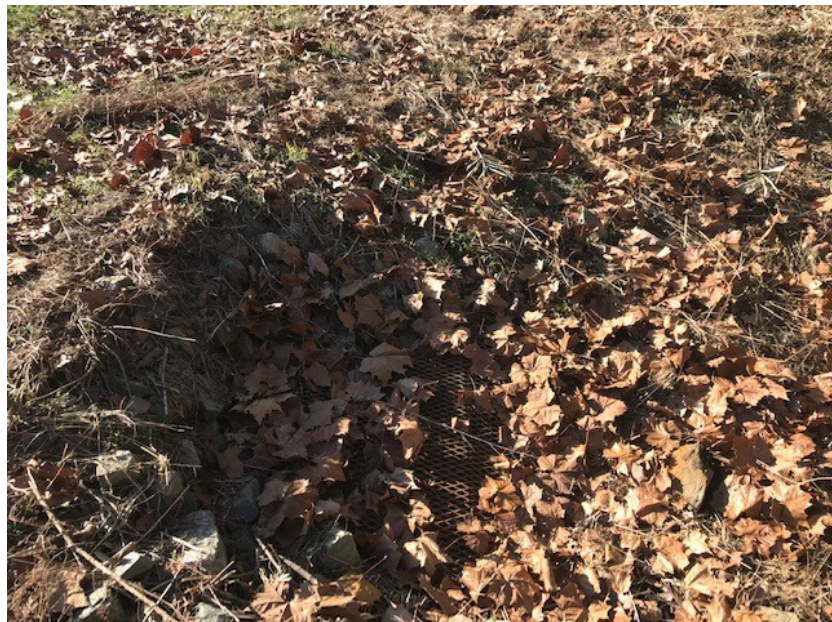
Photograph No. 12

Description: Documentation of Maintenance – Spillway outlet pipe after the overgrown vegetation on Photograph No. 11 were removed
