June 9, 2017
Project No. 17-5796

**DAM SAFETY INSPECTION REPORT
PLANT CRISP CCW IMPOUNDMENT
CRISP COUNTY POWER COMMISSION**

This Letter Report summarizes the observations and resulting recommendations from our dam safety inspection of the Plant Crisp Coal Combustion Waste (CCW) Impoundment performed on Friday, May 19, 2017. RIZZO Associates (RIZZO) services for this Project were performed in accordance with our May 1, 2017, Proposal submitted to Crisp County Power Commission (CCPC).

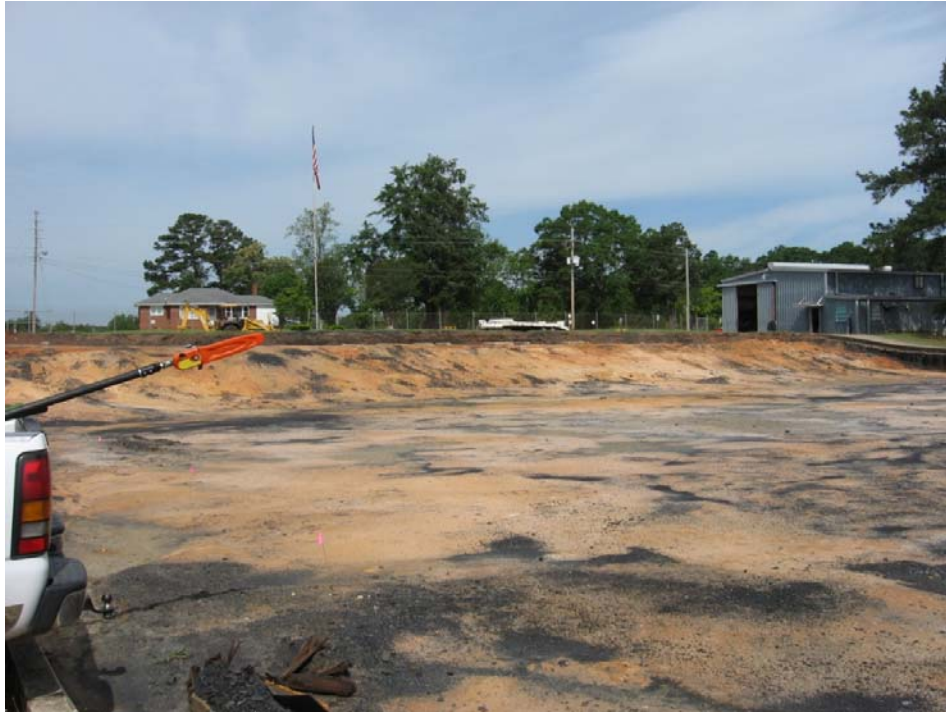
PHOTOGRAPH 1
OLD COAL STORAGE AREA LOOKING WEST TOWARD PONDS

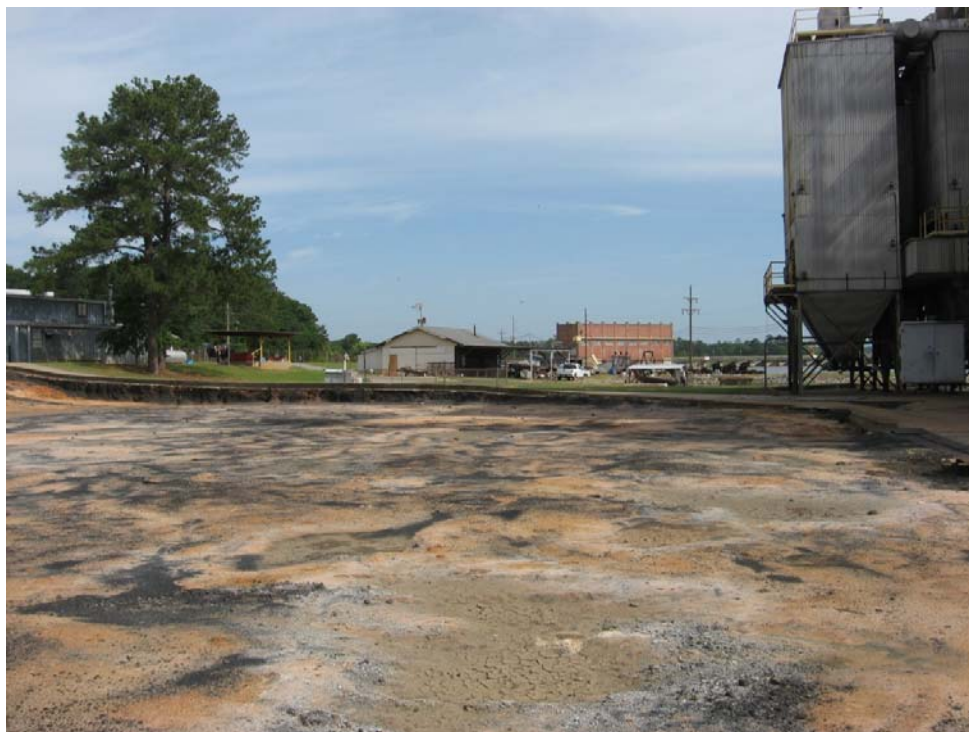
PHOTOGRAPH 2
OLD COAL STORAGE AREA LOOKING NORTH TOWARD HYDRO PLANT

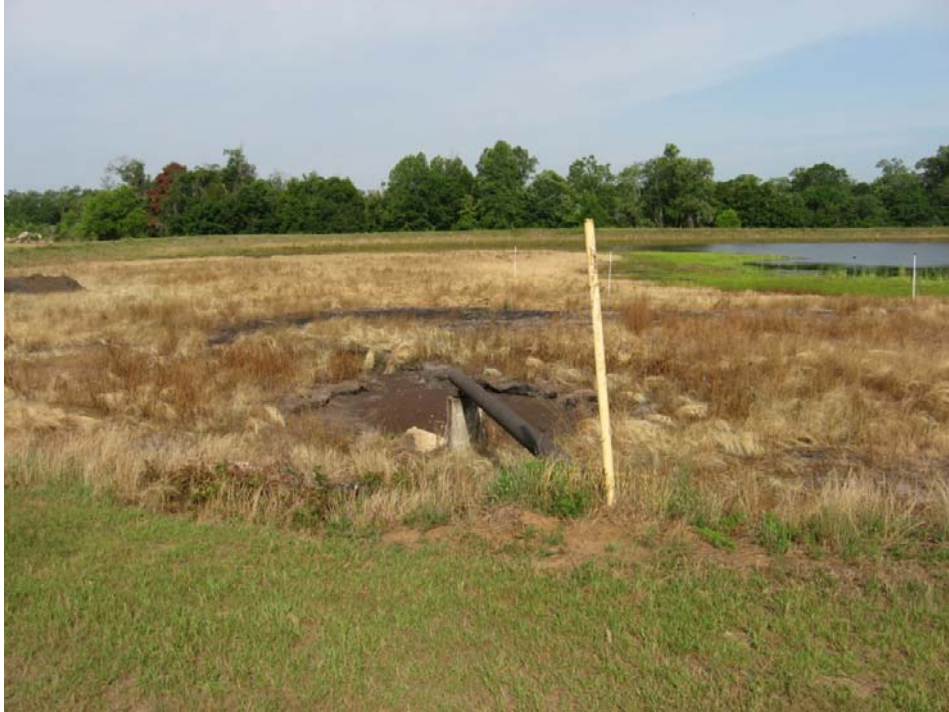
**PHOTOGRAPH 3
CCW SLUICE DISCHARGE AT EAST EMBANKMENT (CAST IRON PIPE)**

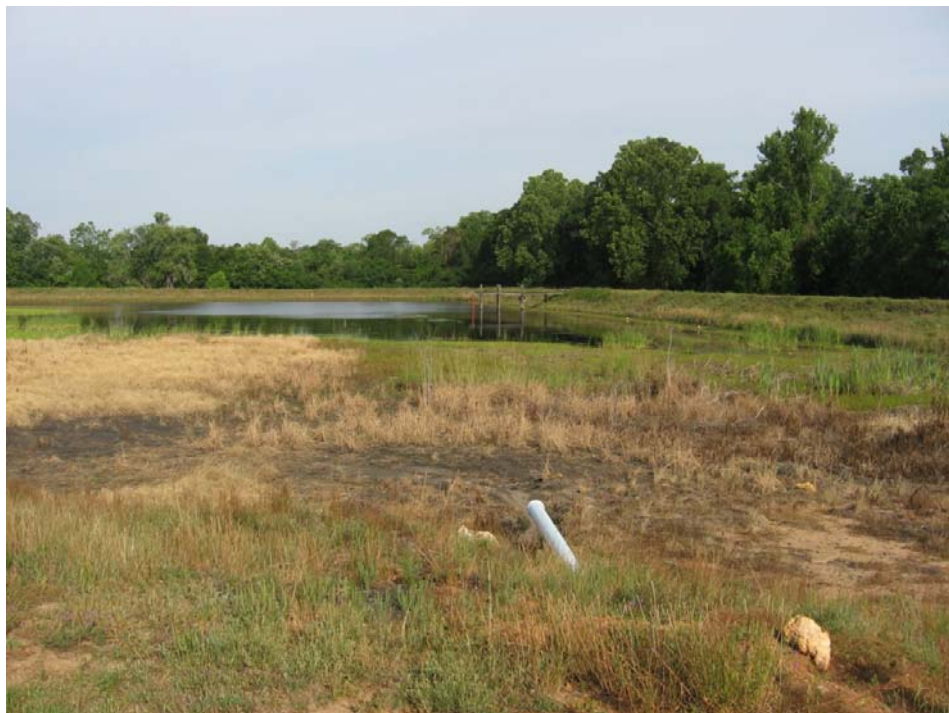
**PHOTOGRAPH 4
CCW SLUICE DISCHARGE AT EAST EMBANKMENT (PVC PIPE)**

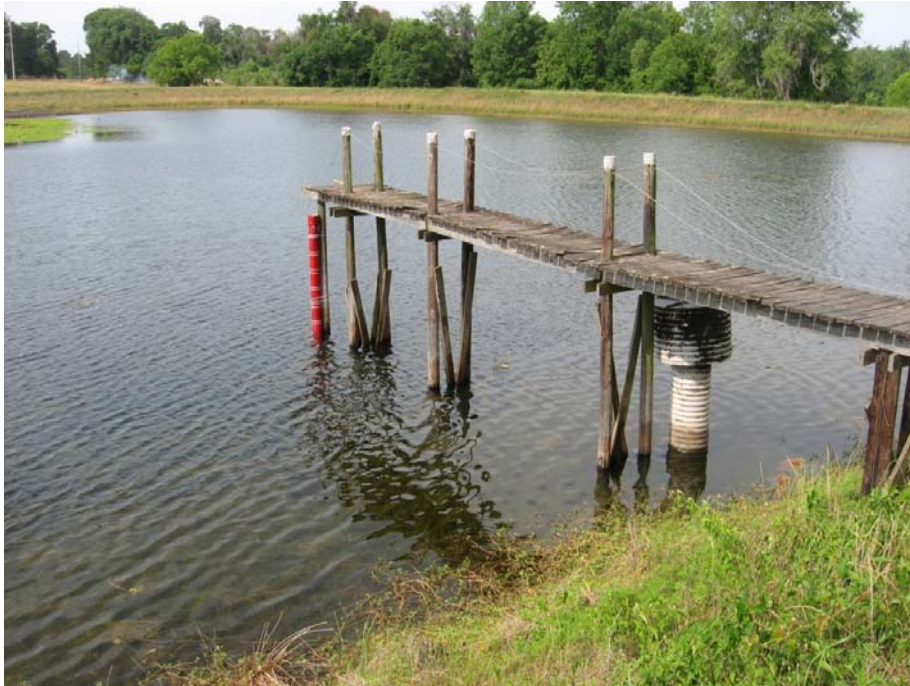
4. The vertical riser of the primary spillway was completely exposed at the time of inspection and appeared to be in good condition. No signs of excessive corrosion or deflection were noted.

**PHOTOGRAPH 5
PRINCIPAL SPILLWAY INTAKE RISER – WATER LEVEL
APPROXIMATELY 8 FEET BELOW DECK**

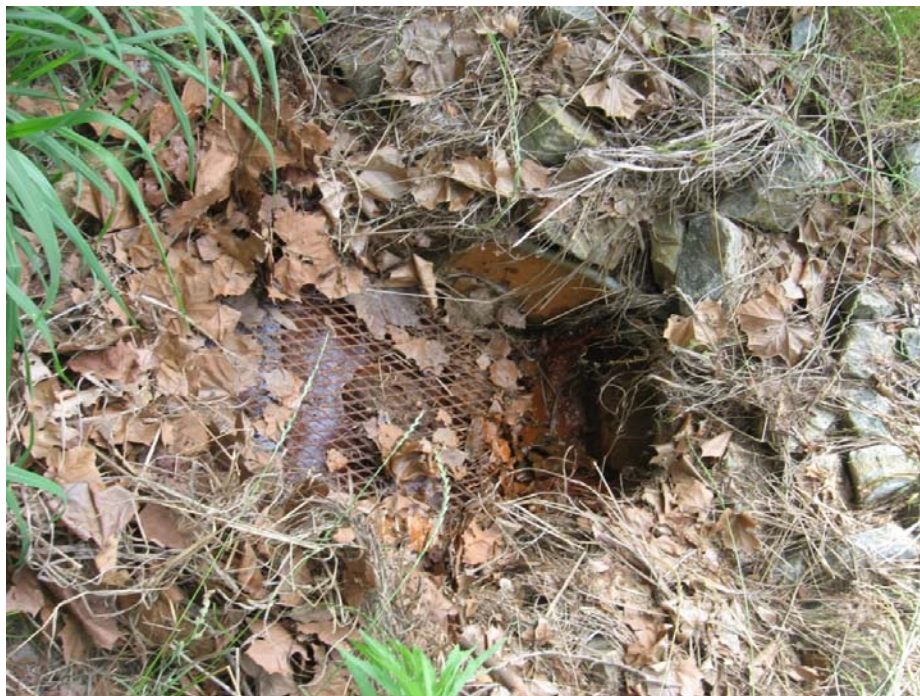
3. The downstream discharge basin of the spillway appeared to be in good condition. The flared end section and small stilling basin appear to be operating properly. At the time of inspection, no flow was occurring and a small pool of stagnant water was observed at the low point of the stilling basin. Vegetation and woody debris should be removed from the stilling basin and outlet channel in order to not impede flow.

**PHOTOGRAPH 6
PRINCIPAL SPILLWAY EXIT BASIN – OPEN EXIT CHANNEL AND
REMOVE TRASH DOWNSTREAM**

e. Exposed Reinforcement?			N/A
f. Boils Downstream?		X	
g. Springs?		X	None noted, existing ponds/swamp to N and W of impoundment
7. Discharge Channel		X	No discharge channel was provided for the outlet pipe, contributing to the discharge being covered and plugged. Discharge channel should be established.

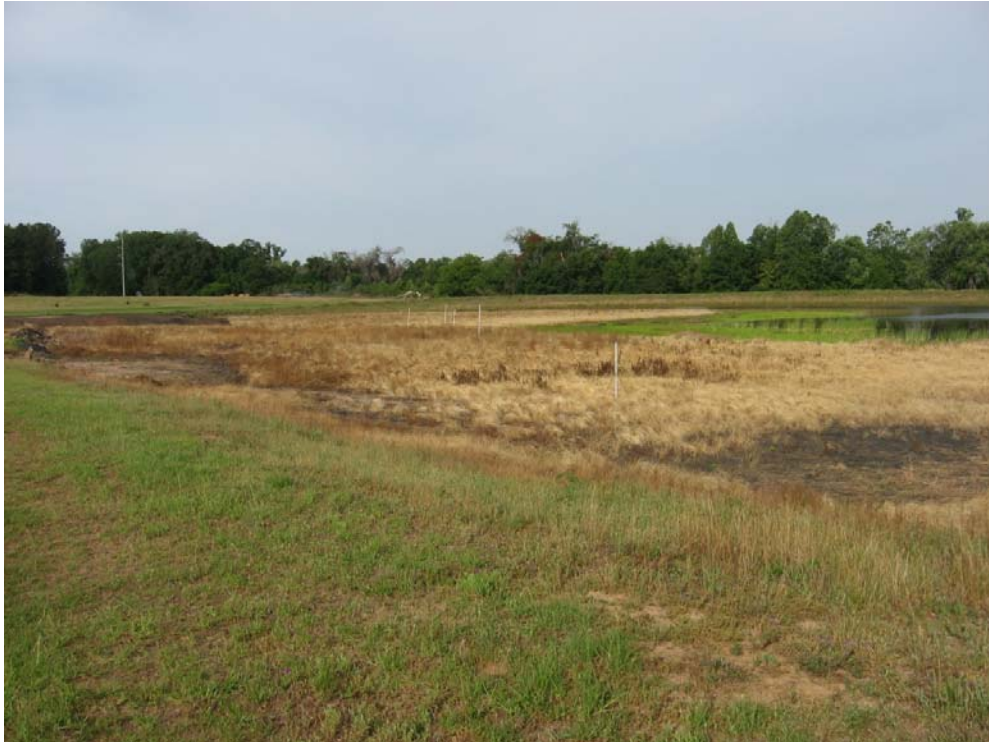
**PHOTOGRAPH 7
ASH POND LOOKING WEST**

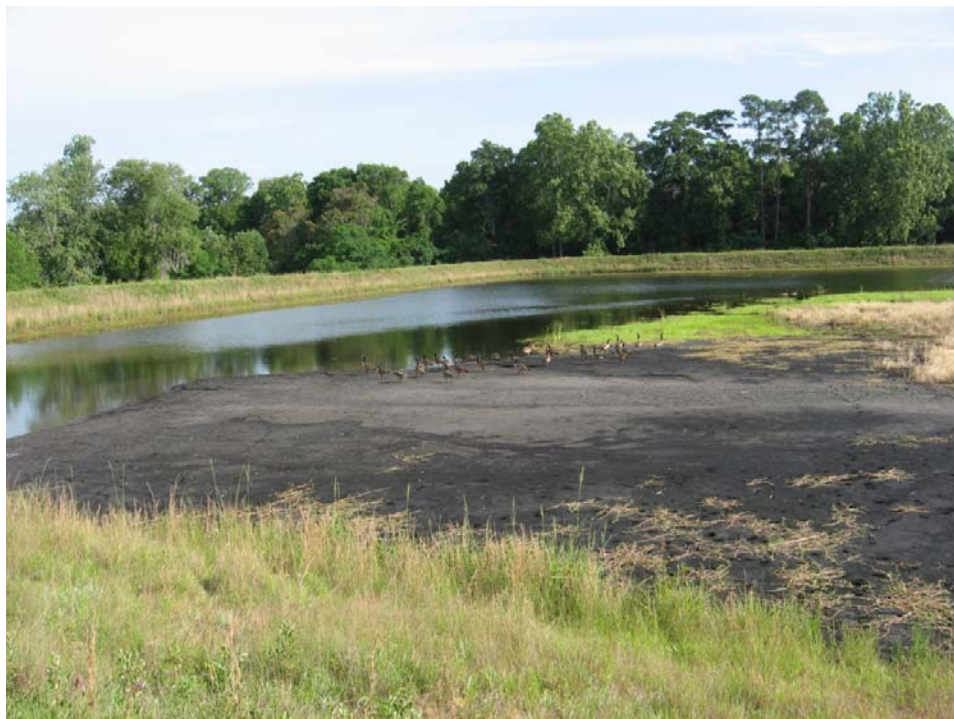
1. The slopes of the West Embankment were somewhat overgrown at the time of inspection. In general the growth consists of low ground cover vines and grasses, but an occasional small tree 1 inch to 2 inch in diameter was noted.

2. The exterior slopes of the West Embankment are irregular, with hummocky areas and some vertical surfaces near the crest. Minor surface erosion was noted at several locations. The condition of the West Embankment should continue to be monitored especially if the pond water level is raised.

**PHOTOGRAPH 8
FROM SOUTH LOOKING TOWARD NORTH AND WEST EMBANKMENTS**

- **Recommendation 1** – The exterior slopes of the West Embankment should be stripped and restored to a consistent section with compacted engineered fill. After the section is restored, the area should be seeded or sodded as appropriate to prevent further erosion in the area.

- **Recommendation 3** – The slopes of the North and West Embankments are overgrown and should be mowed or cleared. In particular, small trees should be removed from the slope to prevent negative impacts on the embankments caused by extending root systems.

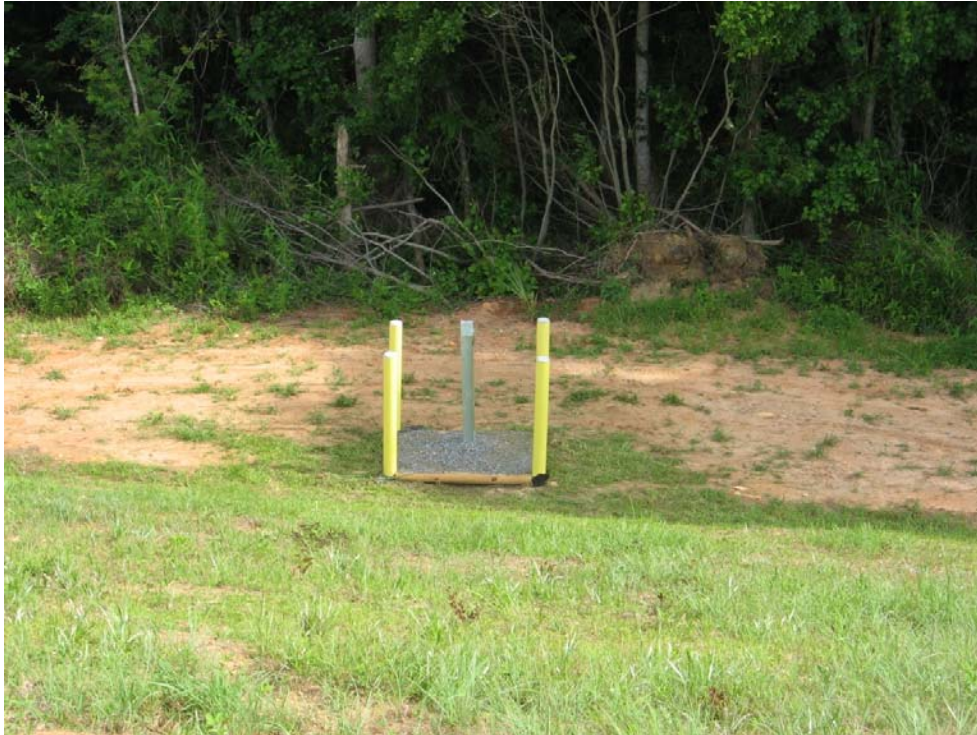
PHOTOGRAPH 9
GROUNDWATER MONITORING WELL ON NORTH TOE OF DAM

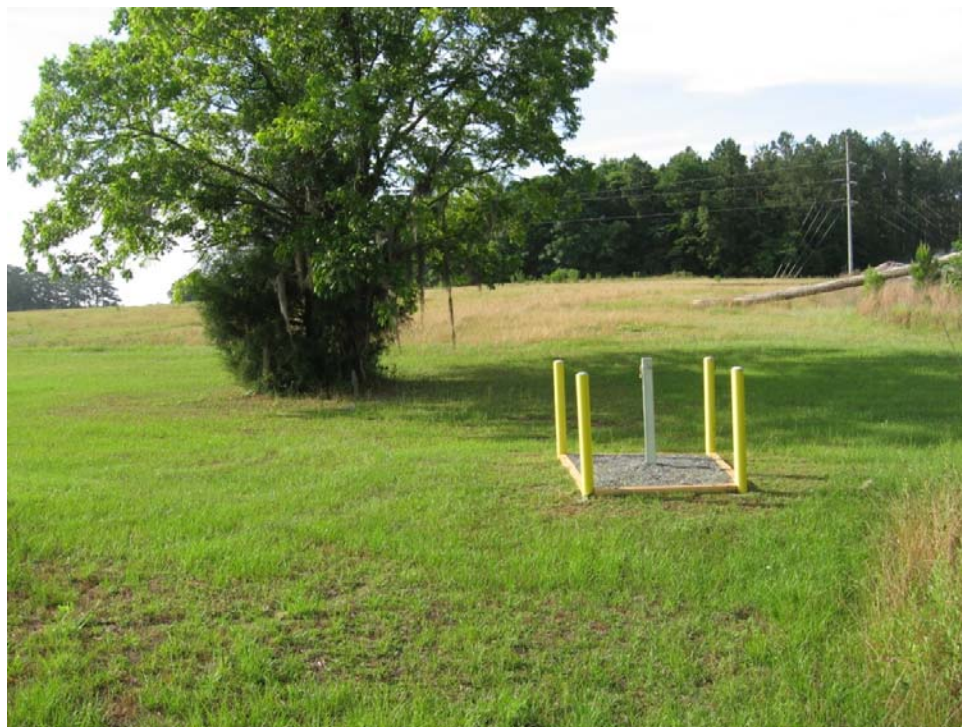
PHOTOGRAPH 10
GROUNDWATER MONITORING LEVEL UPSTREAM OF ASH POND
