# ASSESSMENT OF DAM SAFETY OF COAL COMBUSTION SURFACE IMPOUNDMENTS – FINAL REPORT

**Crisp County Power  
Commission  
Plant Crisp  
Warwick, Georgia**

Prepared for  
*U.S. Environmental  
Protection Agency  
Washington, D.C.*

December 2013  
Revision 1, February 2014

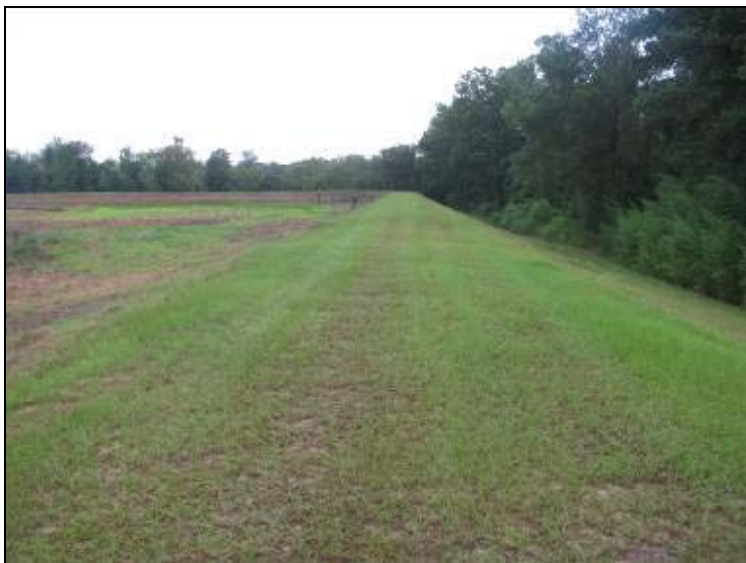
The crest of the perimeter embankment appeared to be in **SATISFACTORY** condition (Photographs 1, 34, 37, 40, 41, 46, 48 and 58). The crest width varies from about 15 and 20 feet. The crest of the embankments has a grass cover that was about 4 to 6 inches high. Reportedly, the crest is exposed to very limited vehicle traffic, only during maintenance operations. No signs of cracks, erosion, scarps, depressions, or settlement were observed on the crest of any of the embankments.

Photo 1: Ash Pond – Crest of north embankment, looking west.

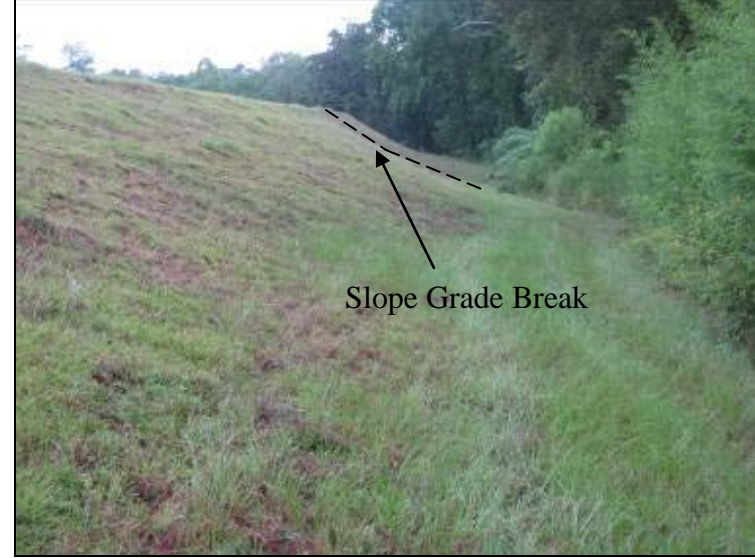
Photo 6: Ash Pond – North embankment exterior slope, change in slope grade from approximately 2.8 H:1V to 2H:1V, looking west.

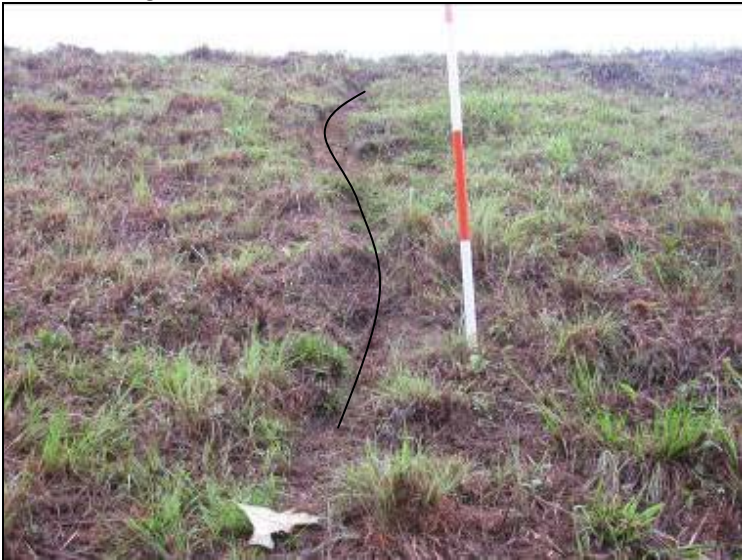
Photo 7: Ash Pond – North embankment exterior slope, surficial erosion rill running from crest to toe of slope looking south.

Erosion rills and scarps – Erosion rills and scarps were observed on the exterior and interior slopes of the west embankment. Structural fill should be placed and compacted in the rills and scarps and the repaired areas graded to meet the adjacent existing contours. After slope restoration, it is recommended that the exposed surface of the embankment be stabilized with sod or hydroseeded to restore vegetation cover on the slopes.

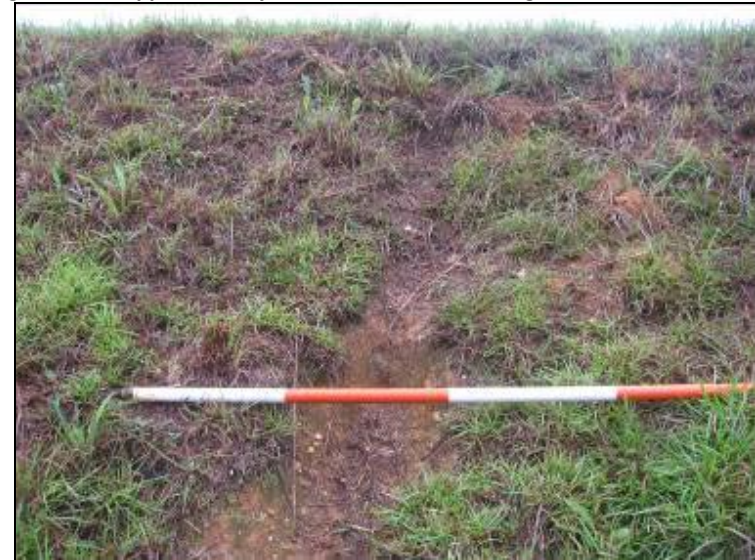
Photo 8: Ash Pond – North embankment exterior slope, erosion rill near crest, looking south.

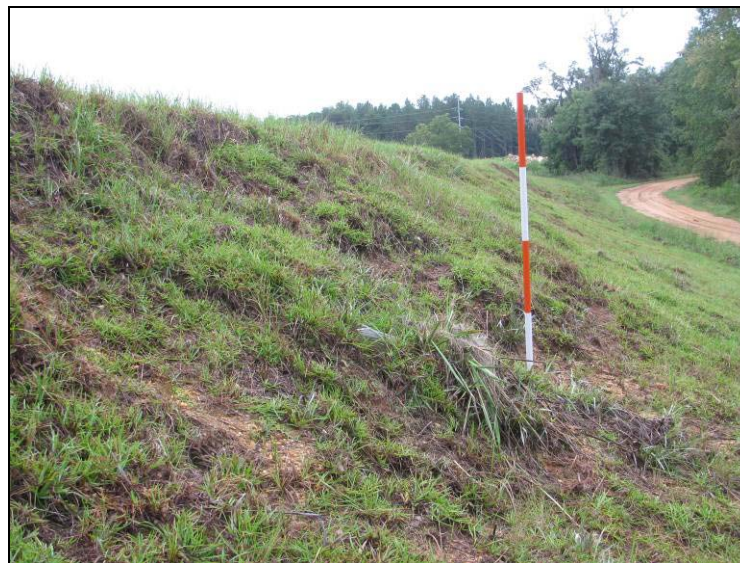
The exterior slopes appear to be in **FAIR** condition. The exterior slopes of the embankments are about 2H:1V at the north and west embankments, 5H:1V at the south embankment, and 4H:1V at the southeast embankment. The east portion of the north embankment has an approximate slope of 3H:1V with a slope break near the outlet structure to 2H:1V (Photograph 6). Slopes shown on the drawings provided are 3H:1V. The exterior slopes are covered with grass that was approximately 4 to 6 inches high at the time of the visual assessment (Photographs 14 to 17, 31, 32, 38, 39, 44 and 45). Surficial erosion rills and scarps were observed at the north embankment (Photographs 5, 7 and 8). An apparent 16-foot-long semicircular surficial slough (Photographs 21 to 23) and several minor sloughs and scarps near the crest (Photograph 18, 19, 20, and 24 to 27) were observed on the west embankment.

Photo 18: Ash Pond – West embankment exterior slope sloughing, looking South.

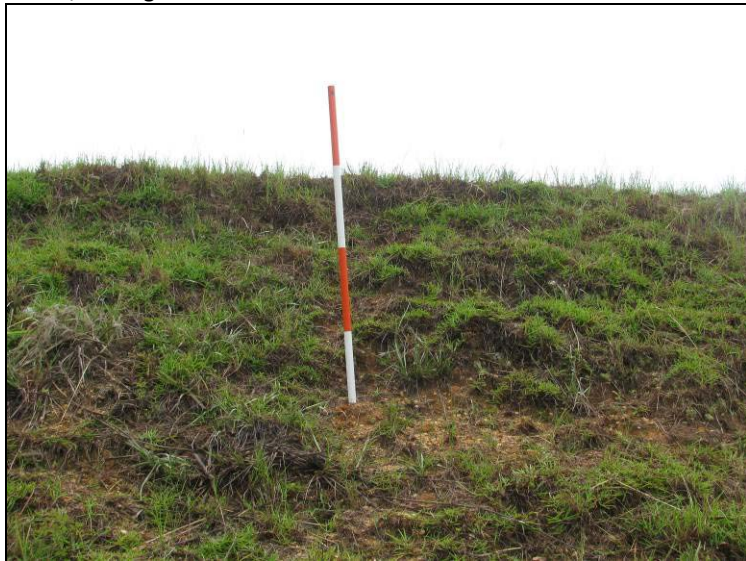
Photo 19: Ash Pond – West embankment exterior slope sloughing, looking east.

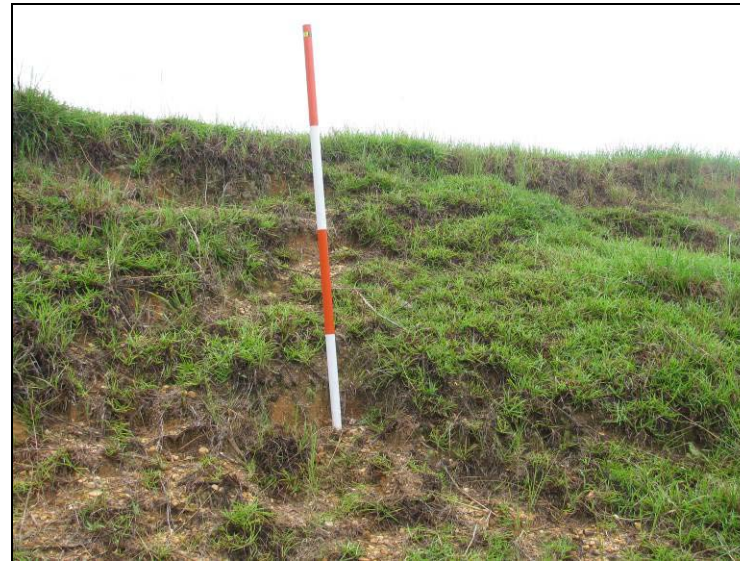
Photo 20: Ash Pond – West embankment exterior slope sloughing, looking southeast.

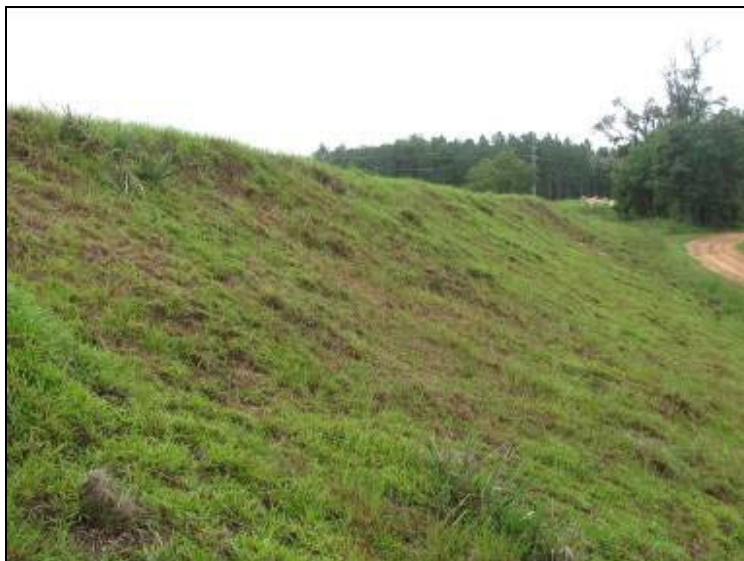
Photo 21: Ash Pond – West embankment exterior slope, apparent 16-foot long semi-circular sloughing, looking southeast.

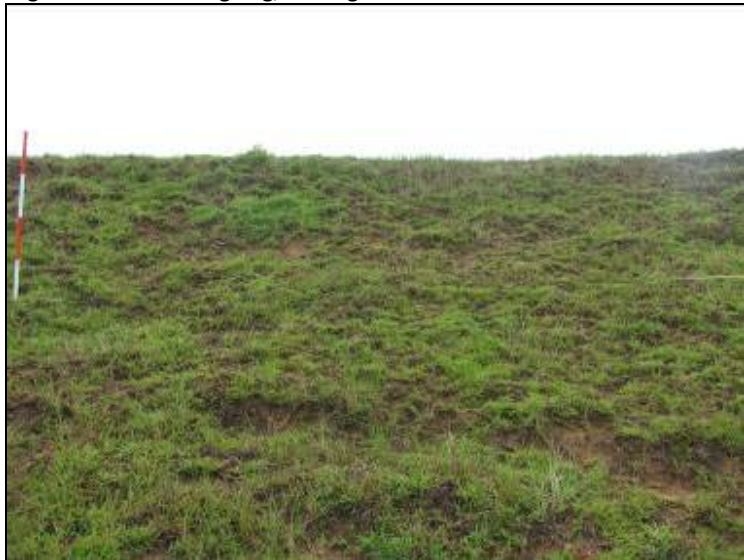
Photo 23: Ash Pond – West embankment exterior slope, apparent 16-foot long semi-circular sloughing, looking east.

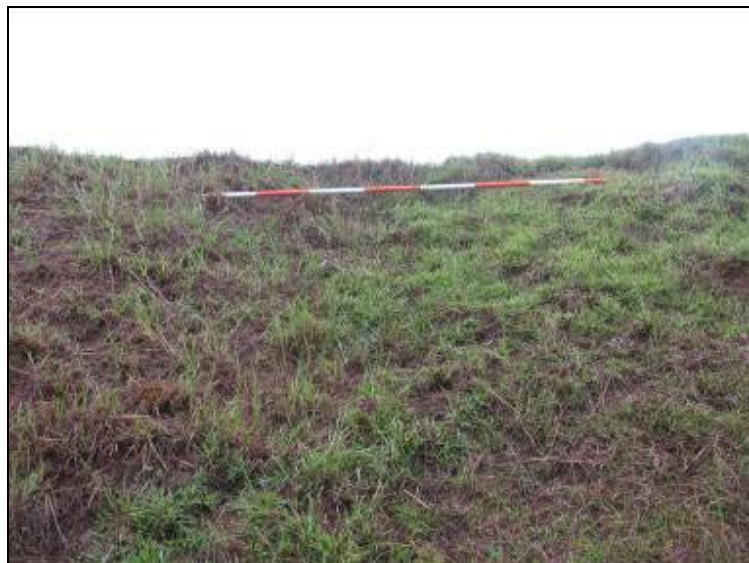
Photo 25: Ash Pond – West embankment exterior slope, sloughing near crest of embankment, looking east.

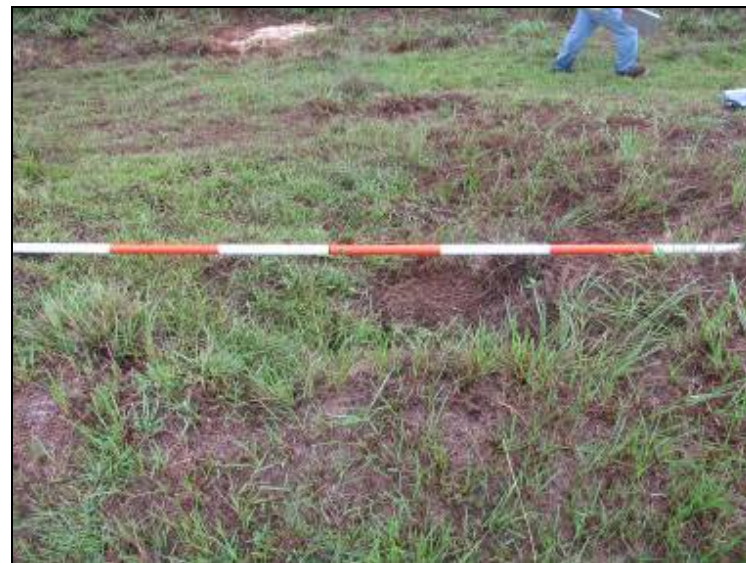
Photo 26: Ash Pond – West embankment exterior slope, sloughing near crest, looking west.

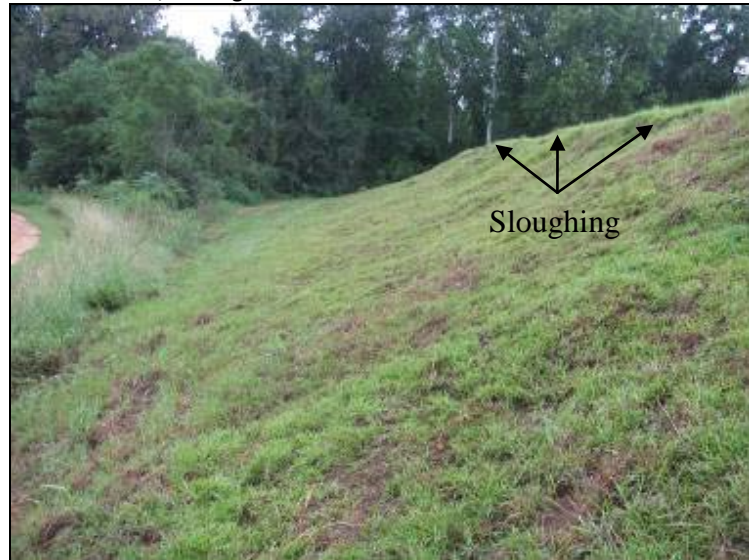
Photo 27: Ash Pond – West embankment exterior slope, looking north.

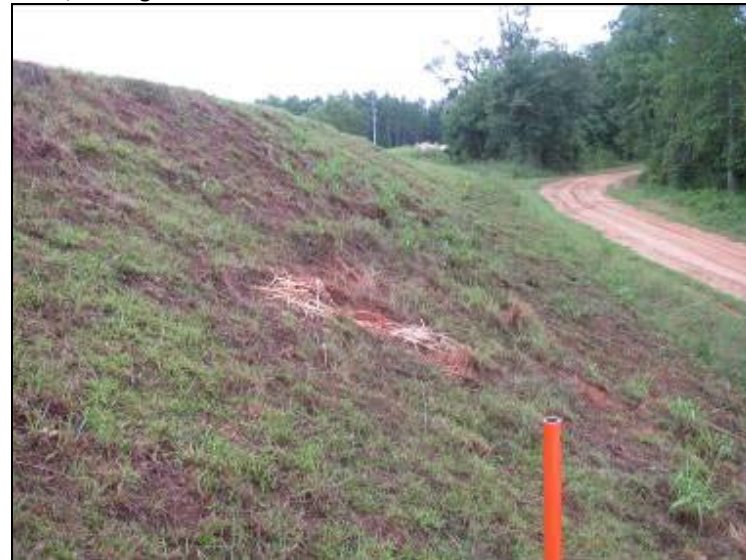
Photo 28: Ash Pond – West embankment exterior slope, looking south.  
Note: steepness of slope (2H:1V).

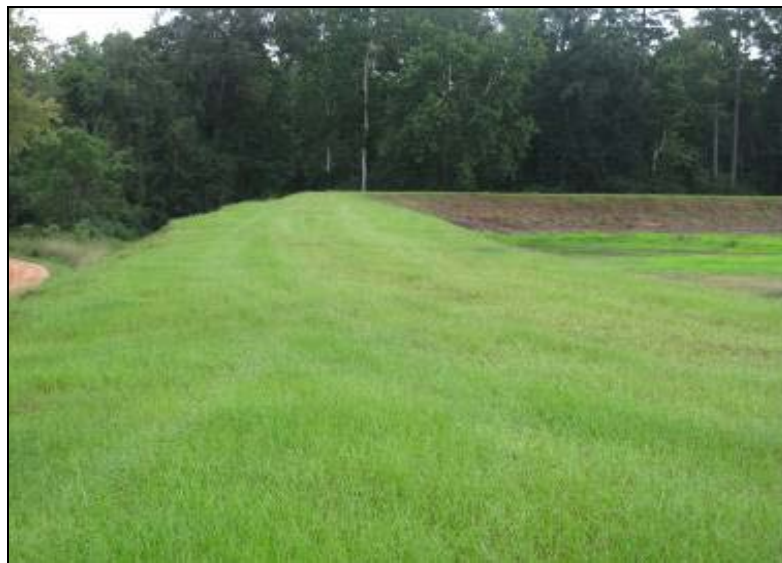
Photo 34: Ash Pond – Crest of west embankment looking north.

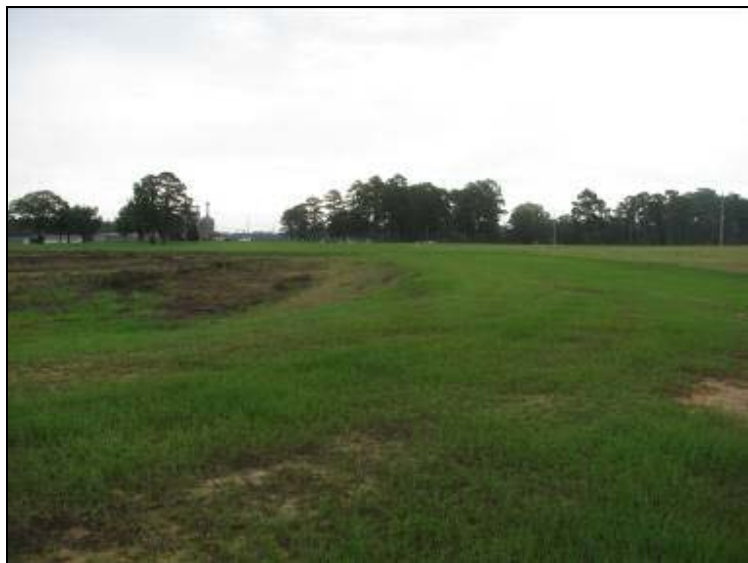
Photo 37: Ash Pond – Crest of South embankment looking east.

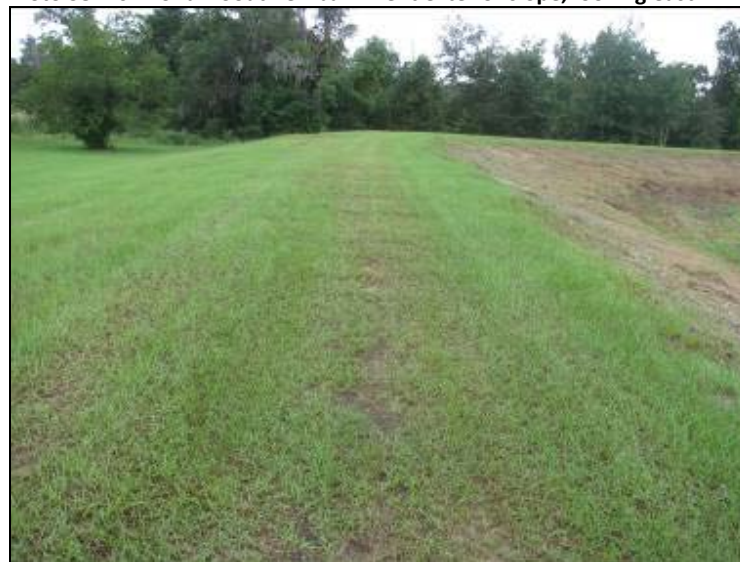
Photo 40: Ash Pond – Crest of south embankment looking west.

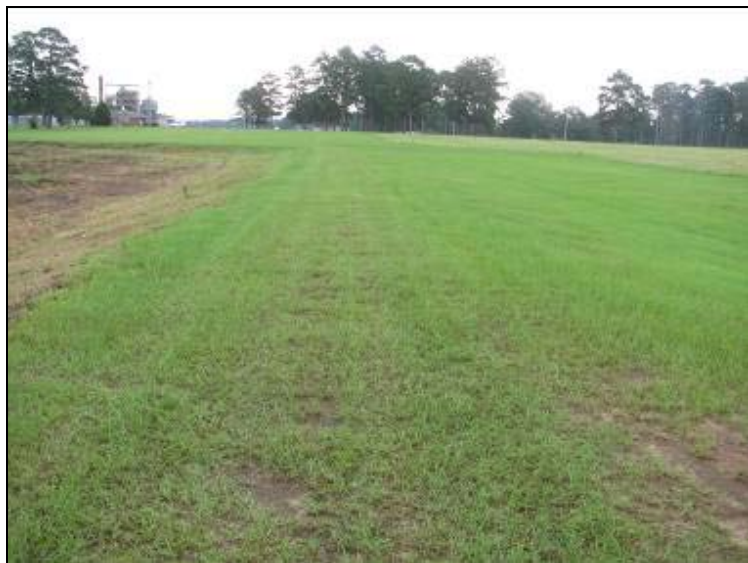
Photo 41: Ash Pond – Crest South Embankment looking east.

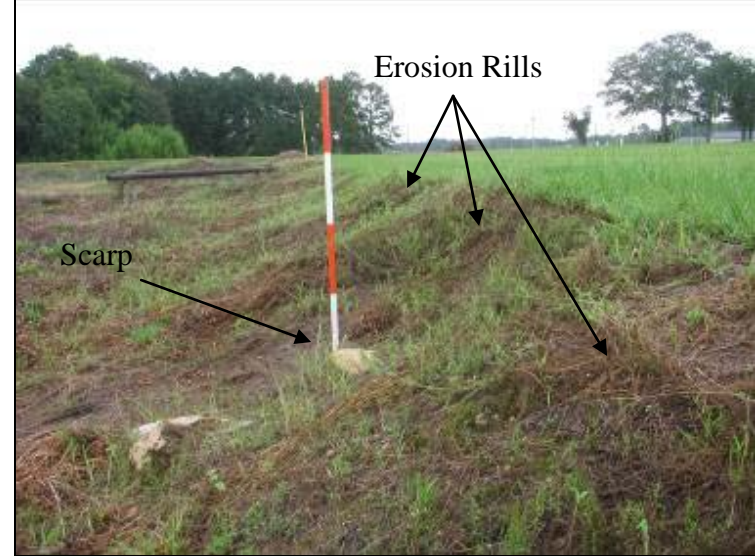
Photo 50: Ash Pond – Southeast embankment interior slope, looking northeast. Note: erosion rills and surficial scarps.

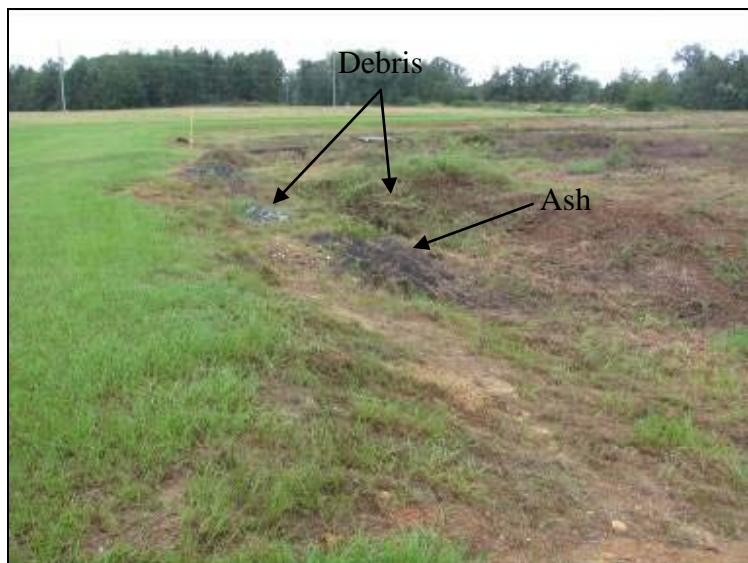
The interior slopes of the Ash Pond embankments appear to be in **FAIR** condition. The interior slopes are about 2H:1V at the north and west embankments, 3H:1V at the south embankment, and 5H:1V at the southeast embankment. Slopes shown on the drawings provided are 3H:1V. Interior slopes have a grass cover approximately 4 inches high (Photographs 4, 9, 10, 42, 43, 57, 60, 67, 71 and 72). Scarps and erosion rills (Photographs 50, 59, 61, 62, 66, 70 and 75) were observed along the interior slopes of the north, west, and south embankments. Several boulders (rocks with size greater than 12 inches) protruding from the face of the slope (Photographs 65 and 73) were observed on the north and south embankments. Near the southeast embankment, accumulated ash and debris were clearly visible (Photograph 53).

Photo 53: Ash Pond – Crest and interior slope southeast embankment, looking southwest. Note: Ash and debris at pond surface.

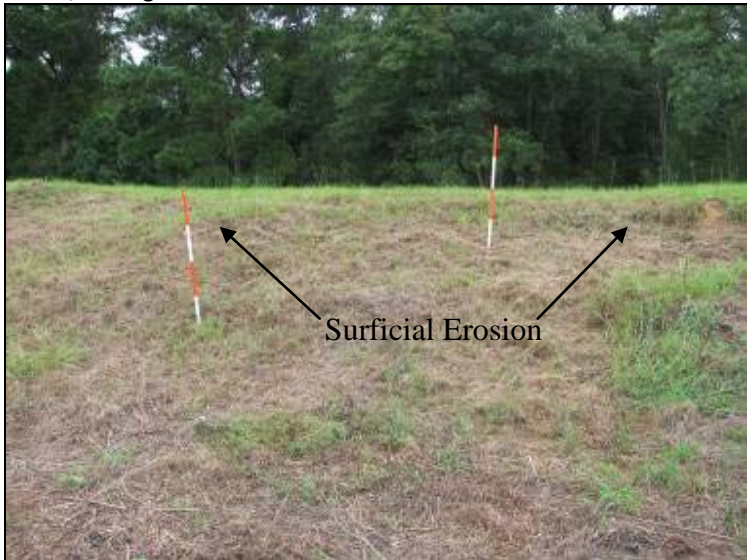
Photo 59: Ash Pond – North embankment interior slope, surficial erosion (30-foot long) looking northwest.

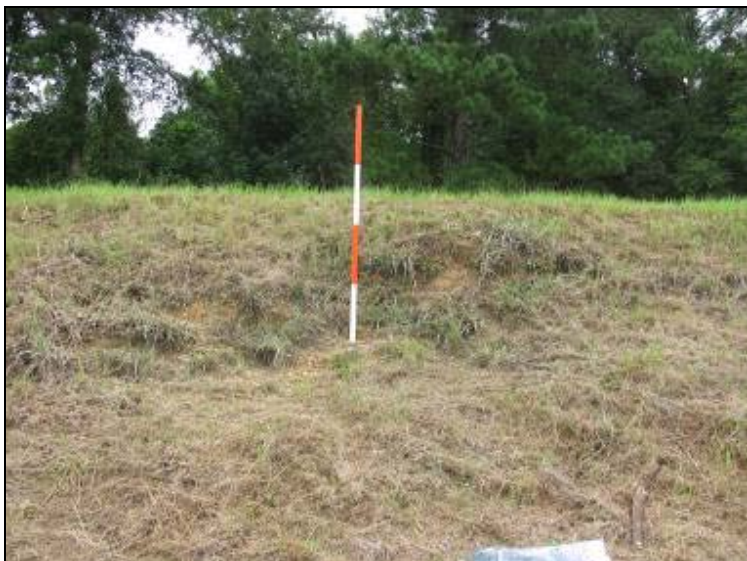
Photo 61: Ash Pond – North embankment interior slope surficial erosion, looking north.

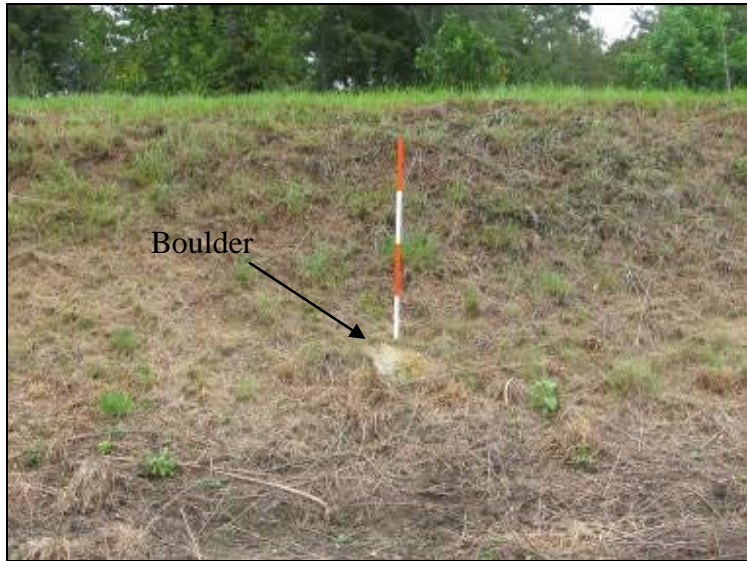
Photo 65: Ash Pond – North embankment interior slope, looking north.  
Note: boulder (12"-24") and steepness of slope (2H:1V).

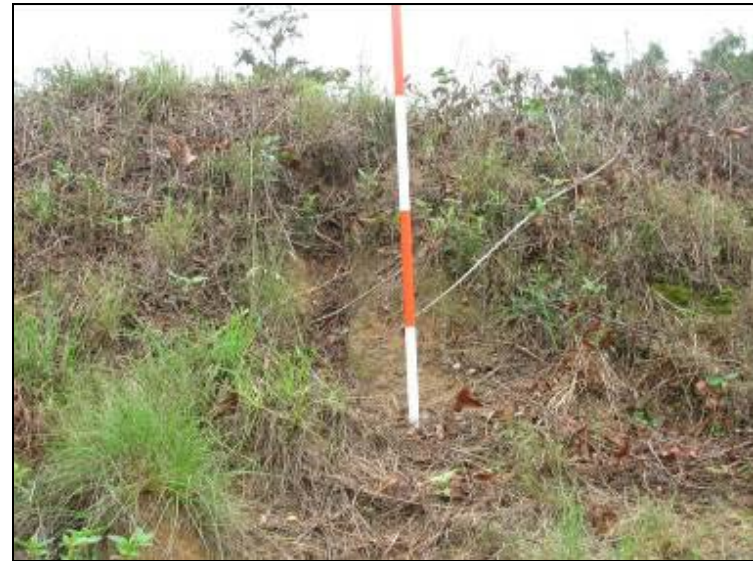
Photo 66: Ash Pond – North Embankment interior slope, erosion rills near outlet structure looking north.

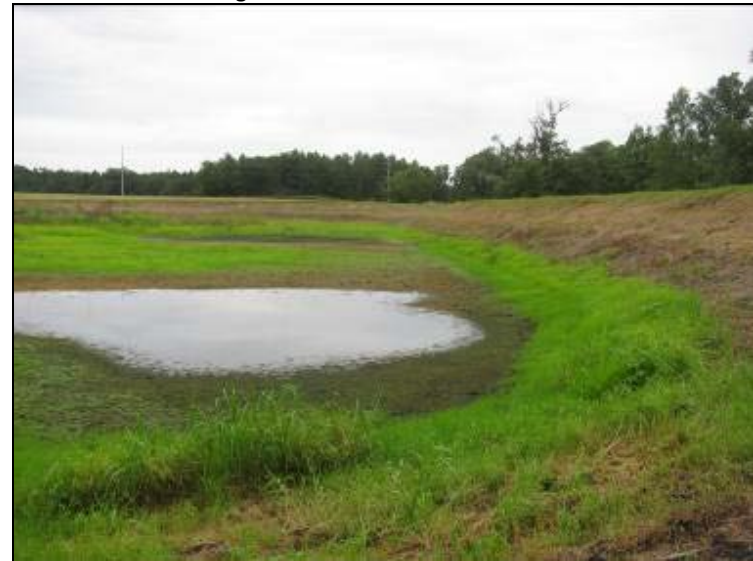
At the time of the assessment, the Ash Pond contained residual ash and a limited amount of ponded water near the northwest corner of the impoundment (Photograph 68). The volume of ponded water did not adversely impact storage capacity of the Ash Pond. The bottom of the pond was covered with well-maintained vegetative cover. It was indicated by the Crisp County Power Commission staff that the Ash Pond has never been dredged to remove accumulated ash. Approximately 8 feet of freeboard was available near the northwest corner of the pond, where the ponded water was observed. The Ash Pond is of a side-hill configuration, with the north and west embankments constructed to a height of about 23 feet.

Photo 68: Ash Pond – West embankment interior slope, looking south.  
Note: ponded water near northwest corner of pond.

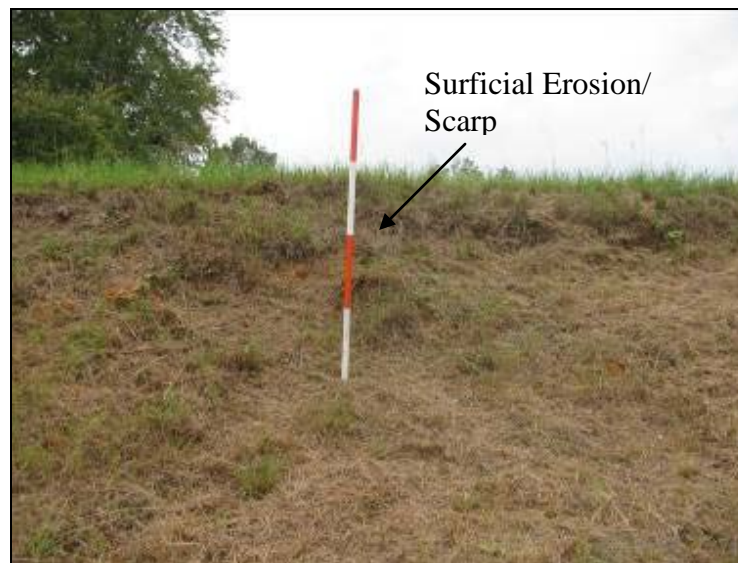
Photo 70: Ash Pond – West embankment interior slope surficial erosion/scarp, looking west.

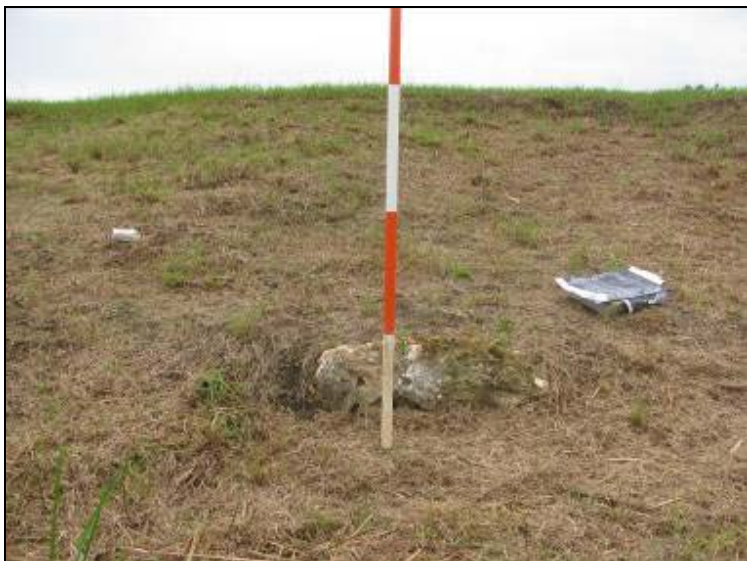
Photo 73: Ash Pond – South embankment interior slope, looking south.  
Note protruding rock at slope face.

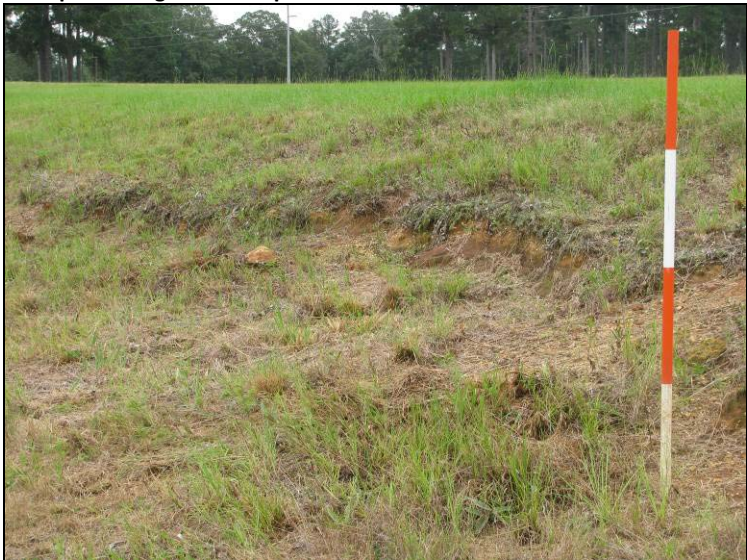
Photo 75: Ash Pond – South embankment interior slope, surficial erosion looking southeast.
