PERIODIC DAM SAFETY ASSESSMENT
PLANT CRISP ASH POND
CRISP COUNTY POWER COMMISSION
40 C.F.R. Parts 257.83 (b) and 257.73(a)(2), (d), and (e)
Prepared by Geosyntec Consultants

ASH POND INSPECTION - (40 C.F.R. § 257.83 (B))

The objective of this section is to document the dam safety inspection conducted by Geosyntec Consultants (Geosyntec) on 30 December 2019 in accordance with the requirements outlined in 40 C.F.R. § 257.83. The previous annual inspection was completed by Rizzo International, Inc. (Rizzo) in March 2019.

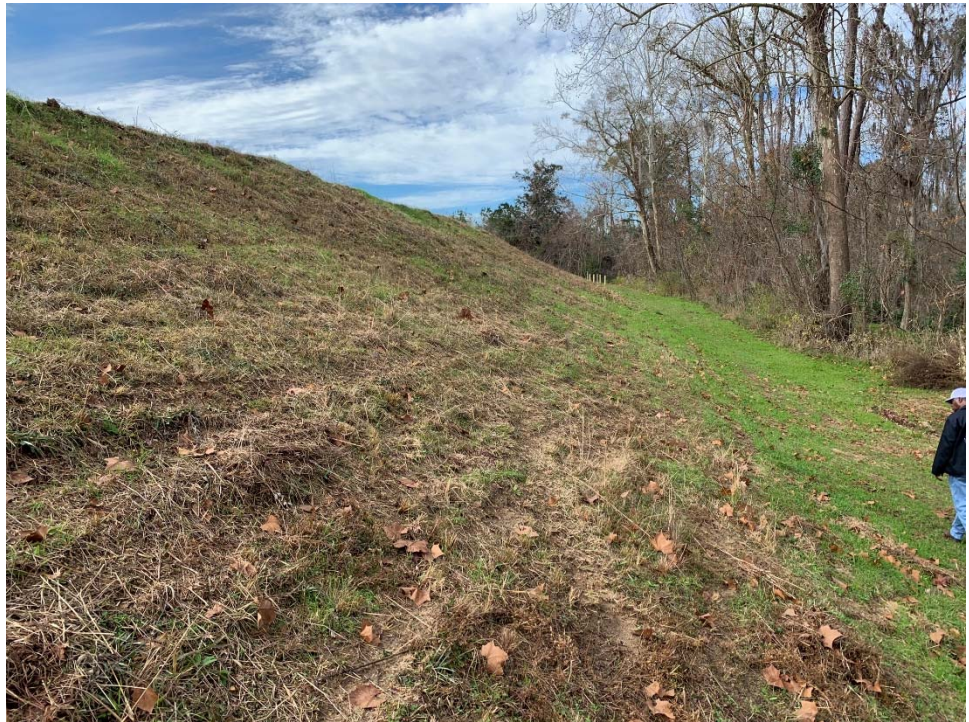
Description:

rainy season, which typically ends in April or May of each year. This was confirmed for this calendar year by review of the 2019 weekly inspection reports, for which the wet area was observed to have dried up during the inspection performed the week of 28 May 2019. The wet area is located adjacent to potential wetlands to the north of the AP and review of the measured groundwater levels from MW-D3 indicate that piezometric levels varied from 1.1 to 3.7 feet below ground surface (ft bgs) in this area from February 2017 to December 2019. The most recent two readings on 23 October 2019 and 30 December 2019 recorded water levels at approximately 3.7 and 1.8 ft bgs, respectively. Tire rutting was apparent in the area and, therefore, vehicle traffic at the toe of the north slope should be minimized as much as practical.

Exterior Slopes at Toe of North Embankment

- Continue to inspect the impoundment for changes of condition and document these reports in accordance with 40 C.F.R. § 257.
- Continue monitoring the wet area near the toe of the North Embankment for presence of active seeps, discoloration, soft zones, sloughing, cracking, or other evidence of slope

instability. This area and the slope immediately upstream of the wet area should be closely monitored during periods when the AP impounds water behind the dike. If signs of turbid seepage are observed in this area, we recommend having the condition inspected by a licensed engineer.

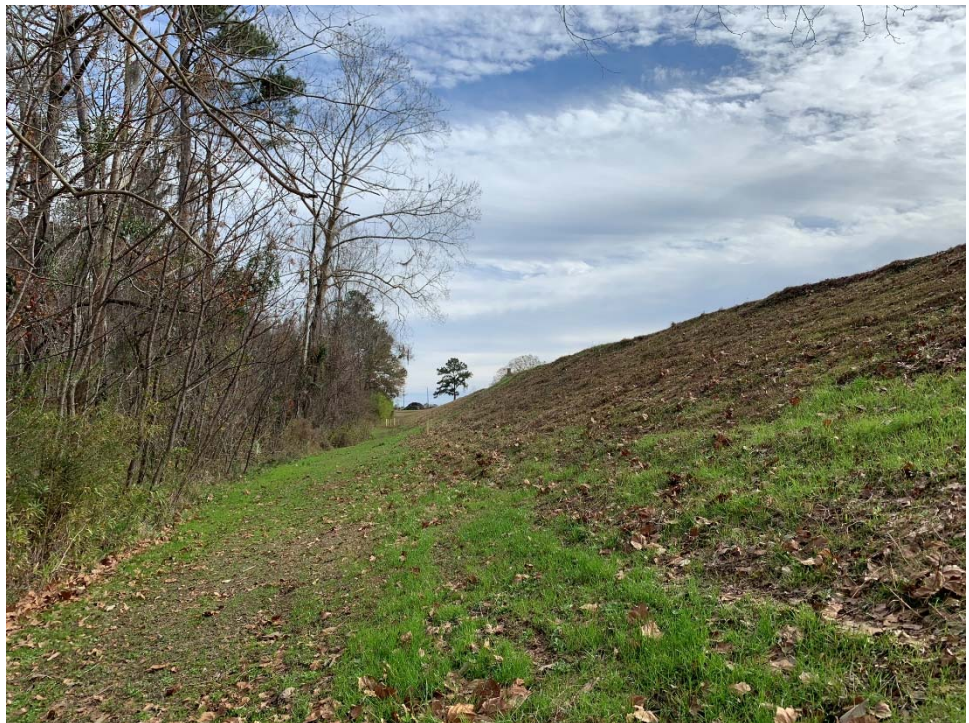
Photograph No. 08

Exterior Slopes at Toe of North Embankment

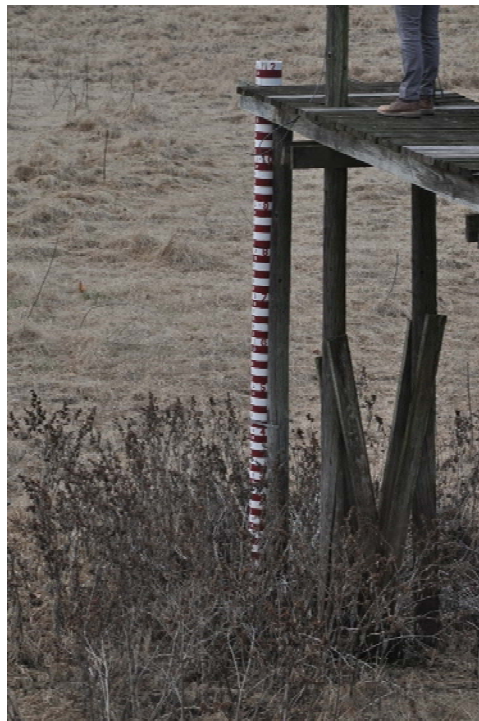
Photograph No. 14

**12' Tall Gage at
Boardwalk to CMP Drop
Inlet. No ponded water
was observed in the
vicinity of the outlet
structure; Ash Pond
appeared to be mostly
dry at time of inspection,
.**

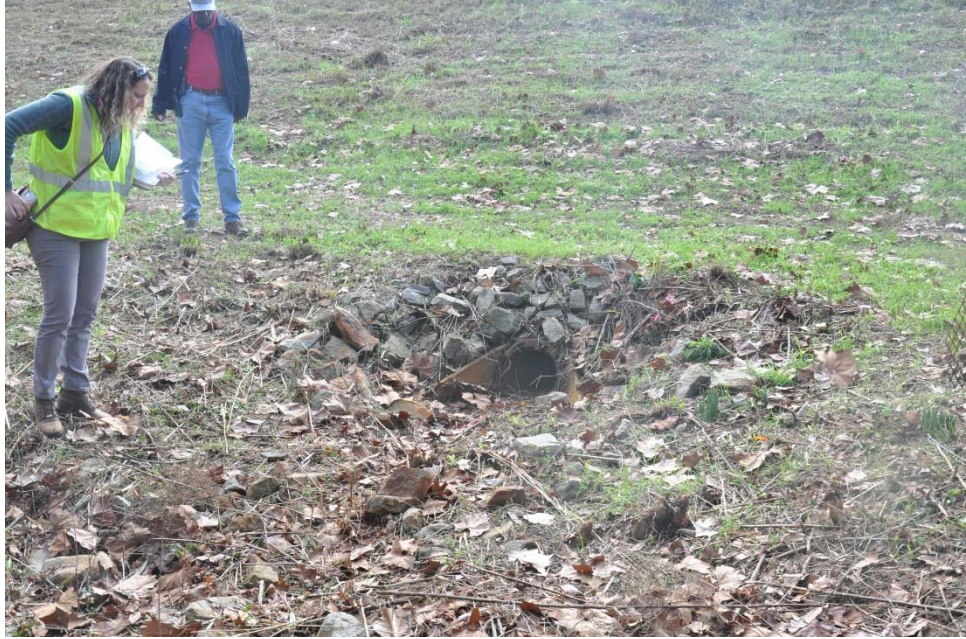
Photograph No. 17

**Flared End-Section
Added to Drop Inlet
Outlet Structure Outfall
(protective grating for
animal control removed
for photo). No
flow/discharge observed.**

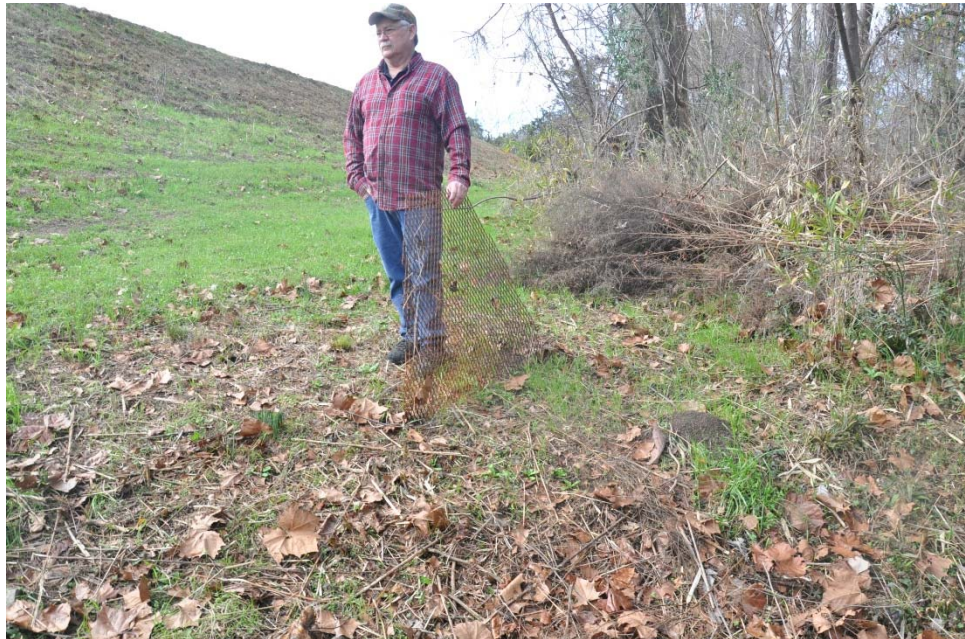
Photograph No. 18

**Grate To Be Reinstalled
Over Outfall**

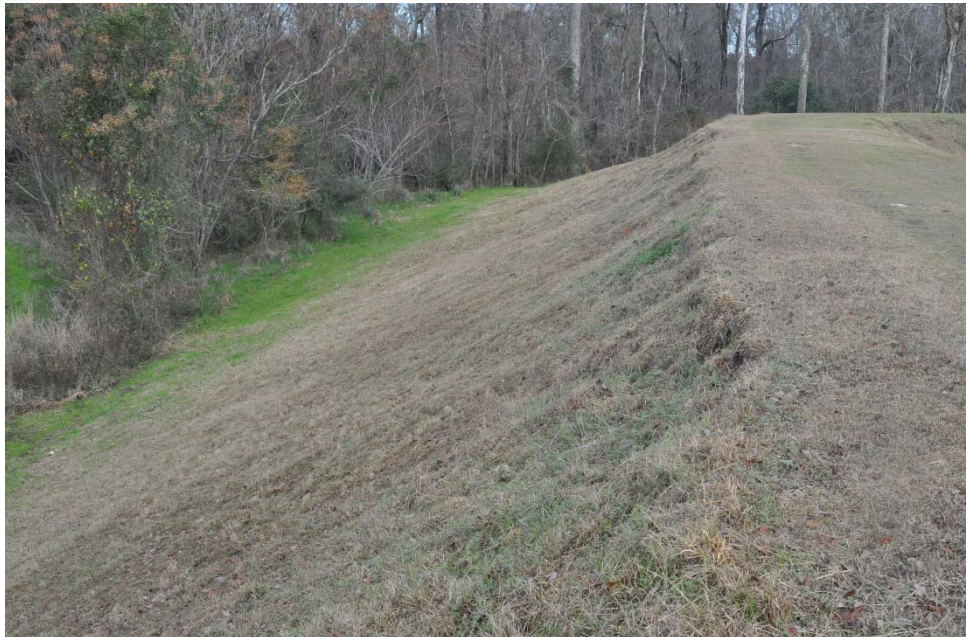
Photograph No. 28

**West Embankment
Exterior Slope in
Hummocky/ Bare Area**

| ITEMS | YES | NO | REMARKS |
|---|---|---|---|
| b. Sloughs or Slumps | x | | There are 1- to 1.5-ft-high vertical faces along the crest on the outside slope at several locations on the west embankment. The exterior slopes on the west embankment are somewhat irregular/hummocky. No circular slip surfaces or cracks were observed. Based on conversations with site personnel, the irregular surface may be due to removal of extra material during previous brush- clearing operations. |

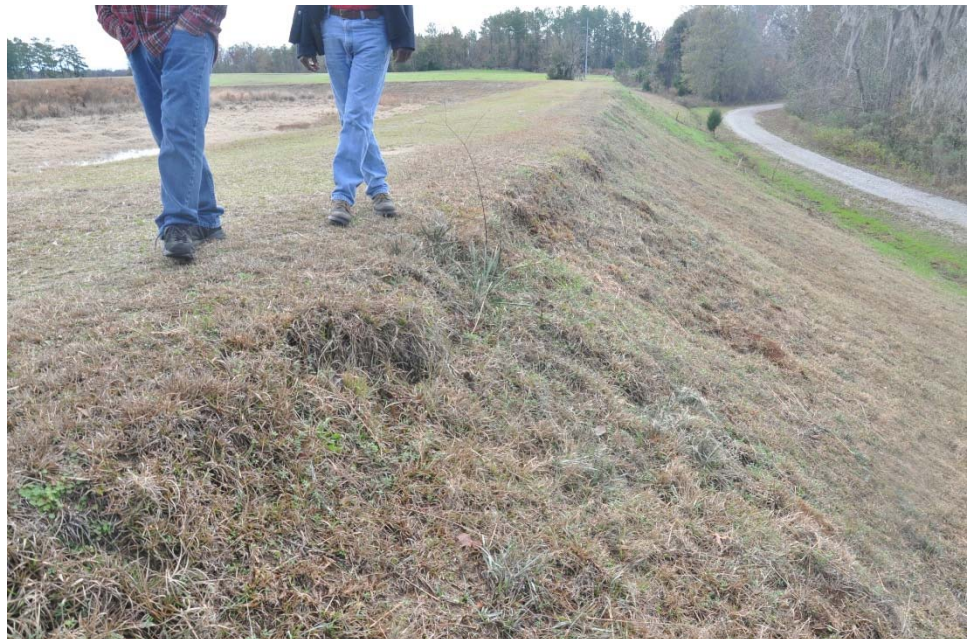
Photograph No. 30

**West Embankment
Irregular Exterior Slope**

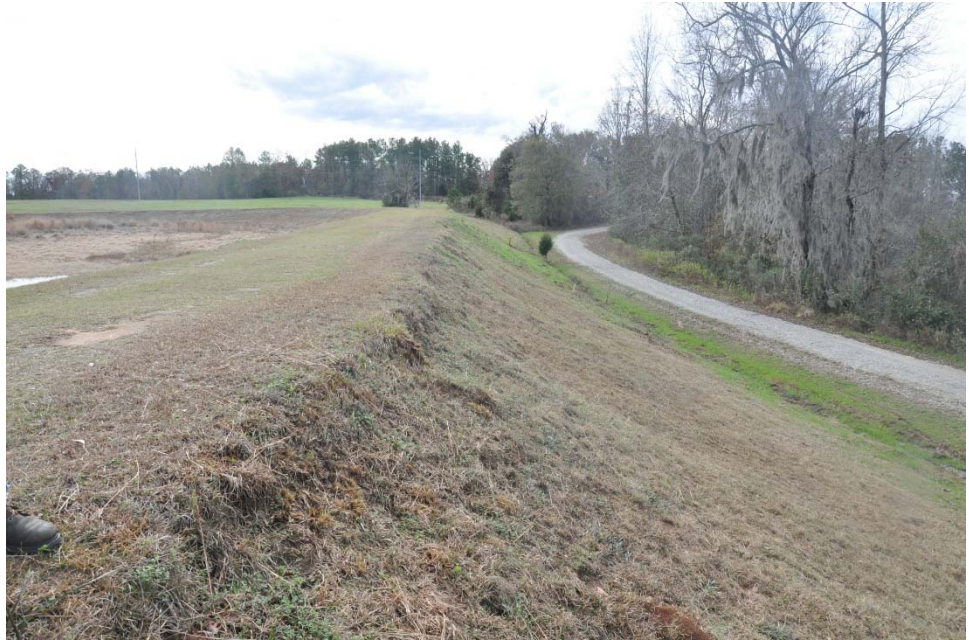
Photograph No. 31

**Description:
Vertical Surfaces at Crest
of West Embankment**

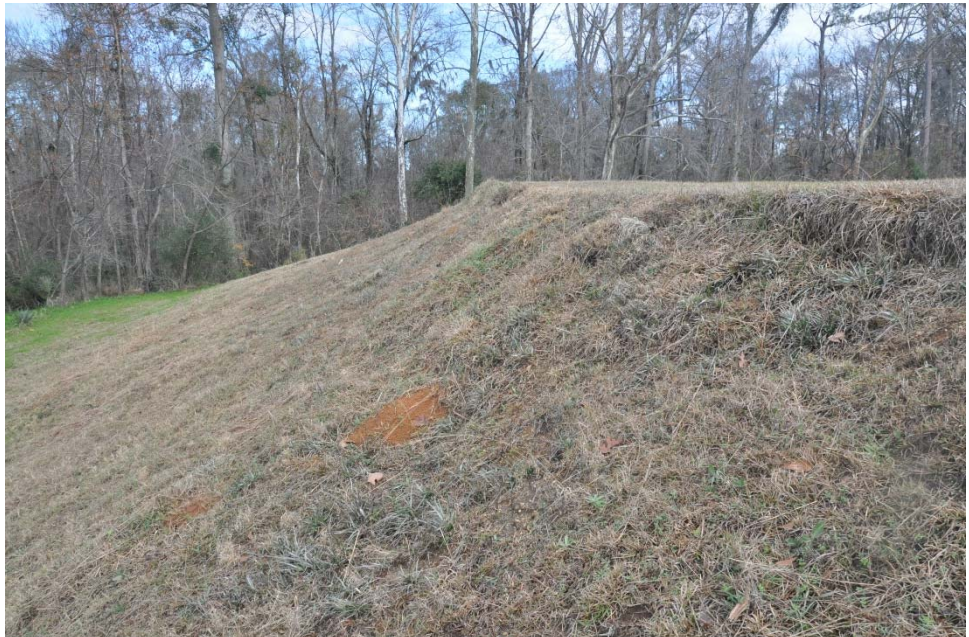
Photograph No. 32

**Description:
Irregular Exterior Slopes
on West Embankment**

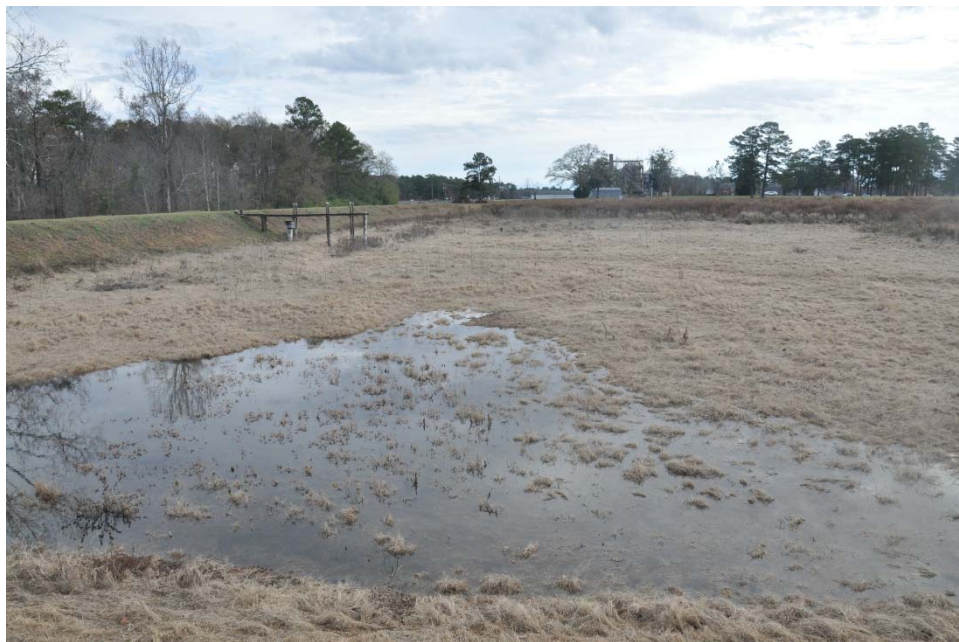
Photograph No. 35

**Interior Slopes of West
Embankment and Pond
Bottom Near NW Corner;
Small Pool of Standing
Water Observed**
