September 30, 2015
Project No. 14-5232

**DAM SAFETY INSPECTION REPORT
PLANT CRISP CCW IMPOUNDMENT
CRISP COUNTY POWER COMMISSION
PROJECT NO. 14-5232**

This Letter Report summarizes the observations and resulting recommendations from our dam safety inspection of the Plant Crisp Coal Combustion Waste (CCW) Impoundment performed on Thursday, September 24, 2015. RIZZO Associates (RIZZO) services for this Project were performed in accordance with our August 20, 2015, Proposal submitted to Crisp County Power Commission (CCPC).

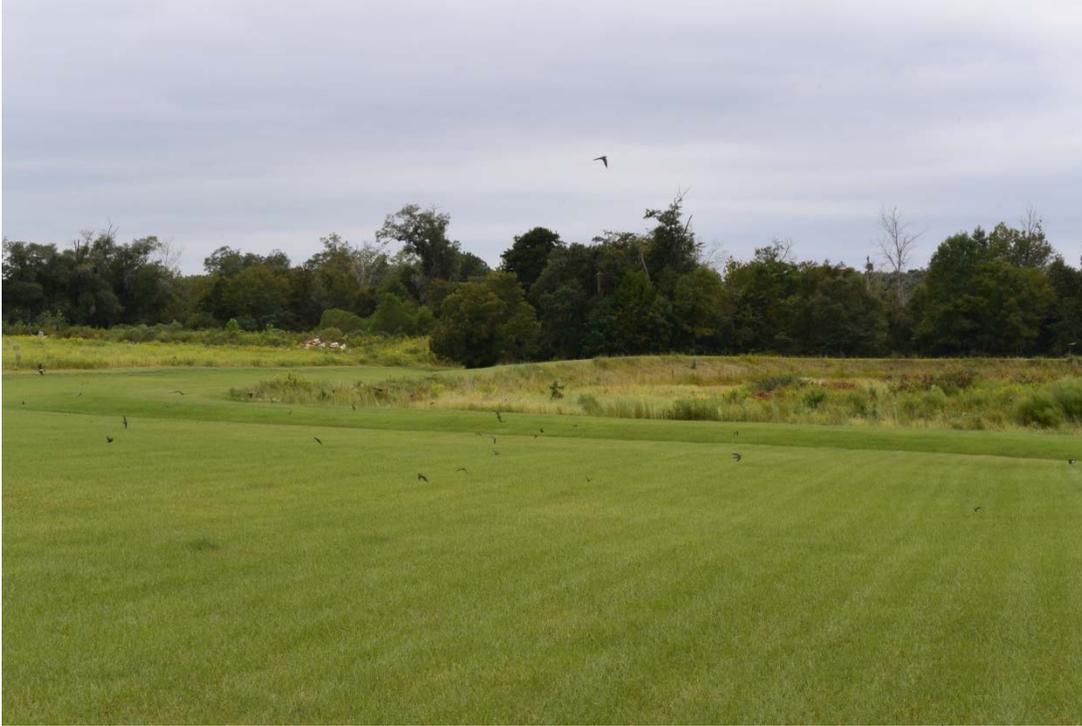
**PHOTOGRAPH 1
SOUTHERN END OF EAST EMBANKMENT (LOOKING W)**

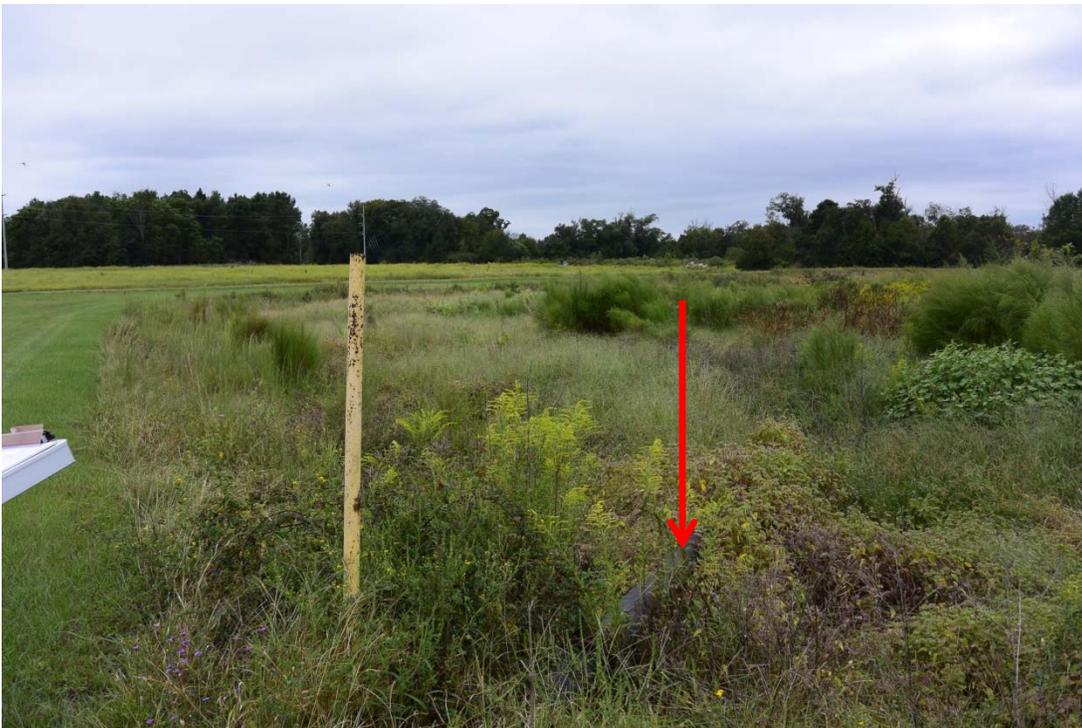
**PHOTOGRAPH 2
CCW SLUICE DISCHARGE AT EAST EMBANKMENT (BLACK IRON PIPE)**

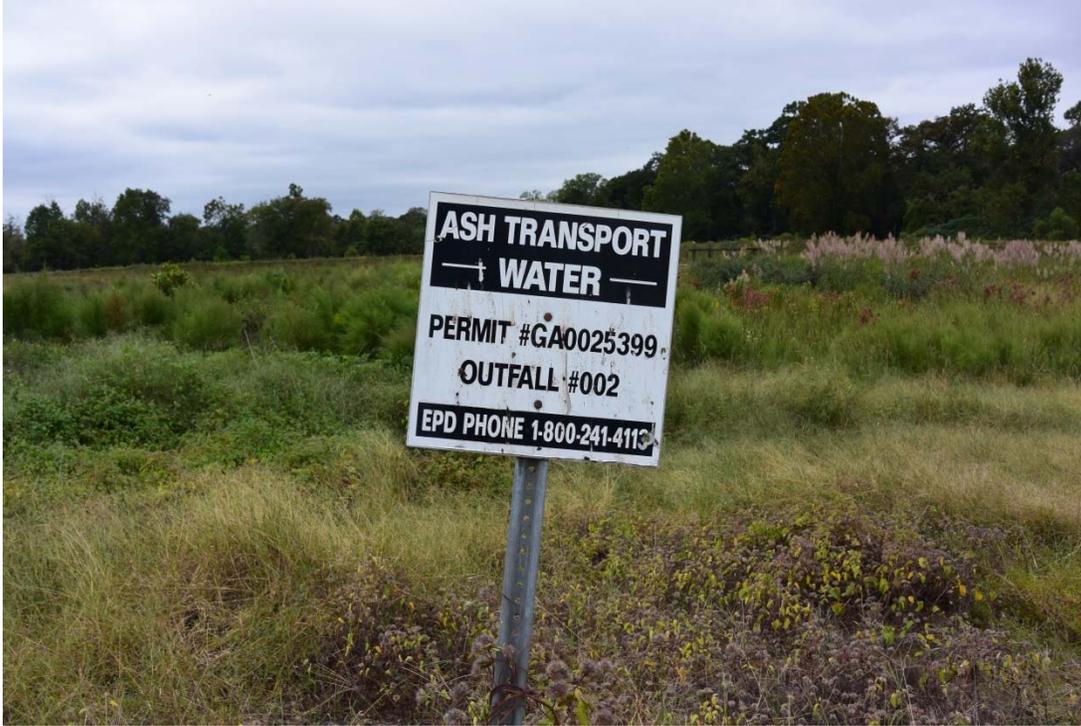
**PHOTOGRAPH 3
ASH TRANSPORT DISCHARGE MARKER**

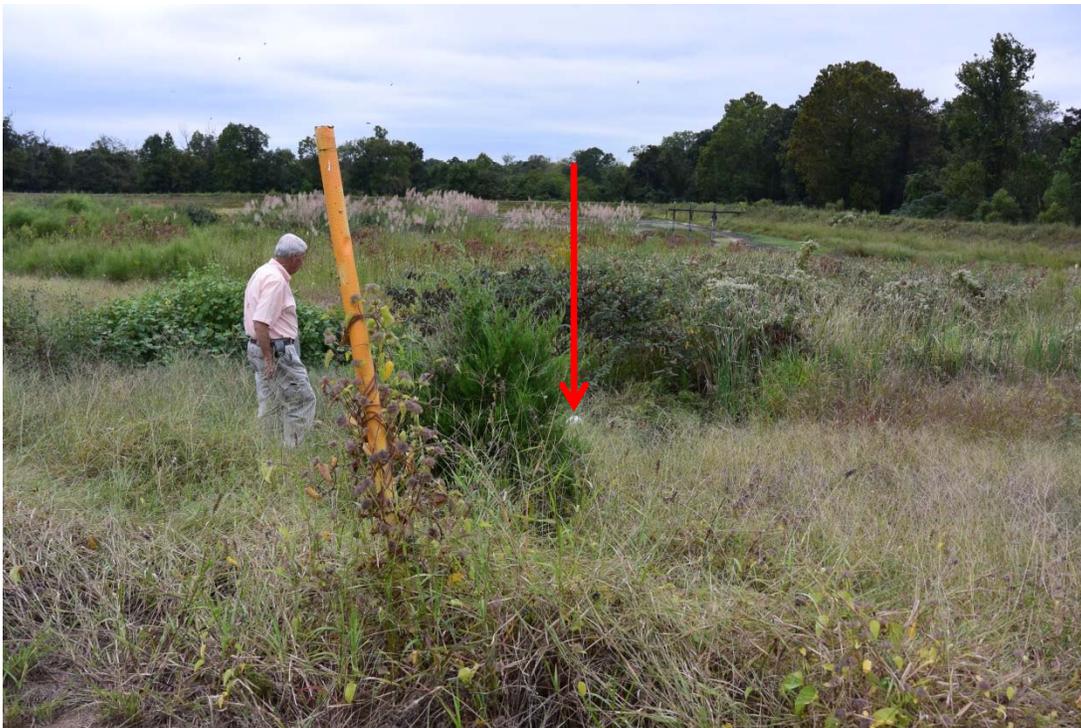
**PHOTOGRAPH 4
WASTE WATER DISCHARGE AT EAST EMBANKMENT (PVC PIPE)**

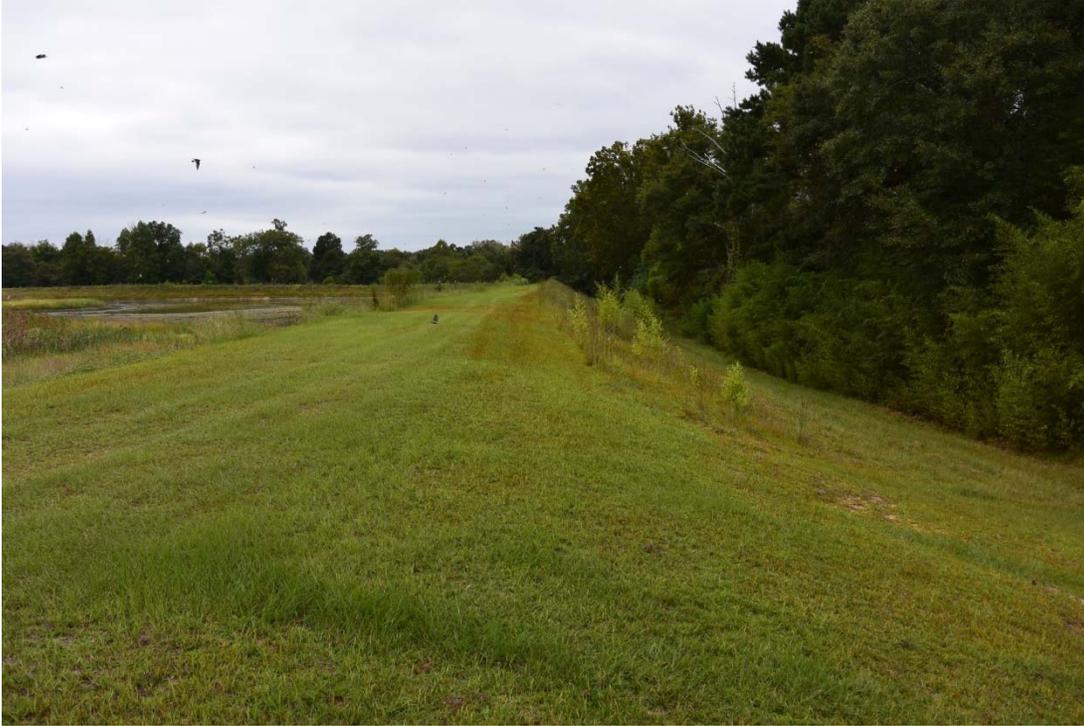
1. The slopes of the North and West Embankments were somewhat overgrown at the time of inspection. In general the growth consists of low ground cover vines and grasses, but a few small trees 1 inch to 2 inch in diameter were noted at some locations.

**PHOTOGRAPH 5
NORTH EMBANKMENT DOWNSTREAM SLOPE (LOOKING W)**

- **Recommendation 3** – The slopes of the North and West Embankments are overgrown and should be mowed or cleared. In particular, small trees should be removed from the slope to prevent negative impacts on the embankments caused by extending root systems.

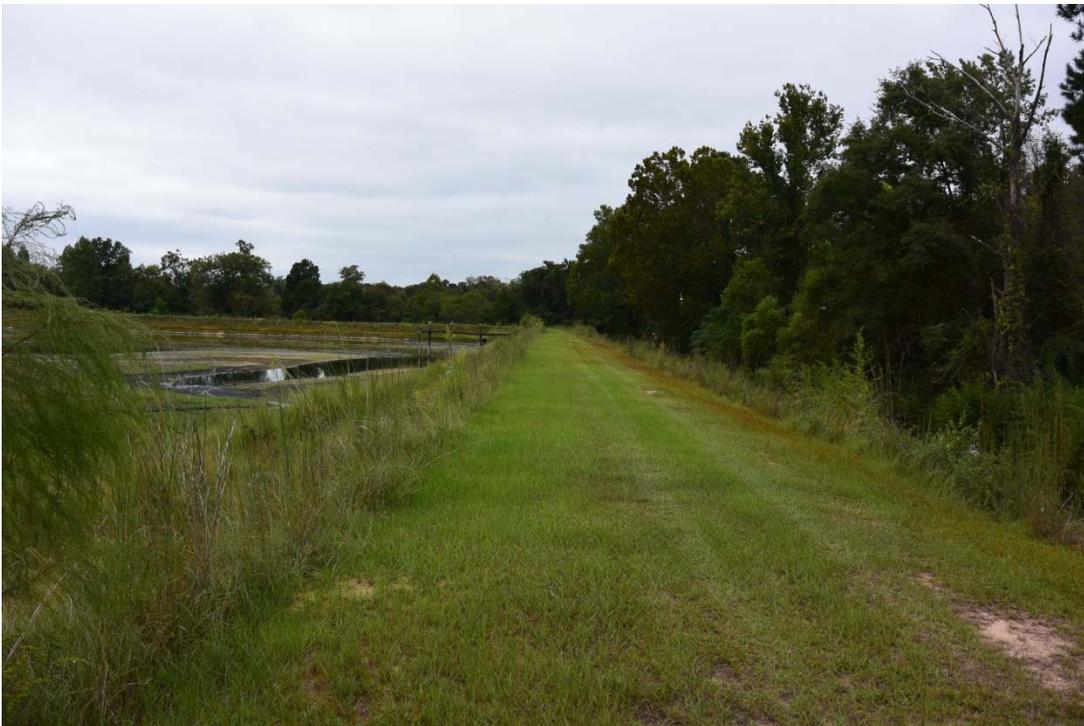
**PHOTOGRAPH 6
NORTH EMBANKMENT UPSTREAM SLOPE AND CREST (LOOKING W)**

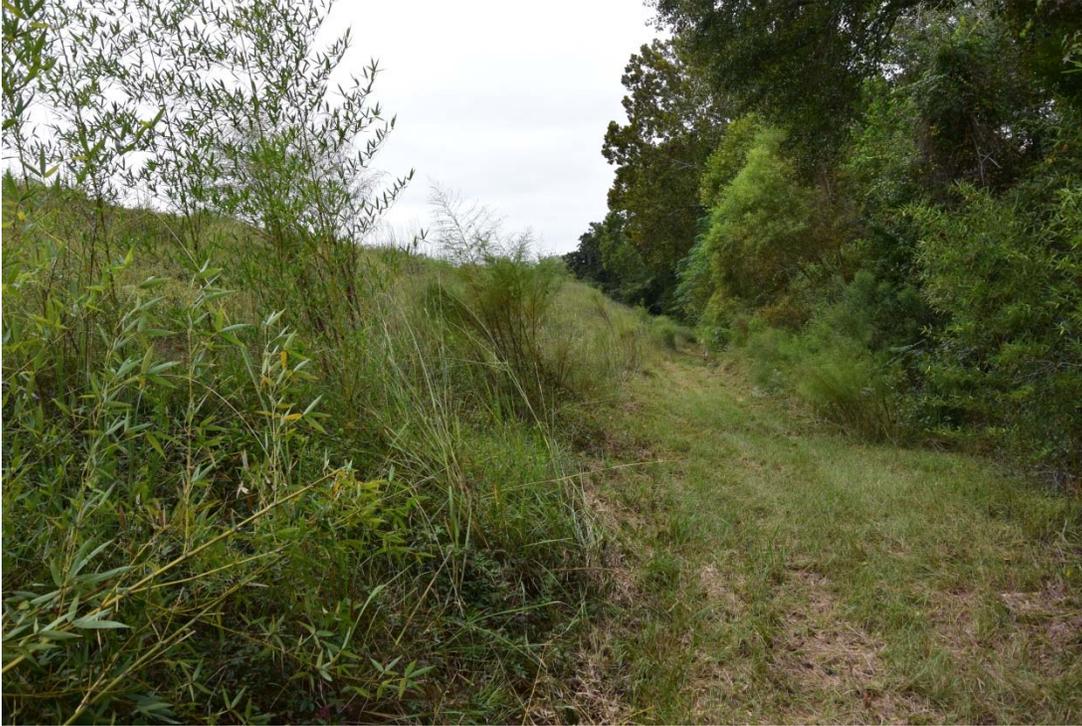
3. In the 2014 inspection, an area of ponded water and soft material was noted along the toe near the midpoint of the North Embankment. This area was found to be dry and unyielding during the 2015 inspection.

**PHOTOGRAPH 7
NORTH EMBANKMENT DOWNSTREAM TOE (LOOKING W)**

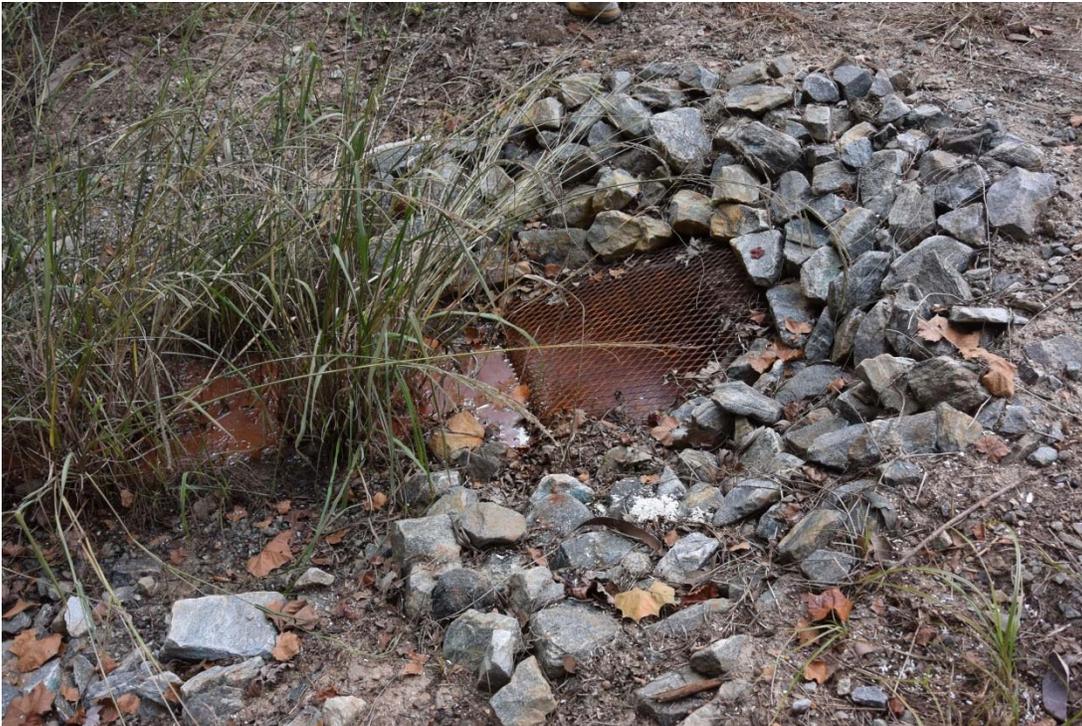
4. The recent (2014) improvements to the downstream discharge of the spillway appeared to be in good condition. The flared end section and small stilling basin appear to be operating properly. At the time of inspection, no flow was occurring and a small pool of stagnant water was observed at the low point of the stilling basin.

**PHOTOGRAPH 8
SPILLWAY DISCHARGE (NEAR MIDPOINT OF N EMBANKMENT)**

- **Recommendation 2** – Visual inspection of the spillway outlet is included in the existing weekly inspection performed by plant personnel. The results of the weekly inspection are documented on a form which is archived at the site. We recommend that Line 10, “Spillway Integrity” be modified with a place to record the depth of water at the discharge, a descriptive estimate of flow rate (none, low, high), and a description of the color/turbidity of the water. Changes to the volume and turbidity of the discharge should be recorded to provide a record of performance of the spillway over time. Such changes may be indicative of deterioration of the corrugated metal pipe spillway and may

make additional activities such as camera inspection with a remotely operated vehicle necessary.

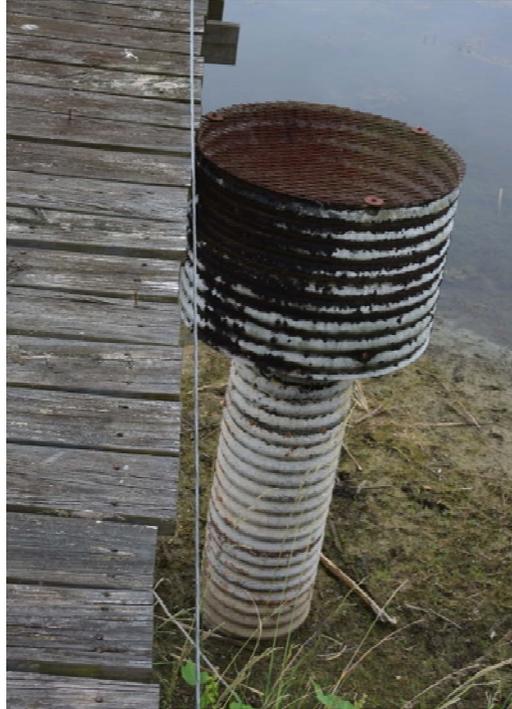
5. The vertical riser of the primary spillway was completely exposed at the time of inspection and appeared to be in good condition, with no signs of excessive corrosion or deflection noted.

**PHOTOGRAPH 9
SPILLWAY DROP INLET**

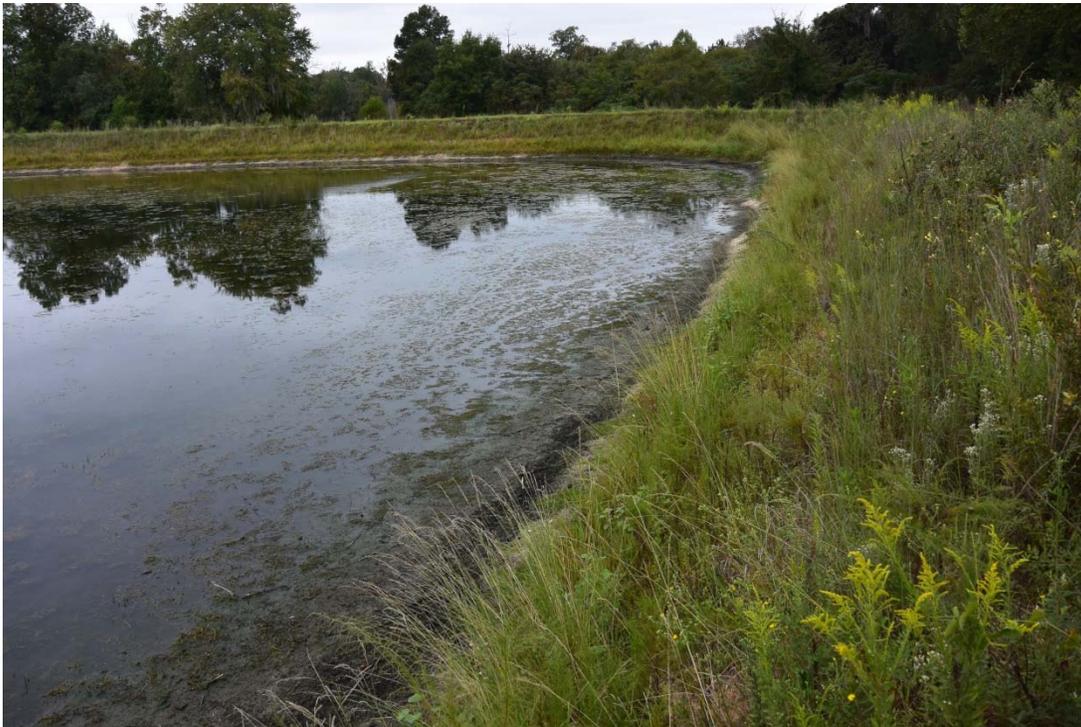
**PHOTOGRAPH 10
INBOARD SLOPES OF N AND W EMBANKMENTS AT NW CORNER**

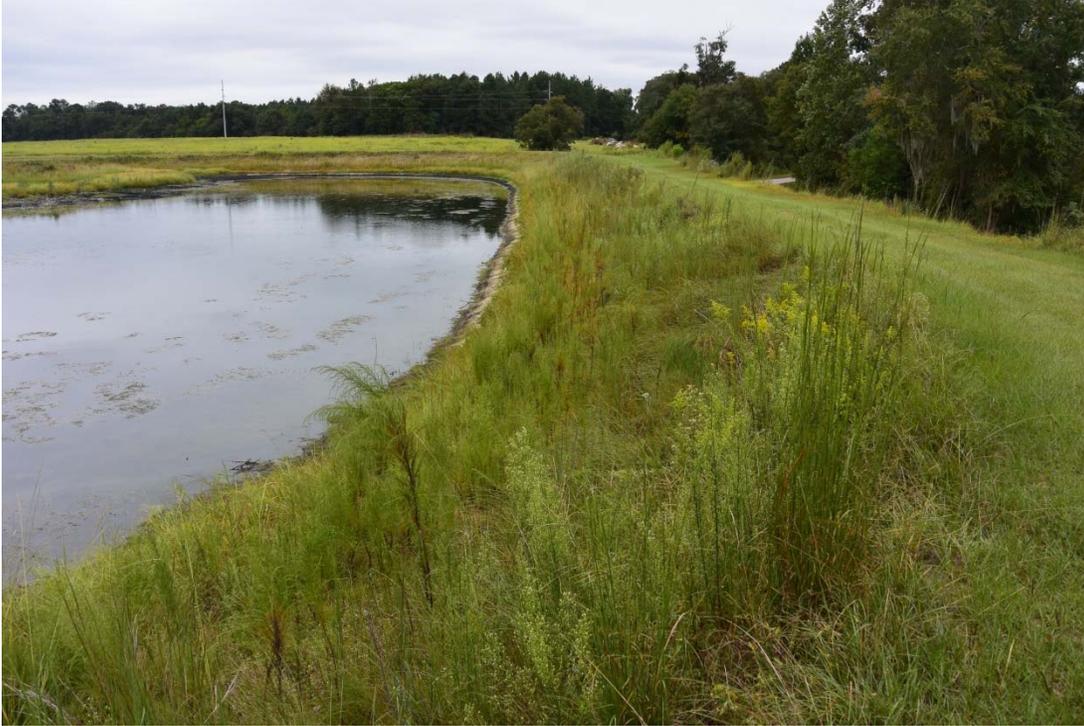
**PHOTOGRAPH 11
WEST EMBANKMENT INBOARD SLOPE (LOOKING S)**

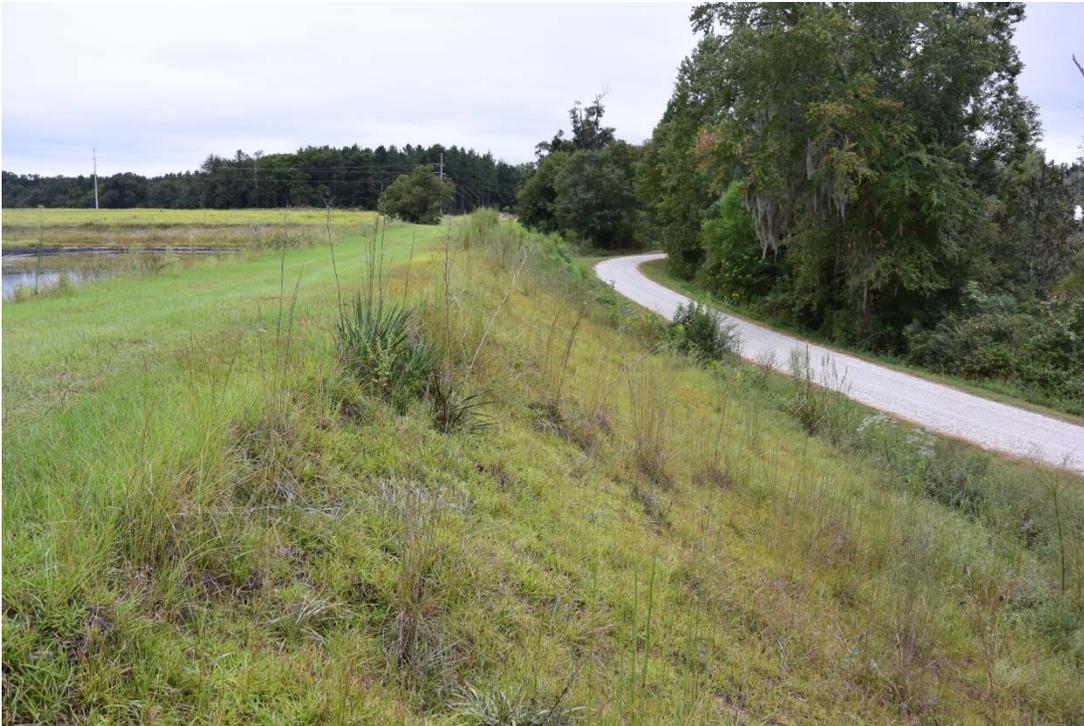
2. The exterior slopes of the West Embankment are irregular, with hummocky areas and some vertical surfaces near the crest, and lack sufficient vegetal cover to prevent surface erosion at several locations. The condition of the West Embankment does not appear to have changed since the 2014 inspection.

**PHOTOGRAPH 12
WEST EMBANKMENT DOWNSTREAM SLOPE (LOOKING S)**

- **Recommendation 1** – The exterior slopes of the West Embankment should be stripped and restored to a consistent section with compacted engineered fill. After the section is restored, the area should be seeded or sodded as appropriate to prevent further erosion in the area.

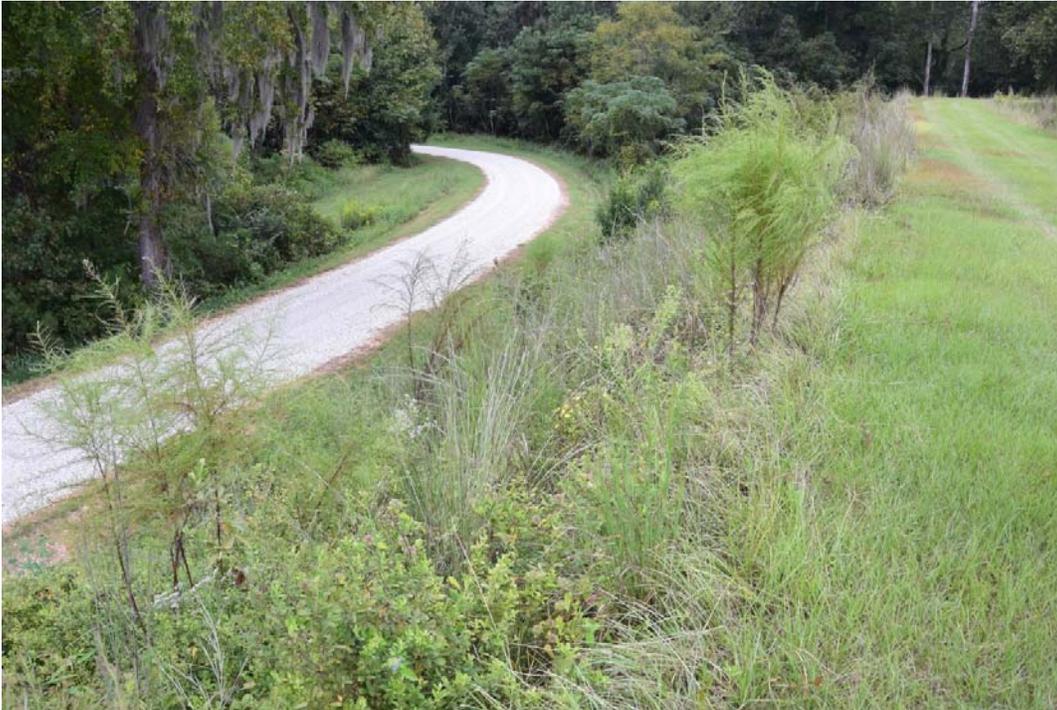
**PHOTOGRAPH 13
WEST EMBANKMENT DOWNSTREAM SLOPE (LOOKING N)**

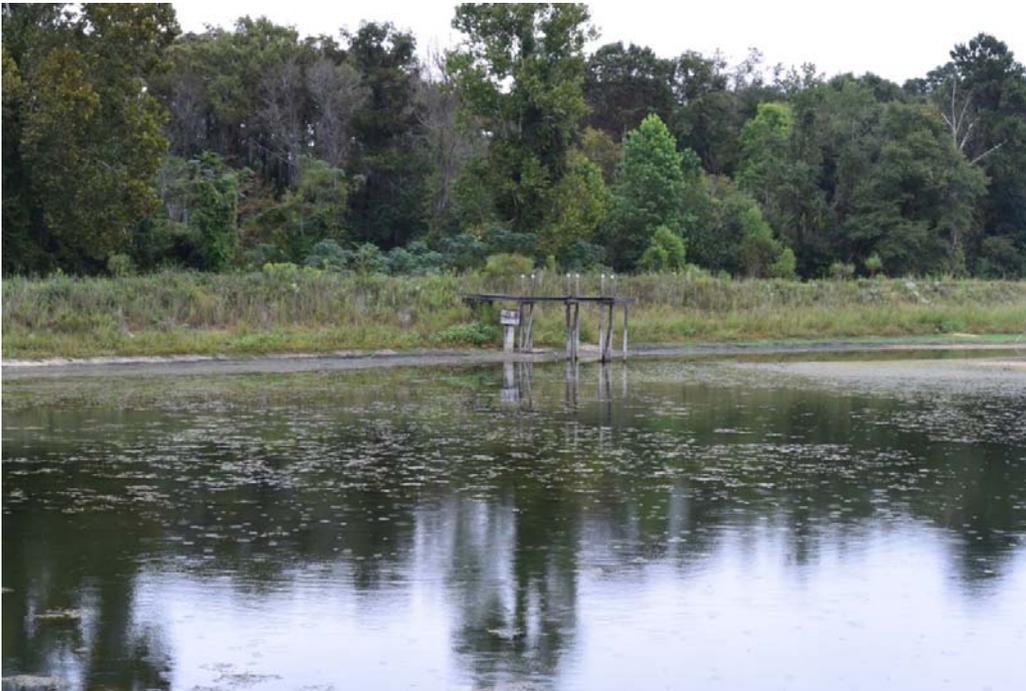
**PHOTOGRAPH 14
IMPOUNDMENT AREA AND SPILLWAY INLET (LOOKING NE)**

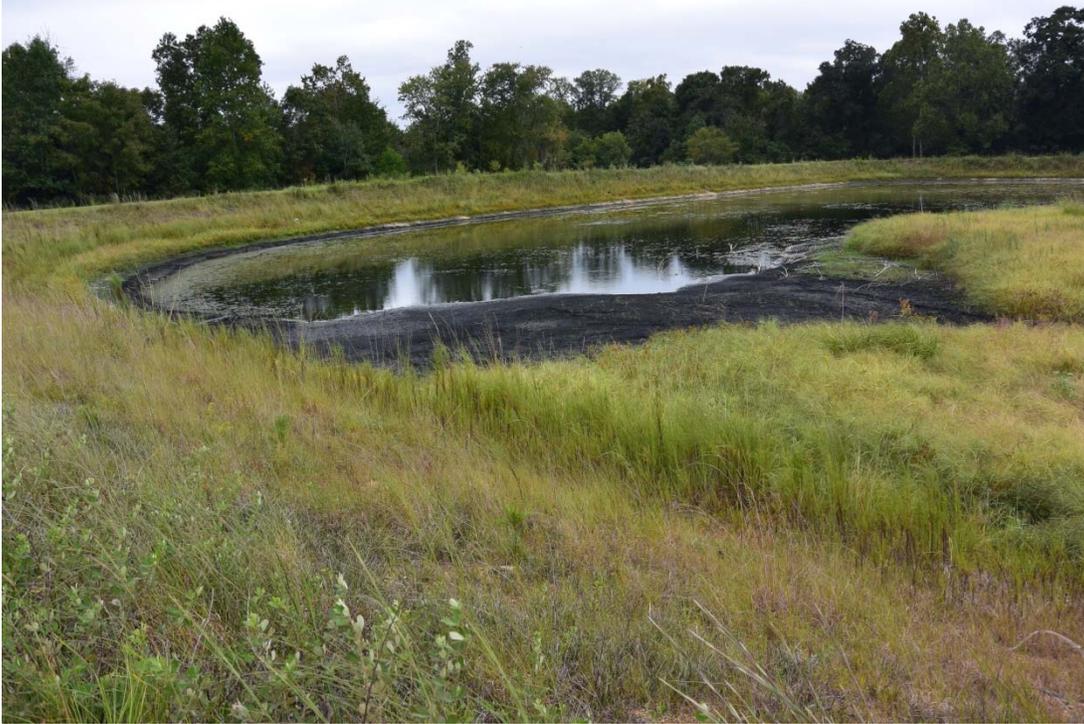
**PHOTOGRAPH 15
INBOARD SLOPES OF WEST AND SOUTH EMBANKMENTS (LOOKING W)**

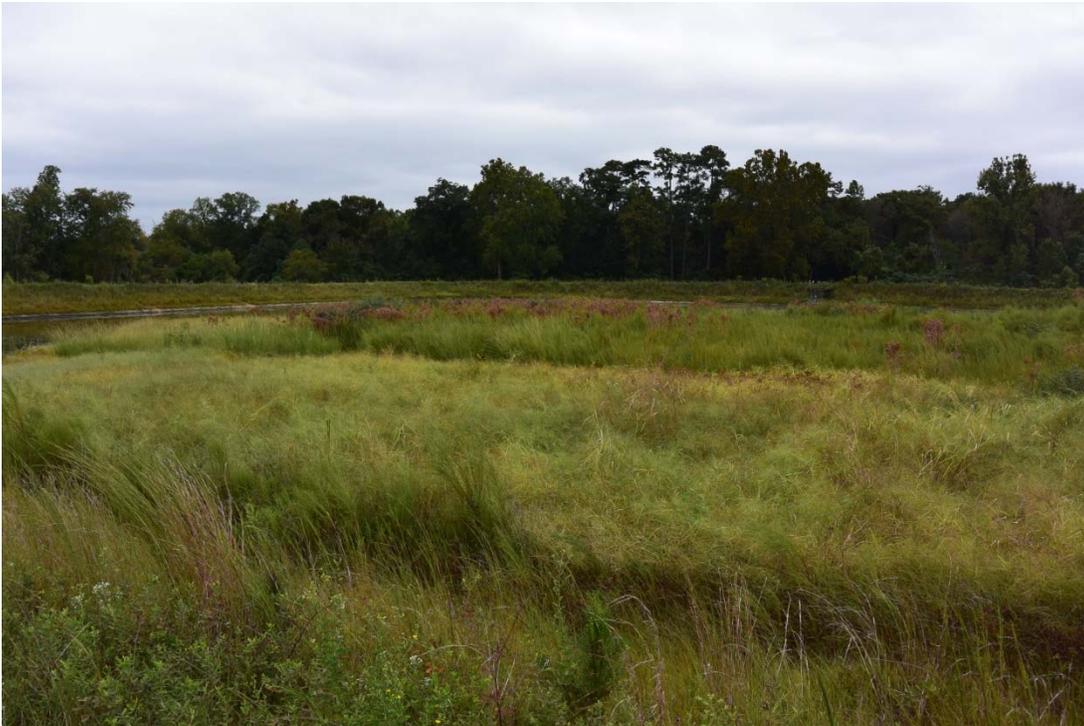
**PHOTOGRAPH 16
IMPOUNDMENT AREA FROM SOUTH EMBANKMENT (LOOKING N)**

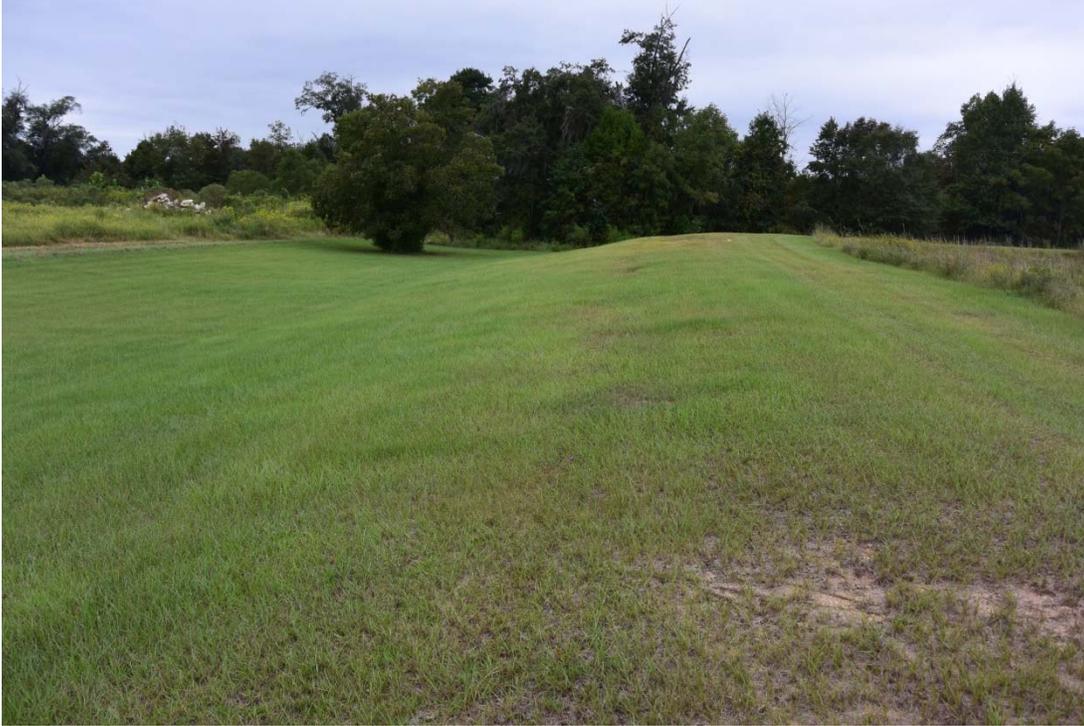
PHOTOGRAPH 17
SOUTH EMBANKMENT DOWNSTREAM SLOPE AND CREST (LOOKING W)

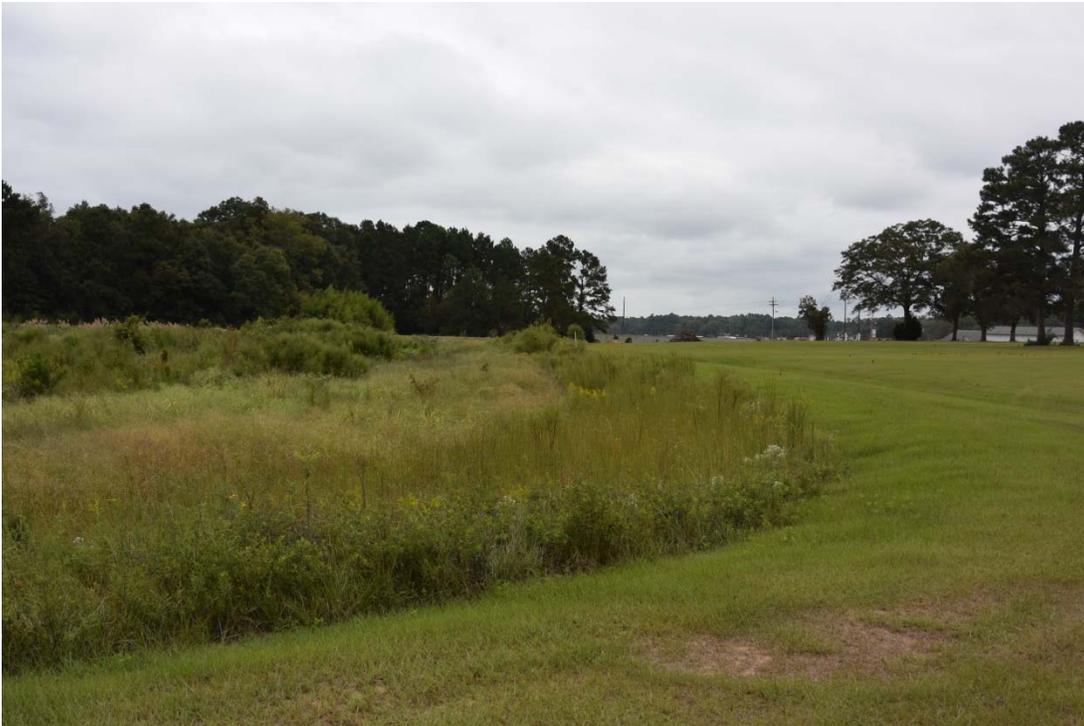
PHOTOGRAPH 18
INBOARD SLOPES AT SE CORNER (LOOKING N)
