June 14, 2018
Project No. 17-5796AMr. Ronnie Miller
Manager of Production
Crisp County Power Commission
961 Power Dam Road
Warwick, GA 31796via email: rmiller@crispcountypower.com

**DAM SAFETY INSPECTION REPORT
PLANT CRISP CCW IMPOUNDMENT
CRISP COUNTY POWER COMMISSION
PROJECT NO. 17-5796A**

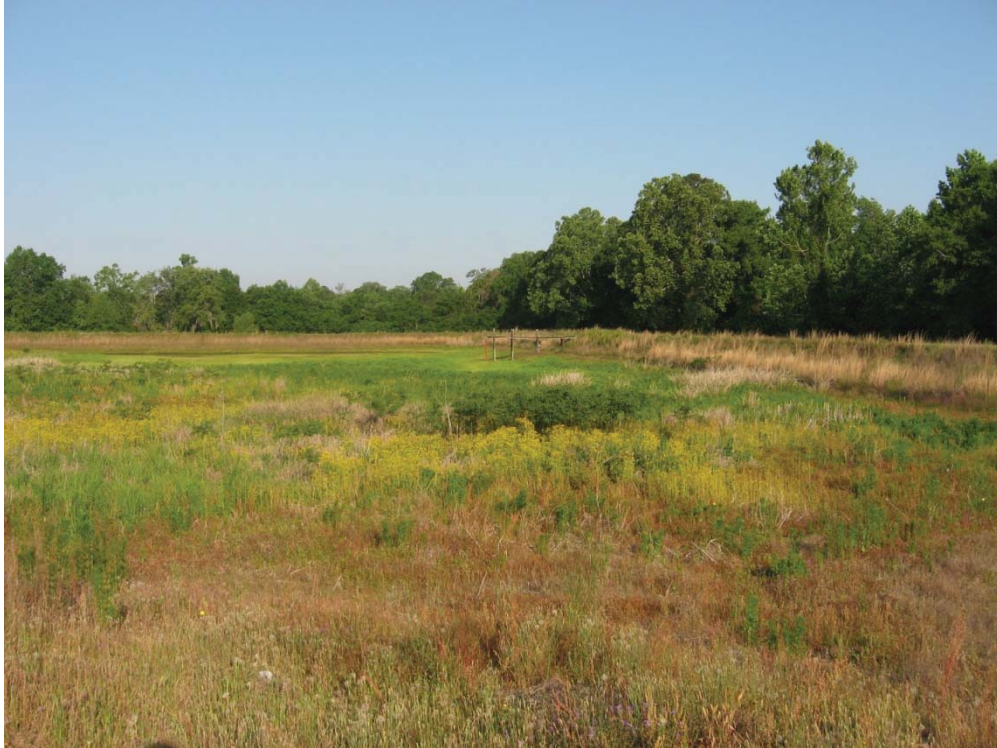
Looking toward Northwest Corner of Impoundment

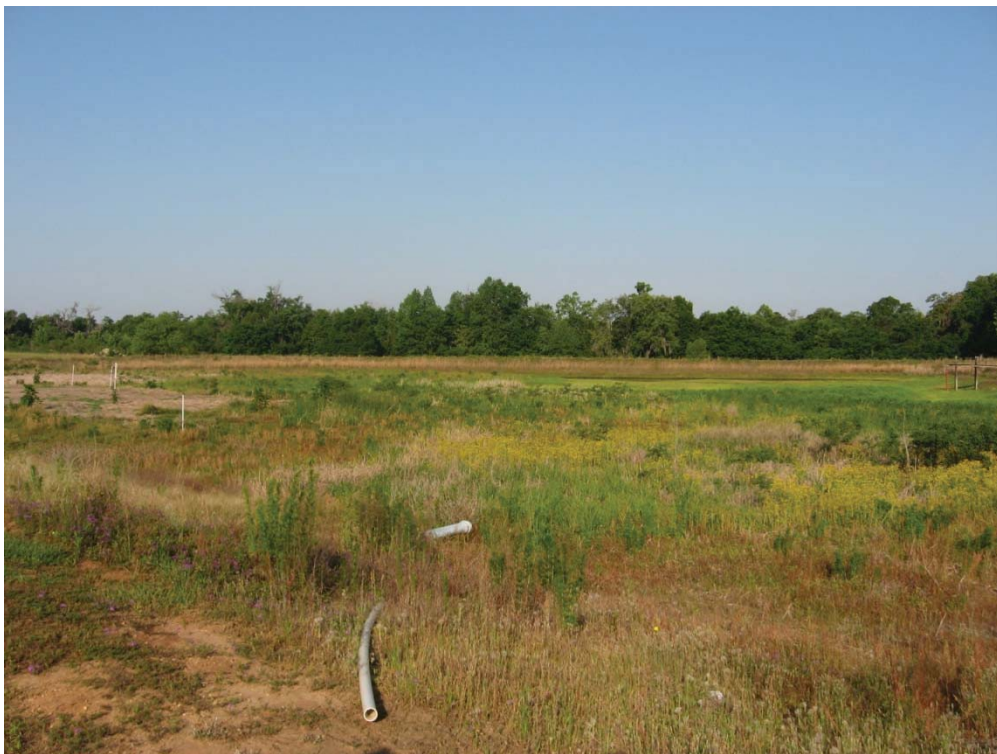
CCW Sluice Discharge at East Embankment

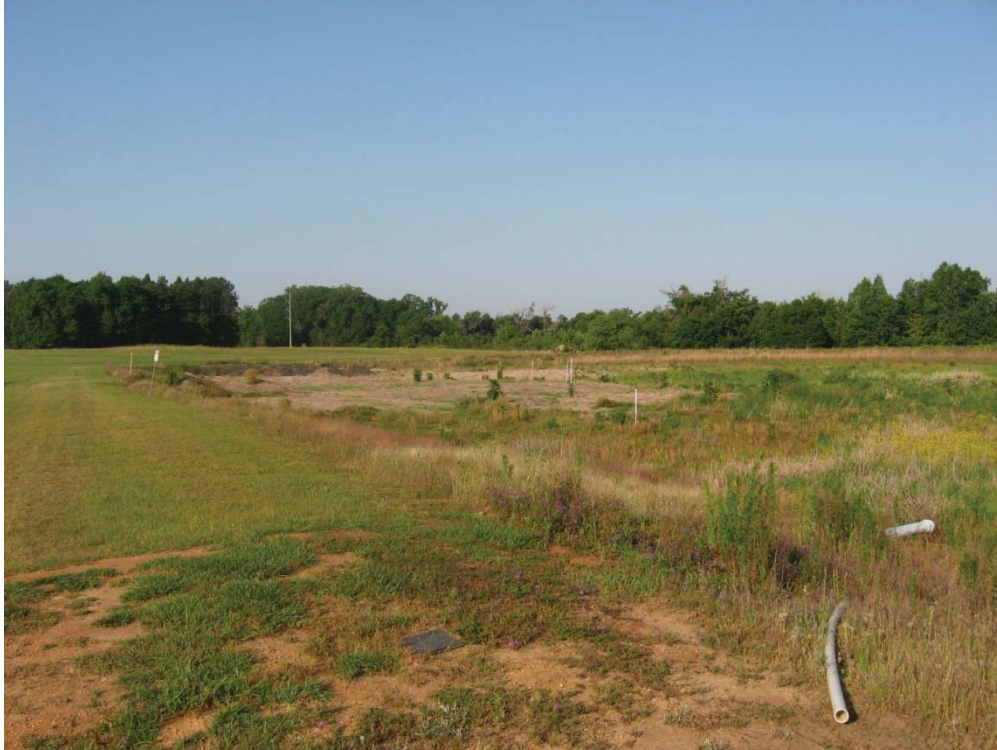
Looking Toward Southwest Corner

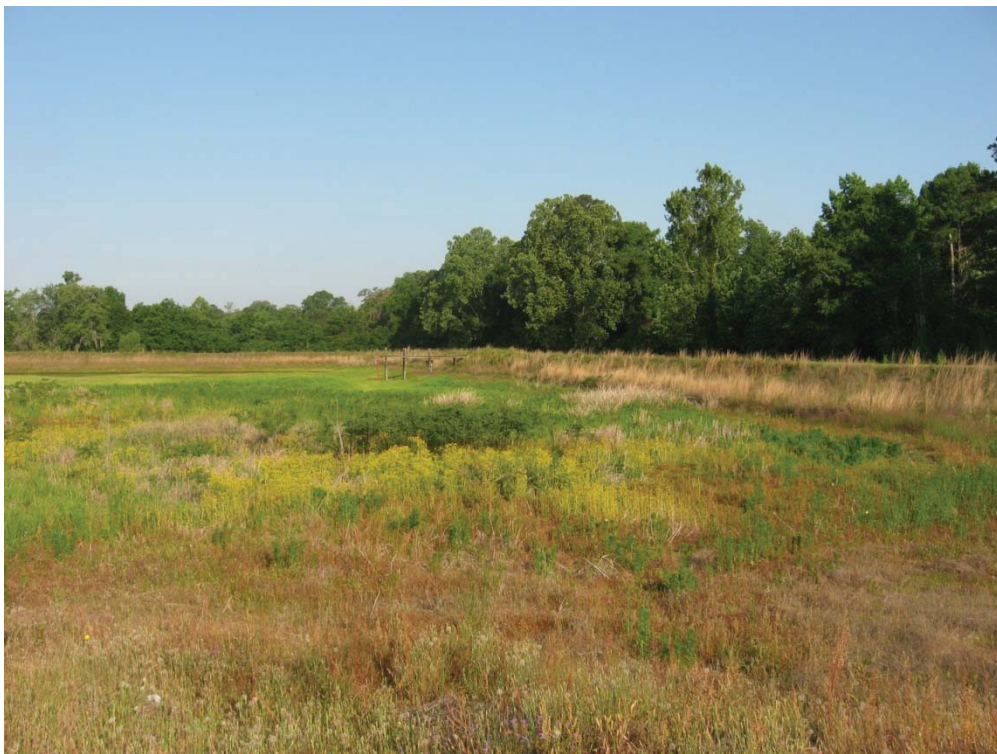
Looking Toward Northwest Corner

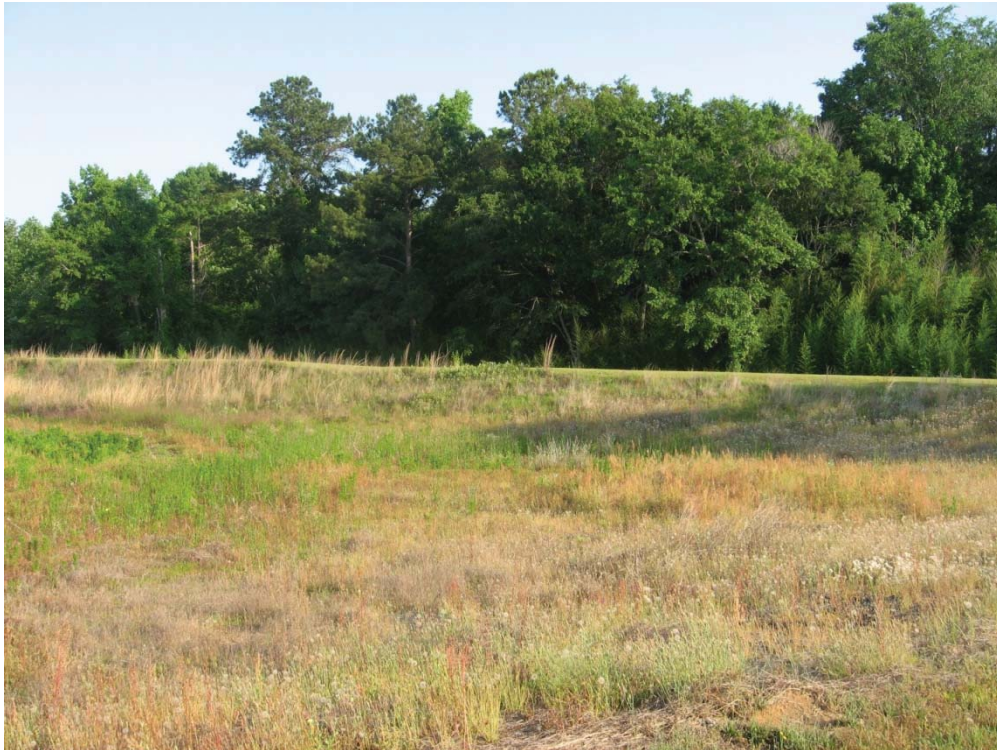
2. The exterior slopes of the West Embankment are irregular, with hummocky areas and some vertical surfaces near the crest. Minor surface erosion was noted at several locations. The condition of the West Embankment should continue to be monitored especially if the pond water level is raised.

Looking To West Embankment

2. Deterioration			
a. Erosion?	X		Some minor surface erosion at locations of concentrated runoff or missing vegetal cover.
b. Sloughs or Slumps?	X		West Embankment – 1 to 1.5 ft high vertical faces along crest on outside slope at several locations. Exterior slopes on W. Embankment are somewhat irregular/hummocky. No circular slip surfaces or cracks observed.

- **Recommendation 1** – The exterior slopes of the West Embankment should be stripped and restored to a consistent section with compacted engineered fill. After the section is restored, the area should be grassed by seeding or sodding as appropriate to prevent further erosion in the area.

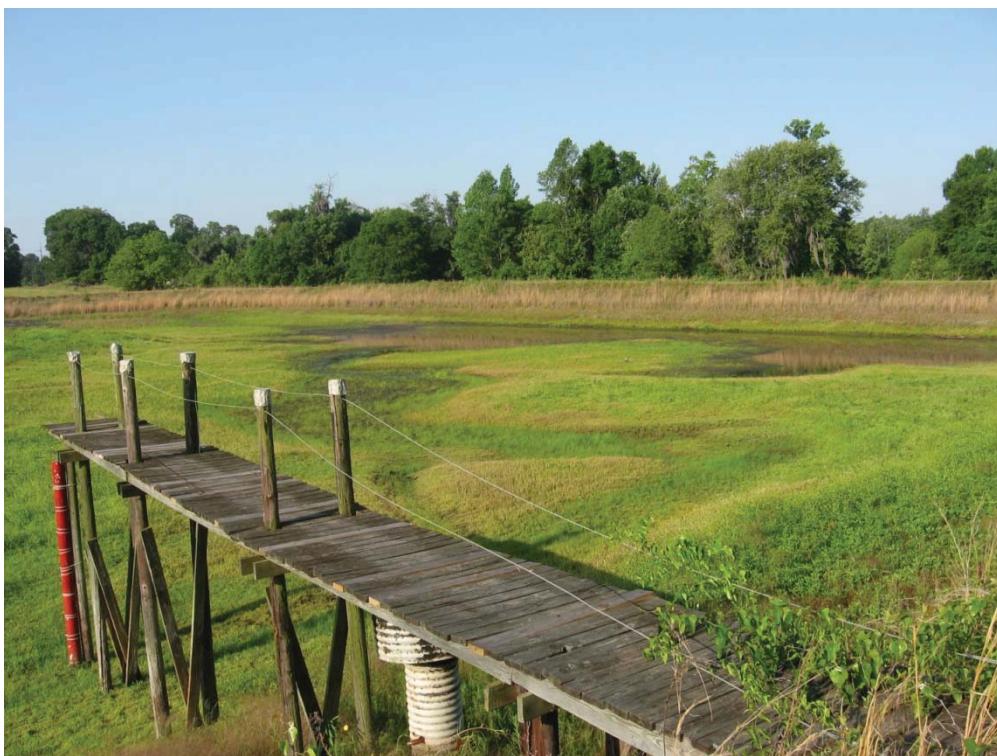
4. The vertical riser of the primary spillway was completely exposed at the time of inspection and appeared to be in good condition. No signs of excessive corrosion or damage were noted.

Principal Spillway Intake Riser Beneath Walkway

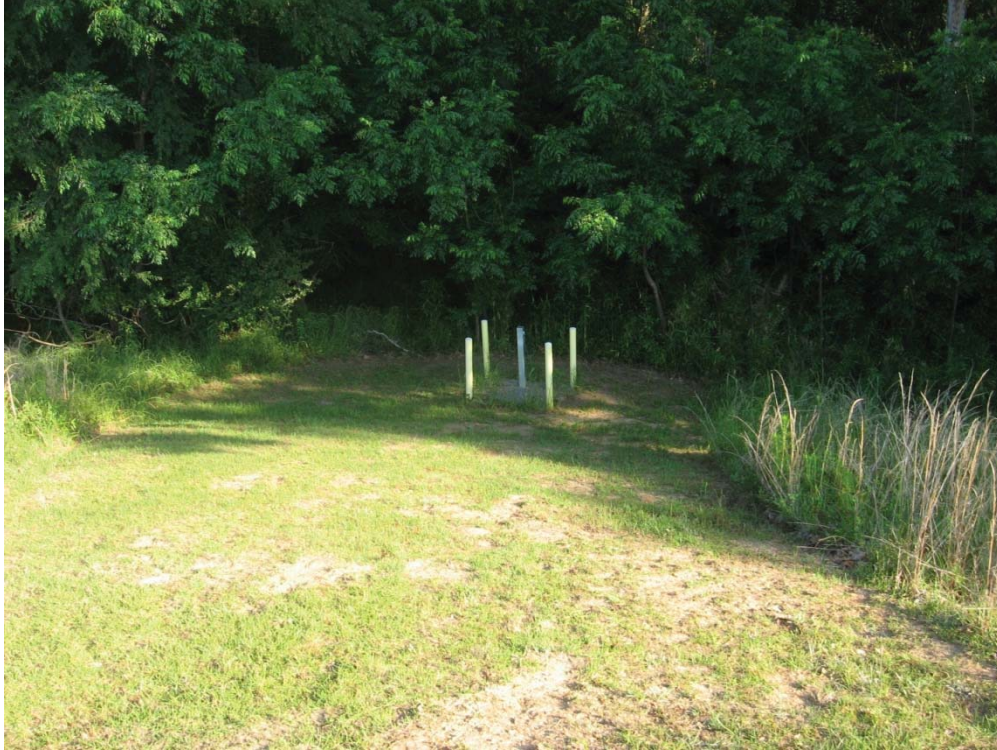
Groundwater Monitoring Well on North Toe of Dam

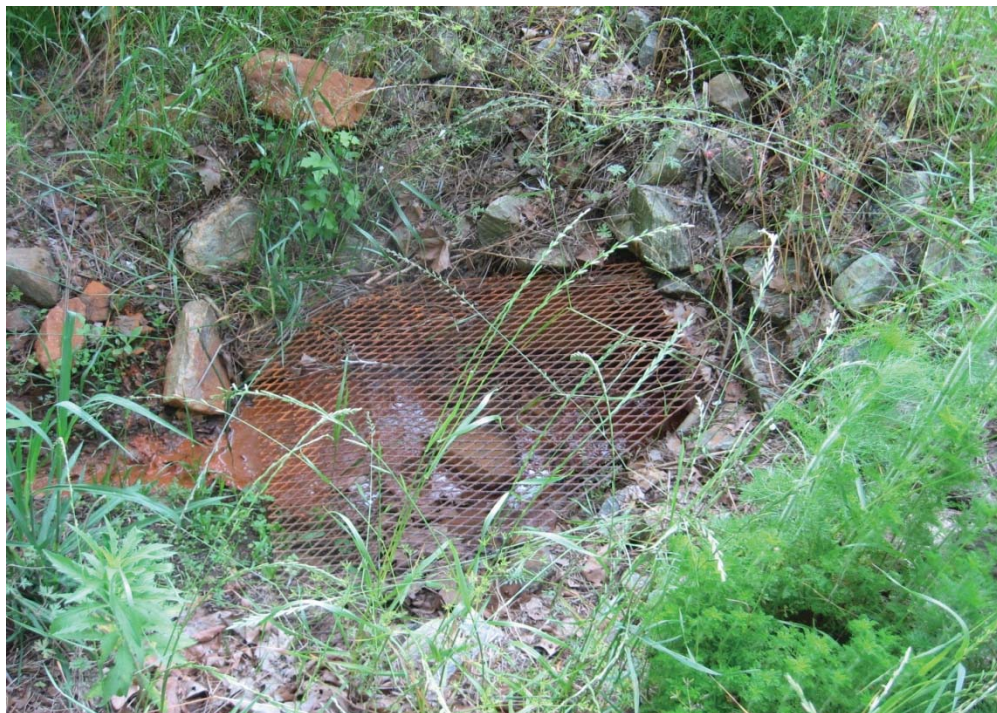
3. The downstream discharge basin of the spillway appeared to be in good condition. The flared end section and small stilling basin appear to be operating properly. At the time of inspection, no flow was occurring and a small pool of stagnant water was observed at the low point of the stilling basin. Vegetation and woody debris should periodically be removed from the stilling basin and outlet channel in order to not impede flow.

Principal Spillway Downstream Discharge Area

- **Recommendation 2** – Visual inspection of the spillway outlet is included in the existing weekly inspection performed by plant personnel. The results of the weekly inspection are documented on a form which is archived at the site. Changes to the volume and turbidity of the discharge should be recorded to provide a record of performance of the spillway over time. Such changes may be indicative of deterioration of the corrugated metal pipe spillway and may make additional activities such as camera inspection with a remotely operated vehicle necessary.

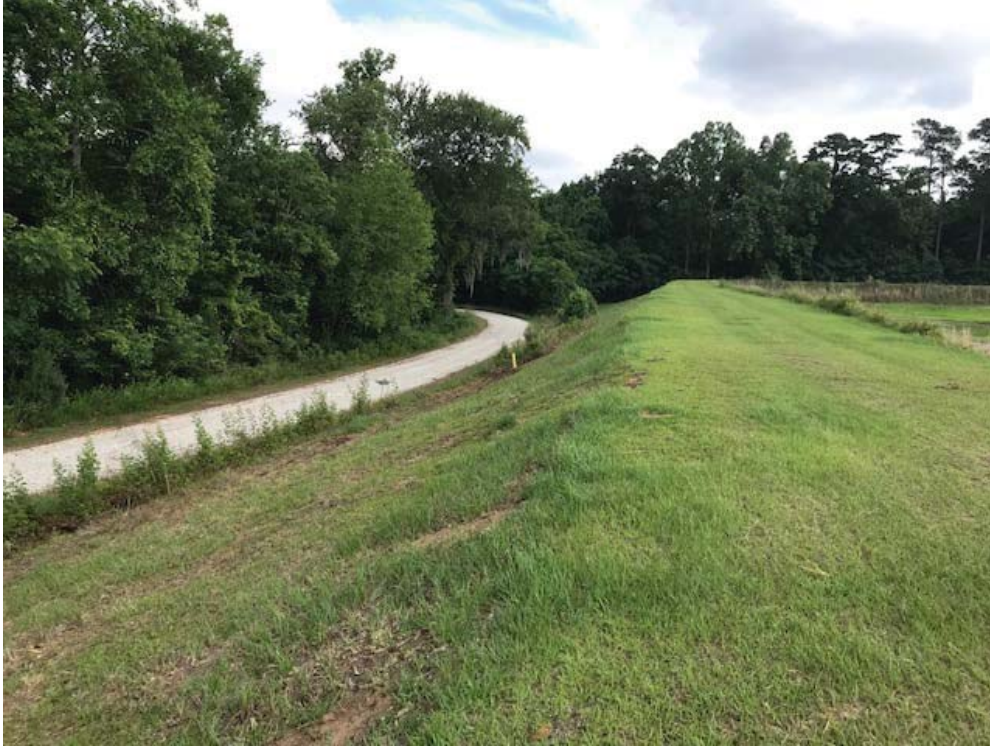
1. The slopes of the North and West Embankment were somewhat overgrown at the time of inspection. In general the growth consists of low ground cover vines and grasses, but an occasional small tree 1- inch to 2-inch in diameter was noted. The embankments have been mowed since the inspection. See photographs.

Looking North Along West Embankment After Mowing

- **Recommendation 3** – Continue to mow the slopes and tops of the embankments. In particular, small trees should be removed from the slope to prevent negative impacts on the embankments caused by extending root systems.

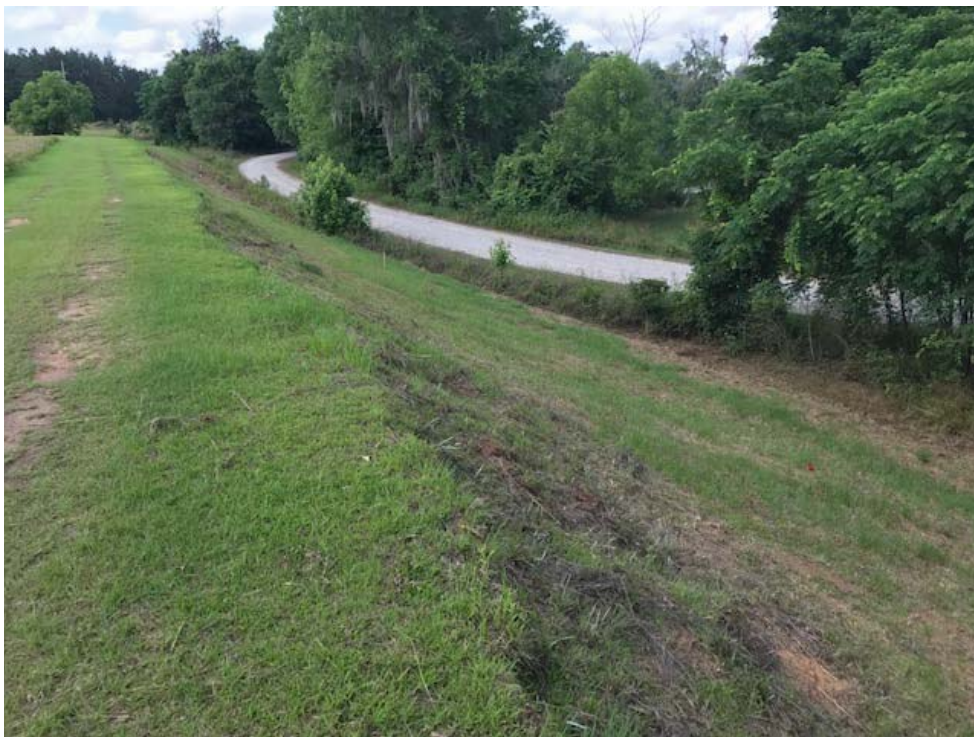
Looking South Along West Embankment After Mowing
