June 13, 2019
Project No. 17-5796BMr. Ronnie Miller
Manager of Production
Crisp County Power Commission
961 Power Dam Road
Warwick, GA 31796via email: rmiller@crispcountypower.com

**2019 DAM SAFETY INSPECTION REPORT
PLANT CRISP CCW IMPOUNDMENT
CRISP COUNTY POWER COMMISSION
PROJECT NO. 17-5796B**

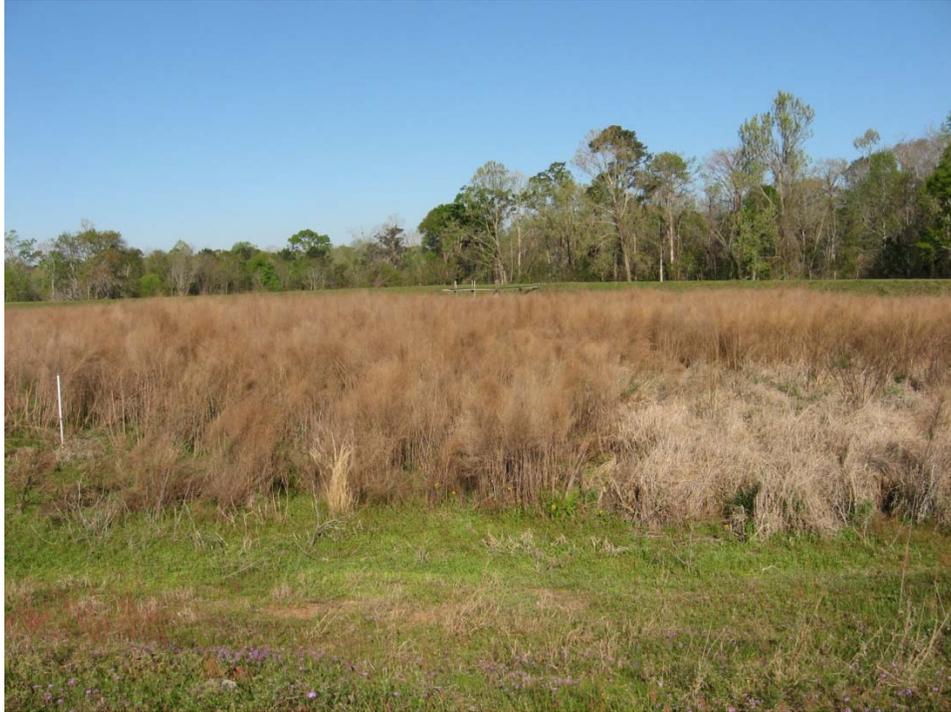
Looking West Across Ash Pond

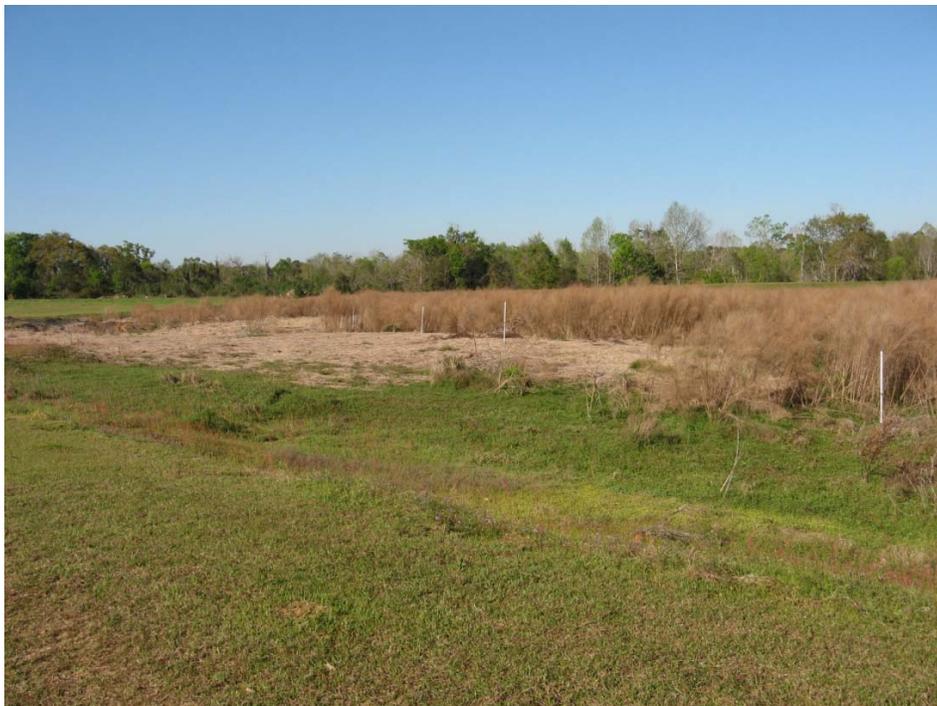
Upper End of Ash Pond

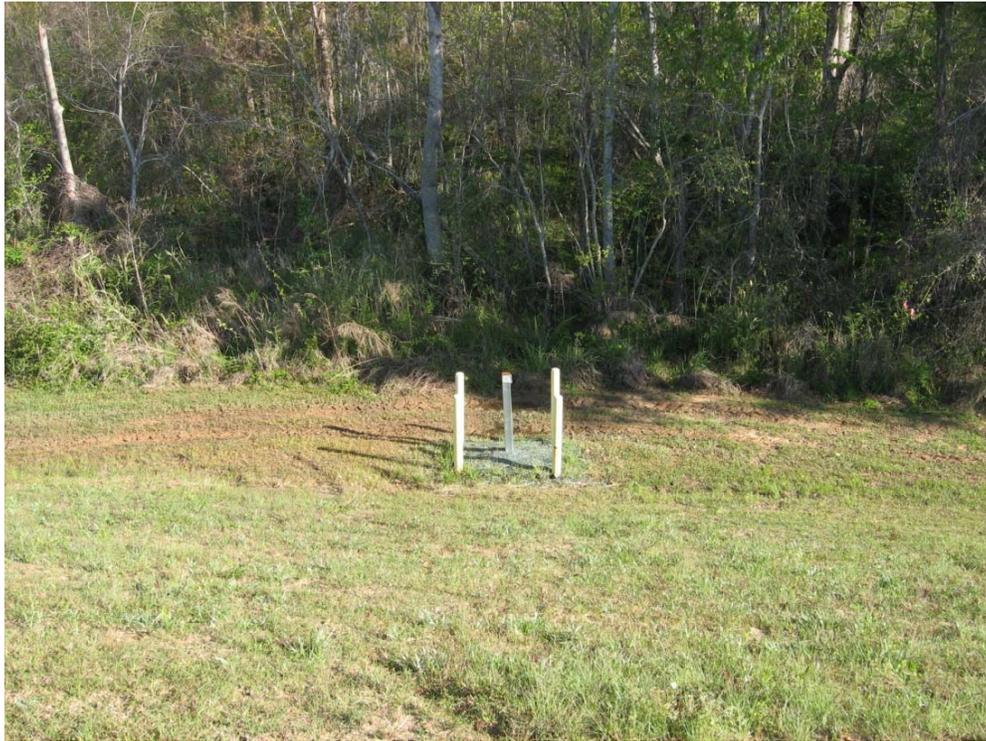
Groundwater Monitoring Well MW-D2

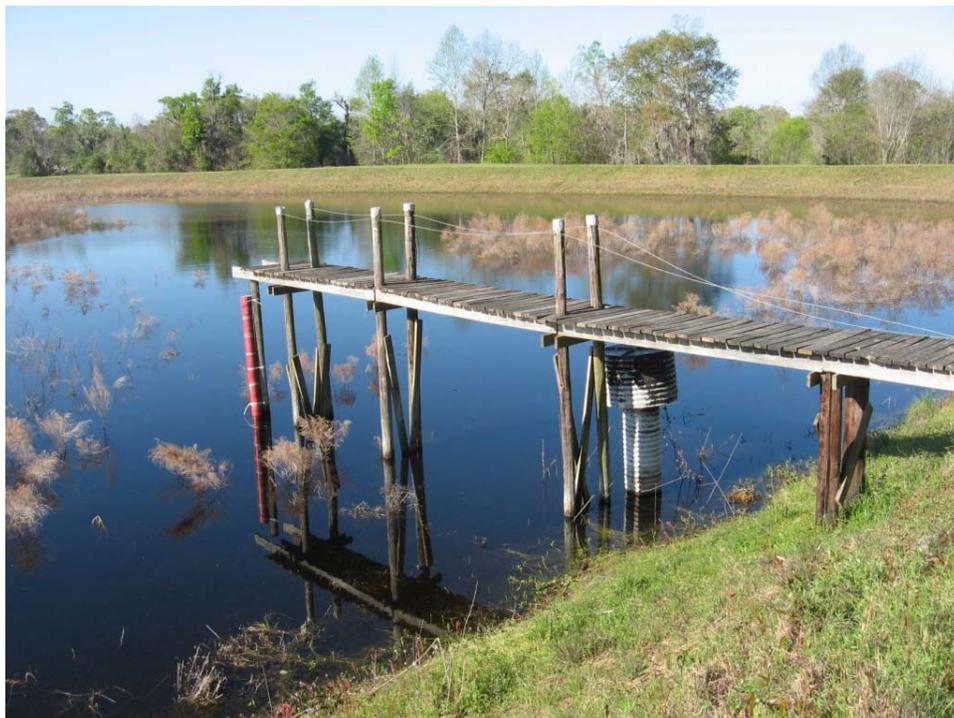
3. The vertical riser of the primary spillway was mostly exposed at the time of inspection and appeared to be in good condition. No signs of excessive corrosion or damage were noted.

Principal Spillway Inlet

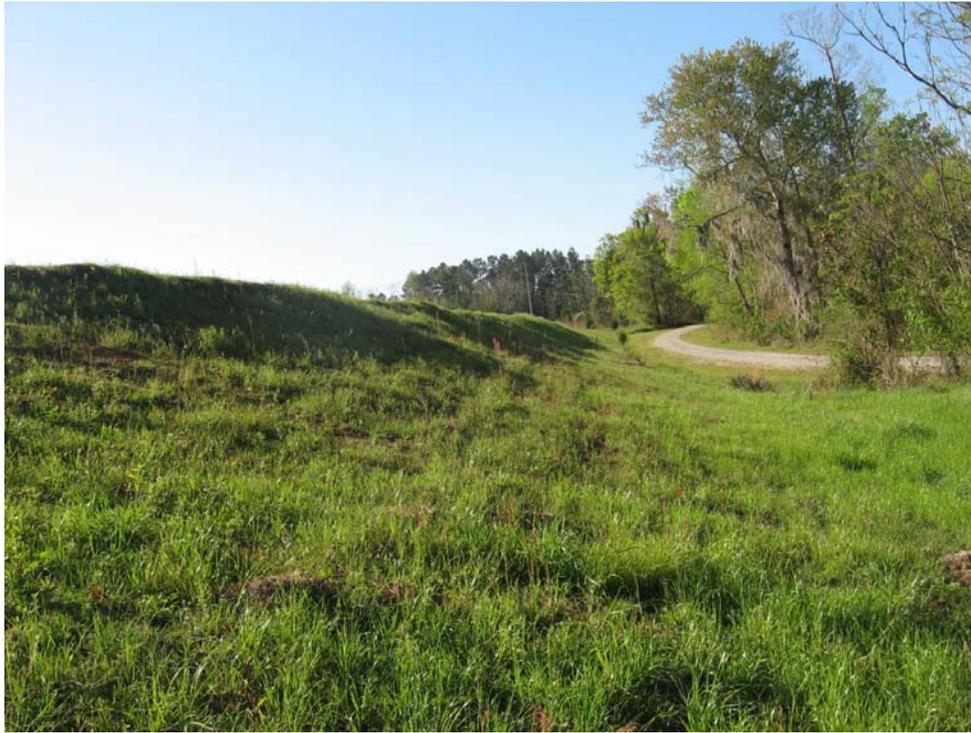
1. Continue to fertilize, maintain, and mow the top and slopes of the West Embankment. Remove small trees while they are saplings and can be removed by mower. The exterior slopes of the West Embankment are irregular, with hummocky areas and some vertical surfaces near the crest. The condition of the West Embankment should continue to be monitored especially if the pond water level is to be raised.
2. The downstream discharge basin of the spillway appeared to be in good condition. The flared end section and small stilling basin appear to be operating properly. At the time of inspection, almost no flow was occurring and a small pool of stagnant water was observed at the low point of the stilling basin. Periodically clear and remove vegetation and woody debris from the stilling basin and outlet channel in order to not impede flow.

Looking South Along West Embankment

2. Deterioration			
a. Erosion?		X	Some minor surface erosion at locations of concentrated runoff or missing vegetal cover.
b. Sloughs or Slumps?	X		West Embankment – 1 to 1.5 ft high vertical faces along crest on outside slope at several locations. Exterior slopes on W. Embankment are somewhat irregular/hummocky. No apparent change since last inspection. No circular slip surfaces or cracks observed.

- **Recommendation 1** – The exterior slopes of the West Embankment should be stripped and restored to a consistent section with compacted engineered fill. After the section is restored, the area should be grassed by seeding or sodding as appropriate to prevent further erosion in the area.

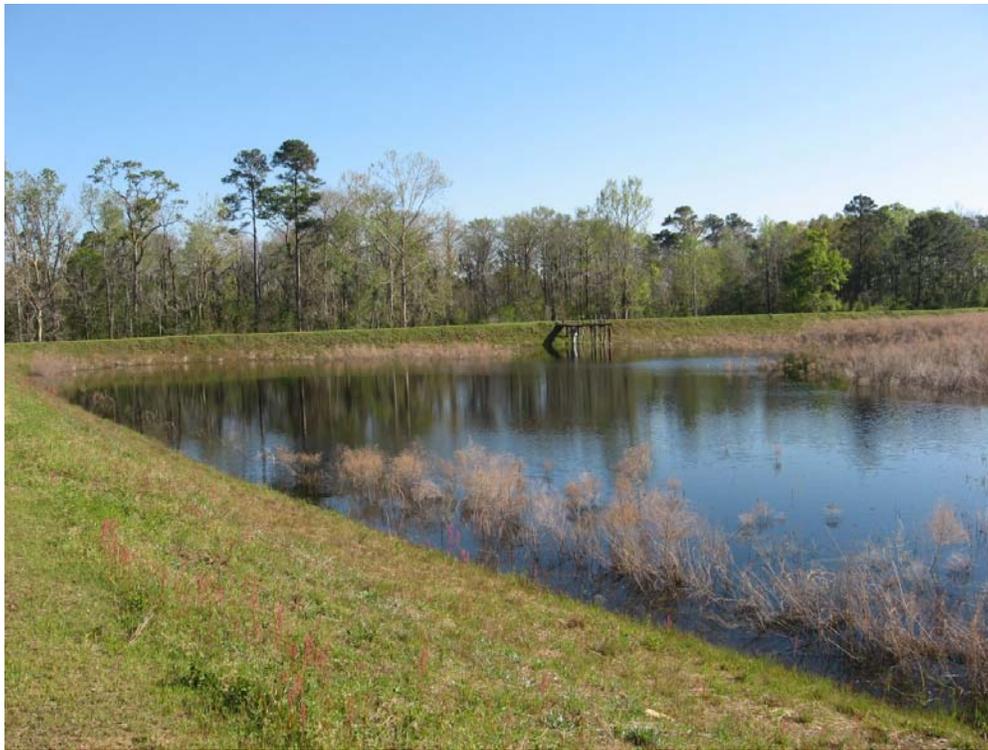
Looking North Along West Bank – Spillway In Background

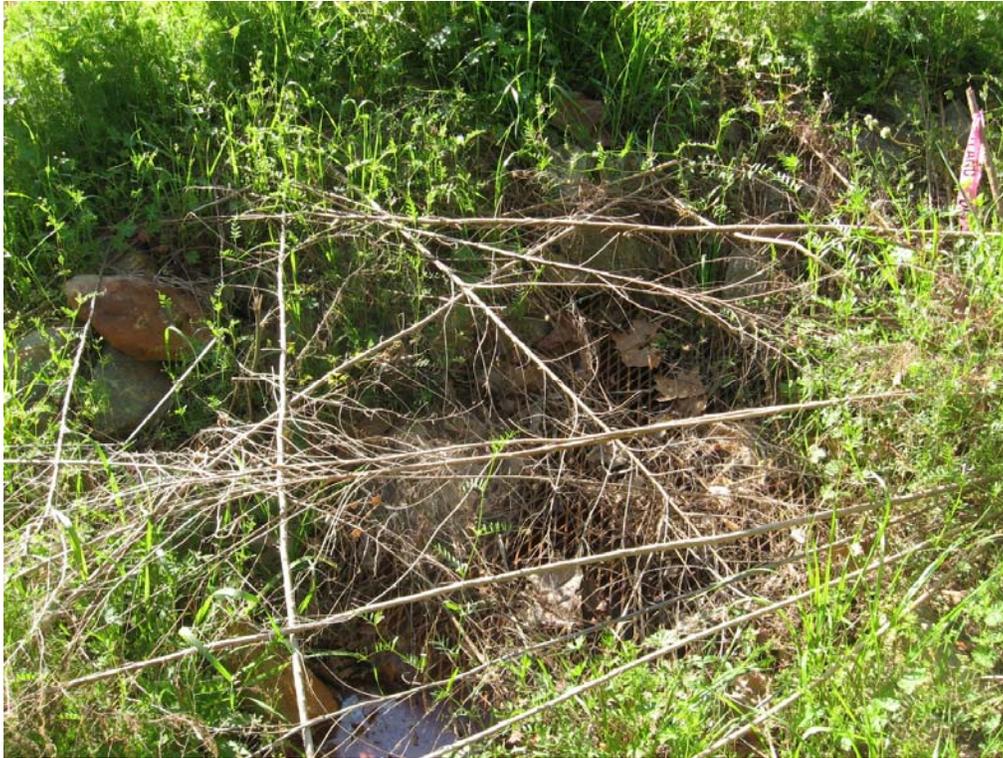
Principal Spillway Outlet Pipe and Channel – Remove Debris From Outlet

7. Discharge Channel		X	No significant discharge channel was provided for the outlet pipe, contributing to the discharge area being covered and plugged. Periodically clean out discharge channel area.

- **Recommendation 2** – Visual inspection of the spillway outlet is included in the existing weekly inspection performed by plant personnel. The results of the weekly inspection are documented on a form which is archived at the site. Changes to the volume and turbidity of the discharge should be recorded to provide a record of performance of the spillway over time. Such changes may be indicative of deterioration of the corrugated metal pipe spillway and may make additional activities such as camera inspection with a remotely operated vehicle necessary. Clear any debris from around upstream and downstream ends of pipe spillway to provide full capacity for storm events.

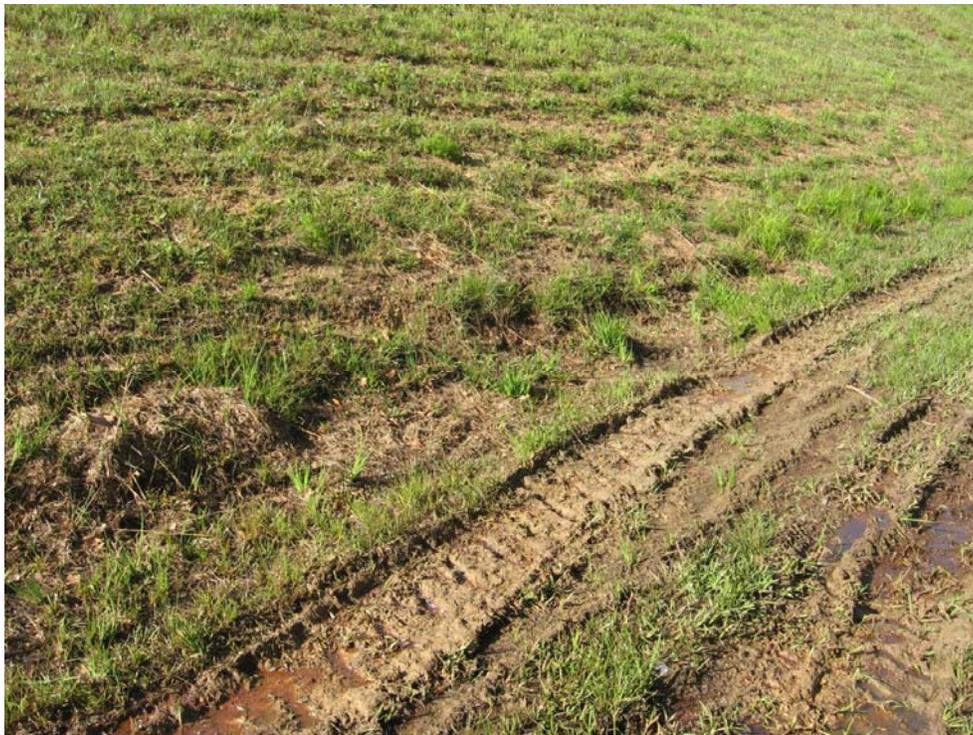
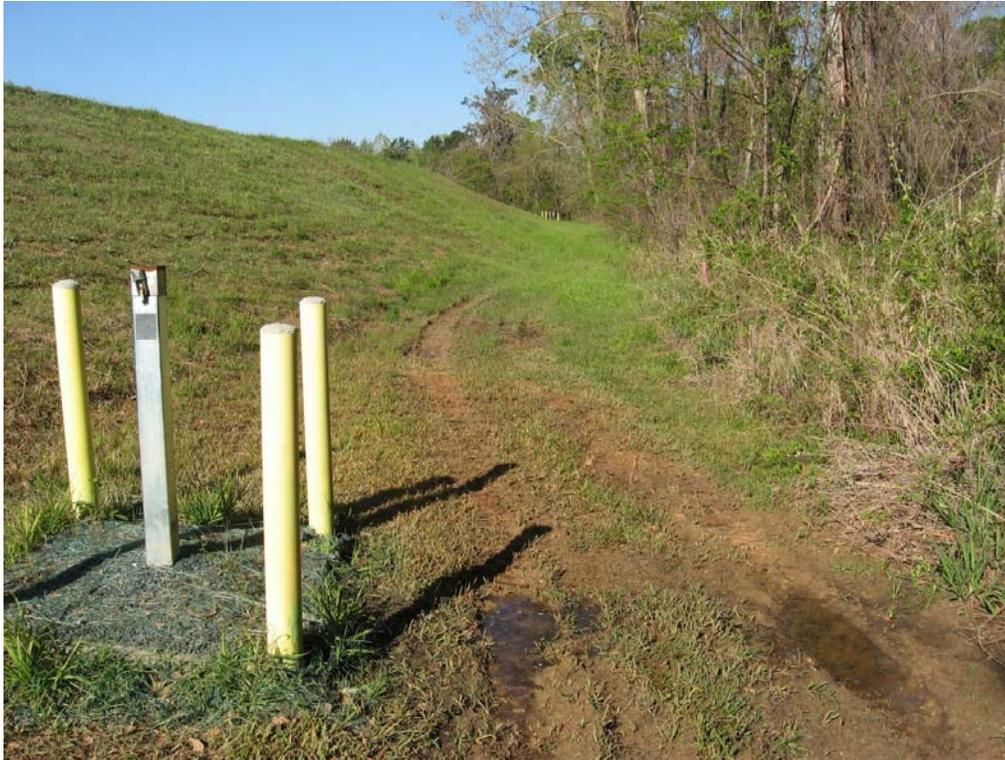
A wet seepage area at the downstream toe near MW-D-3 was noted and photographed. There was standing water in tire ruts in this area. The last groundwater measurement prior to the site visit showed a ground water table within 1 foot+/- of the surface. Minimize vehicle traffic in this area as much as practical.

Seepage Area at MW-D3

c. Riprap?		X	None
d. Damage from nuisance wildlife?		X	No burrows nor undercuts along the bank were noted.
3. Seepage	X		Minor seepage or wet areas on downstream toe of the North Embankment have been observed and noted in this and previous inspections. The wet area is on the road downstream of MW-D-3. The groundwater level in this area averages about 1.5 feet below ground surface year round. At time of inspection, groundwater was about 1 foot below ground surface.

- **Recommendation 4** – Consider mitigating the seepage area MW-D3. This appears to be a relatively high traffic area that provides access to spillway and instrumentation. Recommend installing a hardstand area of gravel over geotextile.
