January 8, 2022

**2021 ANNUAL INSPECTION REPORT  
PLANT CRISP ASH POND  
CRISP COUNTY POWER COMMISSION**

This letter report summarizes the observations and resulting recommendations from our annual inspection of the Plant Crisp Ash Pond performed on Wednesday, November 10, 2021.

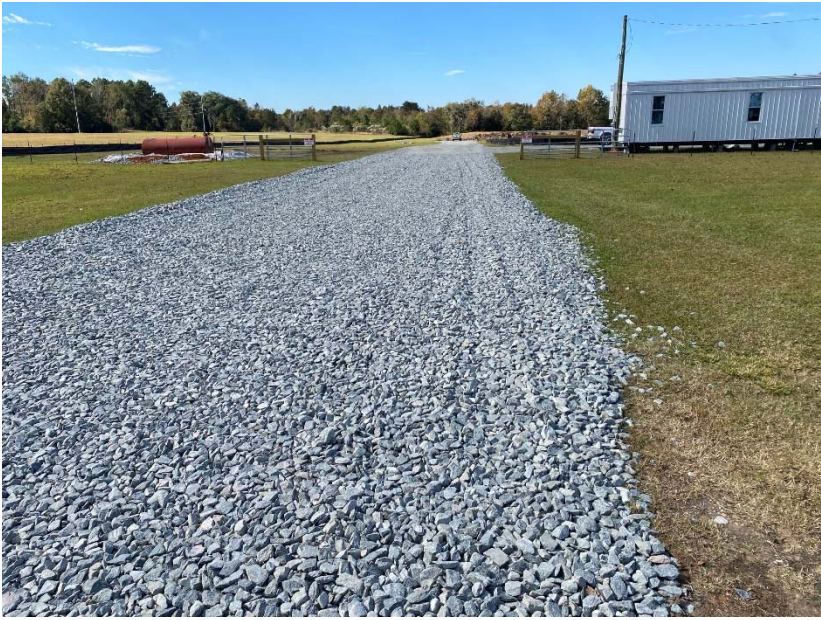
closure construction were mostly installed at the time of the inspection (Photographs 01, 07, 08, 12, and 13).

| <p>Photograph No. 01</p> <p>Date: 11/10/2021</p> <p>Direction: West</p> <p>Description:<br/>Construction<br/>Entrance and Initial<br/>Best Management<br/>Practices</p> | | |

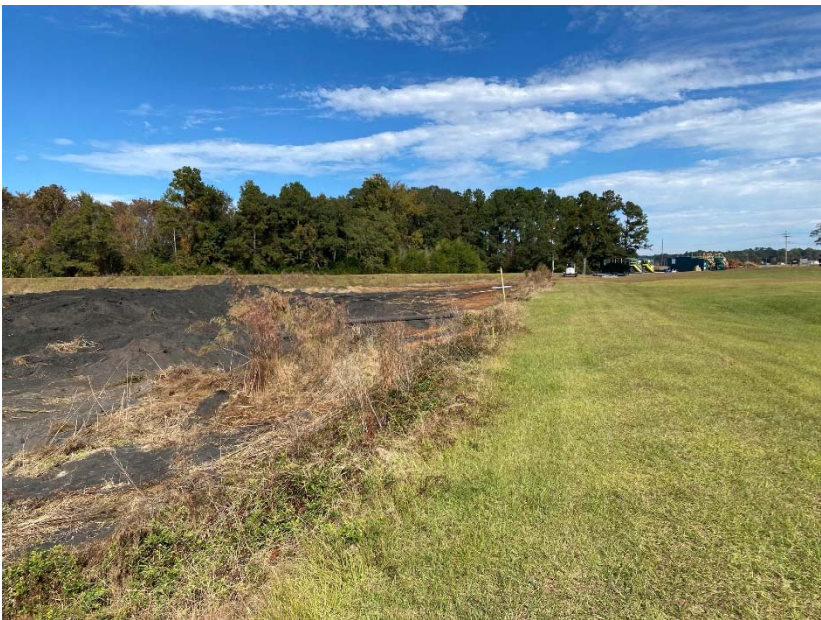
| <p>Photograph No. 02</p> <p>Date: 11/10/2021</p> <p>Direction: North</p> <p>Description: East<br/>Embankment</p> | | |

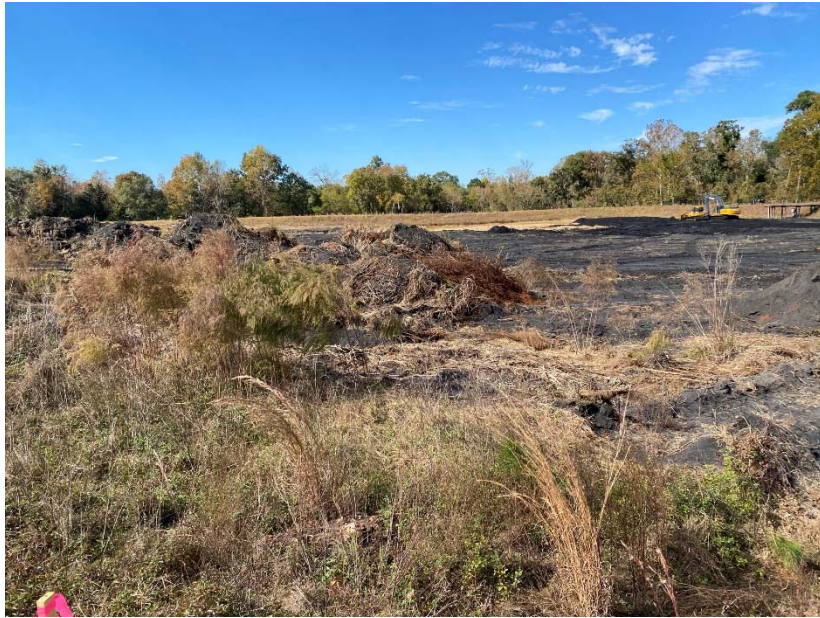
Photograph No. 03

Description:  
Stripping of  
vegetation within the  
ash pond

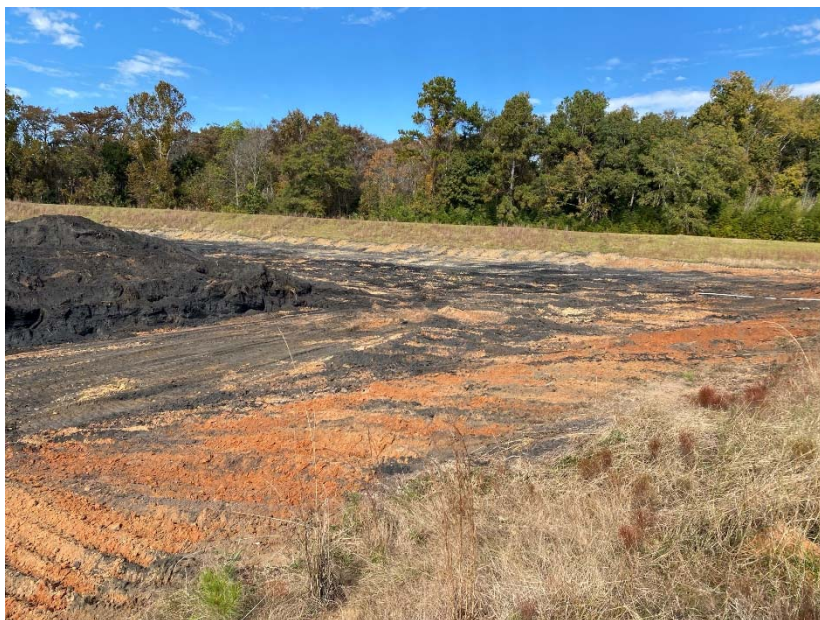
Photograph No. 04

Description: Initial  
ash removal  
activities within the  
ash pond

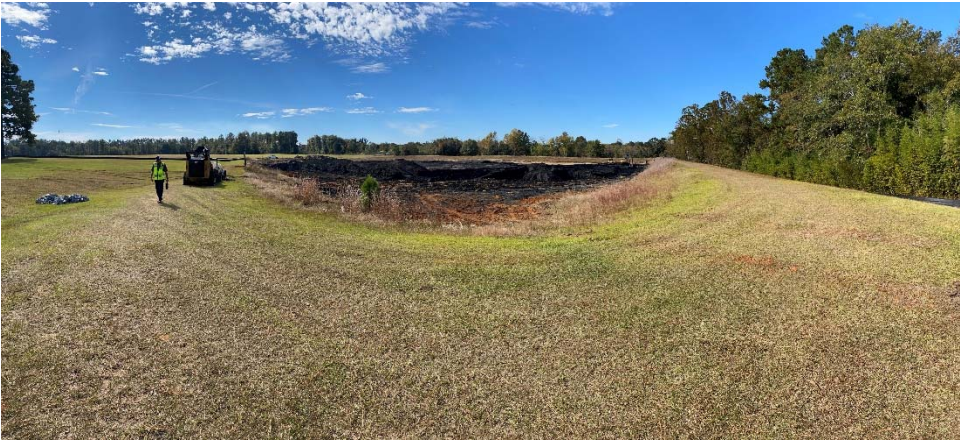
| <p>Photograph No. 05</p> <p>Date: 11/10/2021</p> <p>Direction: Southwest</p> <p>Description:<br/>Panorama of the ash pond from its northeast corner</p> | | |

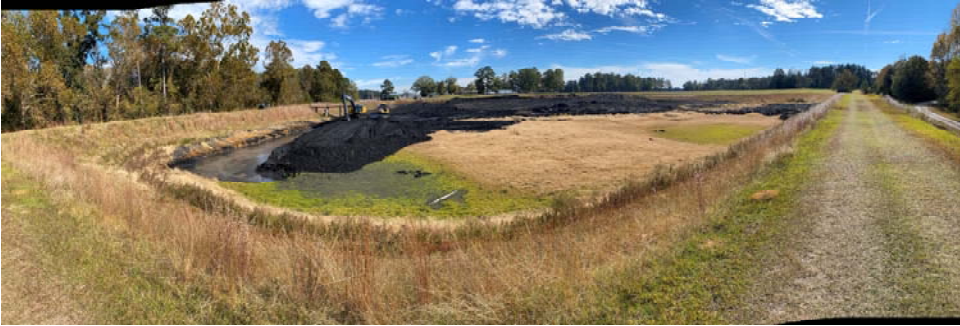
| <p>Photograph No. 06</p> <p>Date: 11/10/2021</p> <p>Direction: Southeast</p> <p>Description:<br/>Panorama of the ash pond from its northwest corner</p> | | |

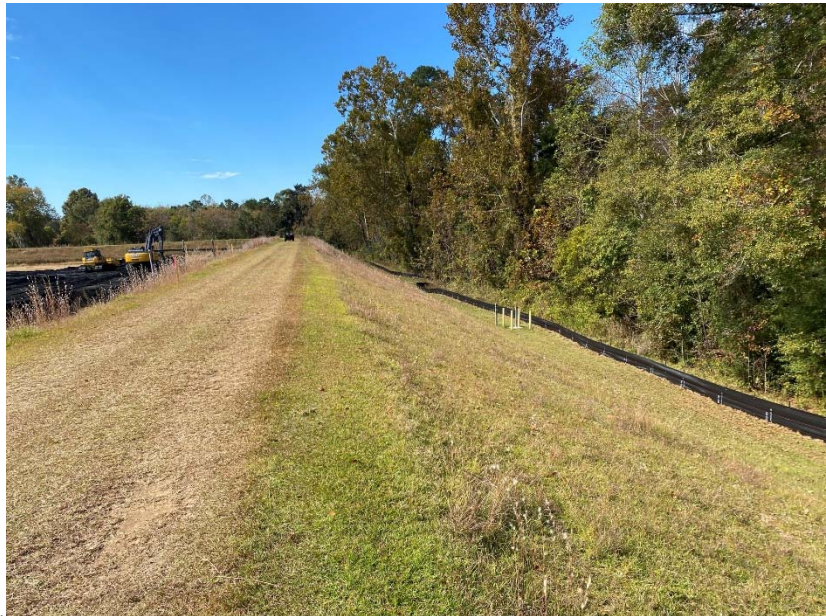
Photograph No. 07

Description: North Embankment and external slope at crest

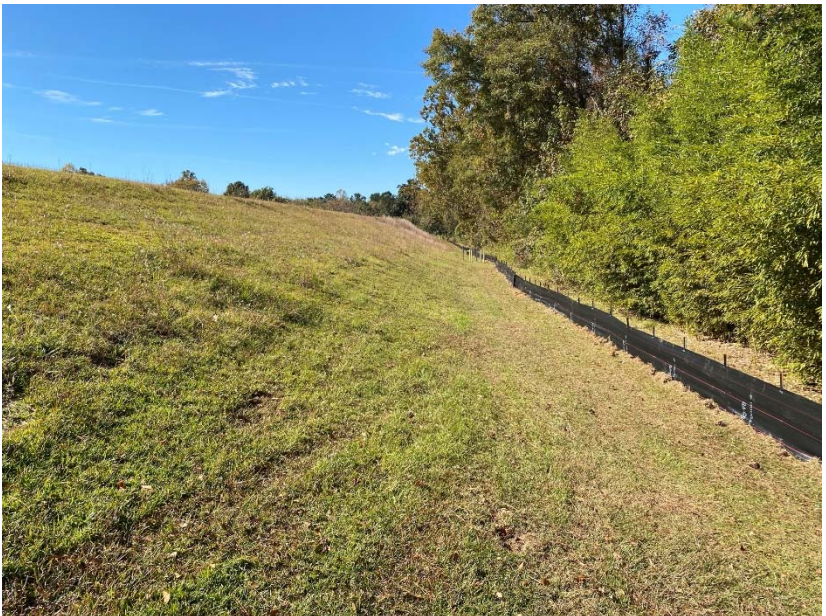
Photograph No. 08

Description: North Embankment and external slope at toe

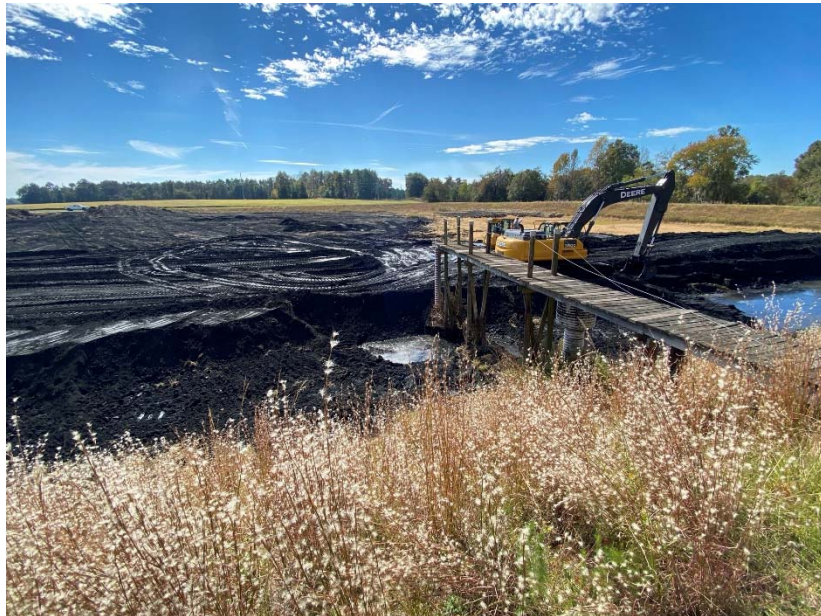
Photograph No. 09

3. Overall grass cover on the embankment slopes is acceptable, with grass heights generally less than six inches on the external slopes. A small area on the external slope of the Western Dike and majority of the internal slopes had overgrown vegetation approximately 6 to 12 inches (Photographs 09, 11, and 12). CCPC indicated that the overgrown vegetation will be mowed as part of the continued maintenance activities. It is noted that the ash pond is already in the process of closure with an ongoing construction where the water levels are and will continue to be maintained as low as possible to facilitate ash removal. Following removal of the ash, the dikes will be lowered and breached.

Description: Internal slope of North Embankment, boardwalk, 12-in spillway riser with 24-in trash screen, and staff gauge

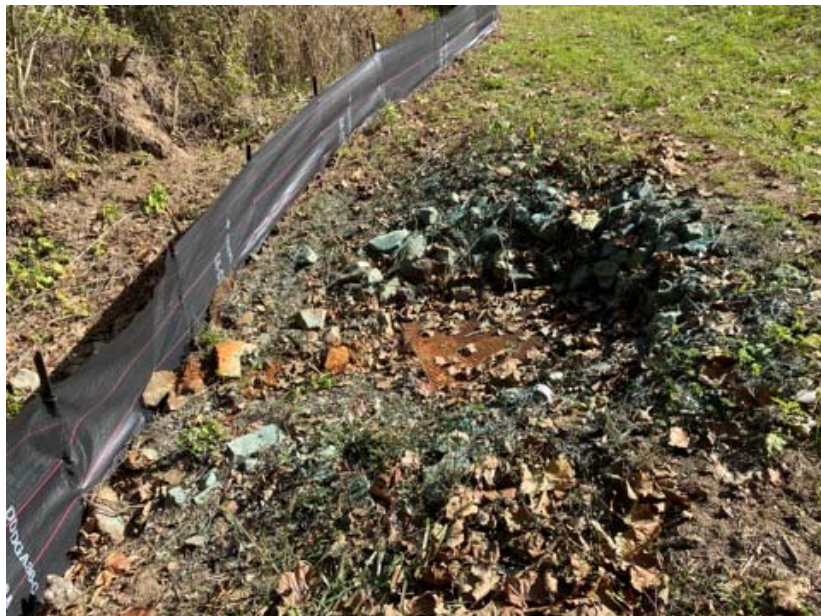
Photograph No. 10

4. The spillway outfall area was clear of vegetation and appeared to be dry (Photograph No. 10).
5. Some of the historical inspections reported a wet area in the vicinity of monitoring well MW-D3, near the toe of the north embankment [Rizzo, 2019; Geosyntec, 2020b]. However, this area appeared to be dry during this inspection (Photograph No. 13), consistent with the previous annual inspection. Additionally, the groundwater level reading on 10/26/2021 at monitoring well MW-D3 was measured to be approximately 3.3 ft below ground surface.

Description: Spillway outlet (installed with a protective grate for animal control); no flow/discharge observed

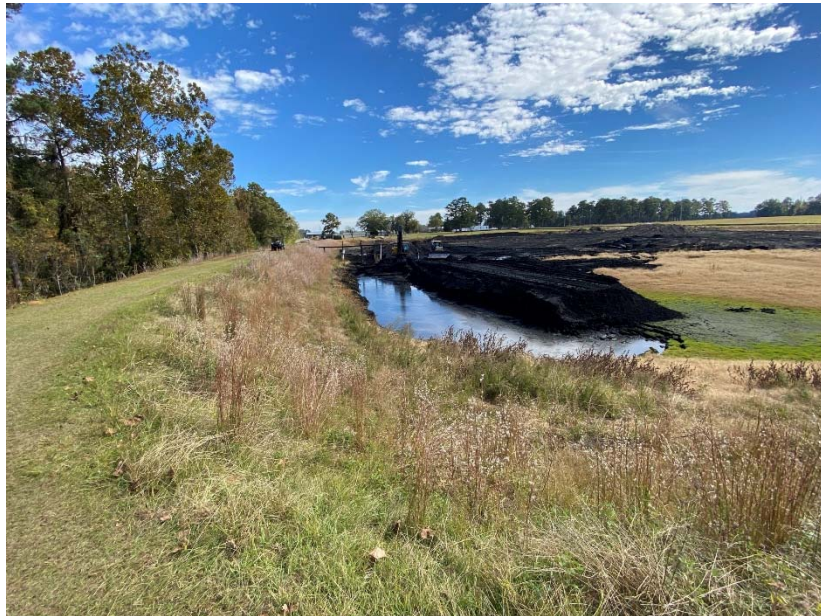
Photograph No. 11

During the inspection, the AP had virtually no free water stored within except one small puddle measuring approximately 15 ft x 100 ft in size, with water depths less than 3 ft (estimated total water volume < 0.11 ac-ft). The estimated volume of the impounded CCR at the time of the inspection is approximately 51,000 cubic yards. Depth of CCR is estimated to vary from 0 to 10 ft; top of CCR elevations vary from approximately 230 ft MSL to 240 ft MSL. Kemron initiated stripping of vegetation (grass and brush) within the ash pond and has started excavation and stockpiling of ash for future hauling to the receiving landfill. No new CCR was added to the impoundment since March 2017. In the past 12 months, depth of water ranged from approximately 0.00 ft to 2.08 ft, as measured at the staff gauge near the boardwalk, which corresponds to top of water elevations ranging approximately equal or less than 232.95 ft MSL to 235.03 ft MSL.

Description: A small puddle along the internal slope toe of the North Embankment

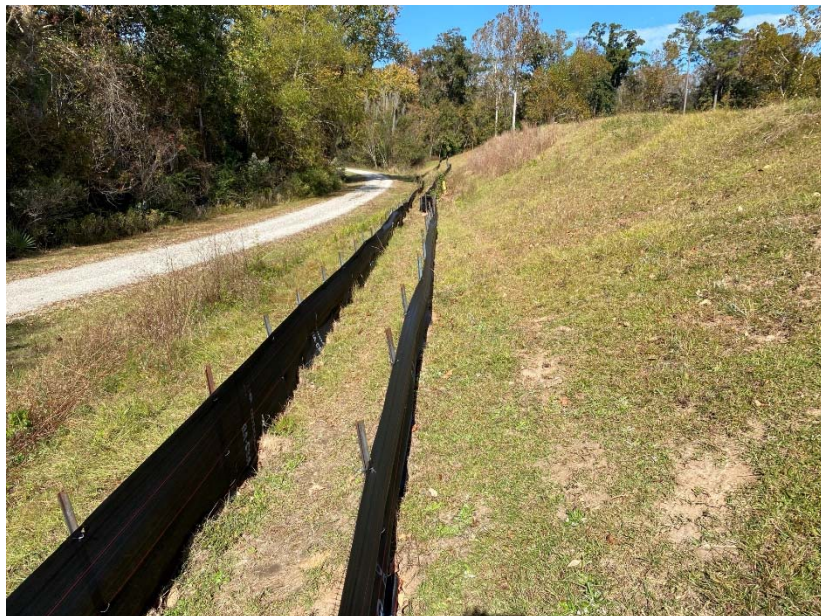
Photograph No. 12

2. Hummocky areas and minor soil erosion with missing grass cover was observed at a few locations on both internal and external slopes of the AP embankments (Photograph 12).

Description: Hummocky areas and minor surface erosion on the external slope of the West Embankment

| Earth Embankments | | | |
|---|---|---|---|
| b. Sloughs or Slumps? | | × | Hummocky areas at several locations on the west embankment; however, no sloughs, slumps, circular slip surfaces, or cracks observed. No apparent change since last inspection. |

- **Recommendation No.1:** Continue monitoring the areas of minor erosion at both internal and external slopes during weekly inspections. If any changes are observed that indicate further degradation of the slopes, CCPC should repair these areas locally to prevent further erosion.
- **Recommendation No.2:** Continue mowing the external and internal slopes of the embankments periodically to discourage overgrowth and facilitate inspection.
- **Recommendation No.3:** Continue monitoring the vicinity of monitoring well MW-D3 for wetness, signs of general slope instability, or embankment distress such as sloughs, tension cracks, bulges.

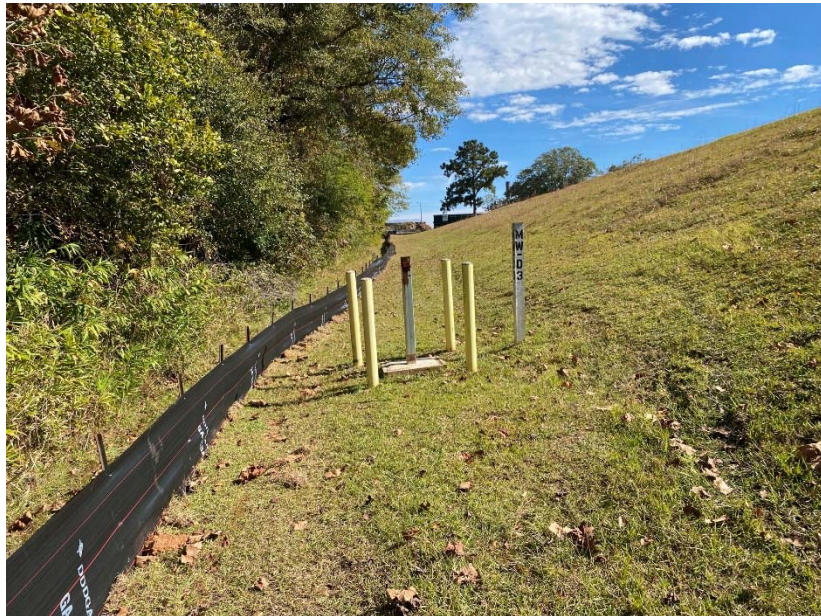
Photograph No. 13

Description:  
External slope of  
North Embankment;  
groundwater  
monitoring well  
MW-D3
