**2020 ANNUAL INSPECTION REPORT**  
**PLANT CRISP ASH POND**  
**CRISP COUNTY POWER COMMISSION**

This letter report summarizes the observations and resulting recommendations from our annual inspection of the Plant Crisp Ash Pond performed on Monday, December 28, 2020.

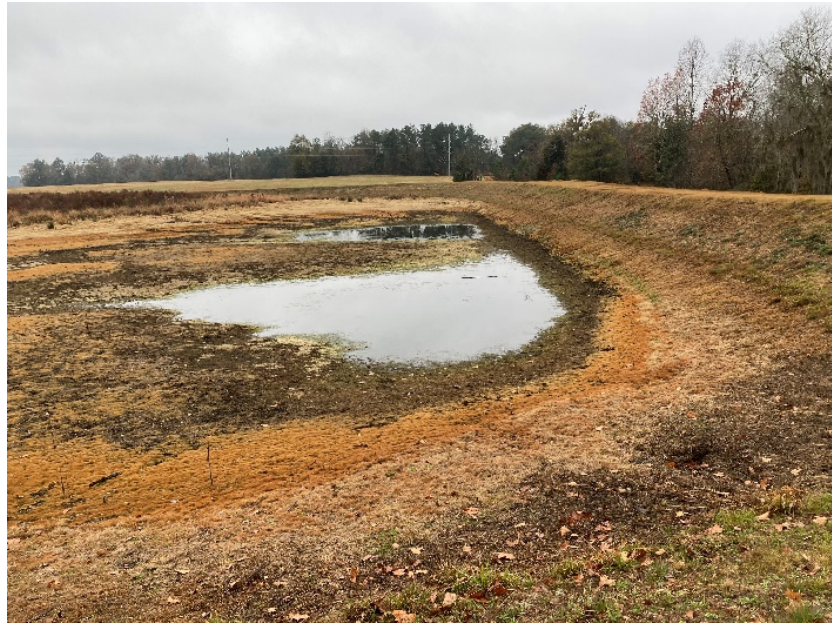
Photograph No. 05

During the inspection, the AP had virtually no free water stored within except two small puddles measuring approximately 20 ft x 30 ft and 30 ft x 30 ft in size, with water depths less than a foot (estimated total water volume < 0.05 ac-ft). The estimated volume of the impounded CCR at the time of the inspection is approximately 51,000 cubic yards. Depth of CCR is estimated to vary from 0 to 10 ft; top of CCR elevations vary from approximately 230 ft MSL to 240 ft MSL. No new CCR was added to the impoundment since March 2017. In the past 12 months, depth of water ranged from approximately 0.0 ft to 4.2 ft, as measured at the staff gauge near the boardwalk, which corresponds to top of water elevations ranging from 232.95 ft MSL to 237.12 ft MSL.

Description: Two small puddles along the internal slope toe of the west embankment

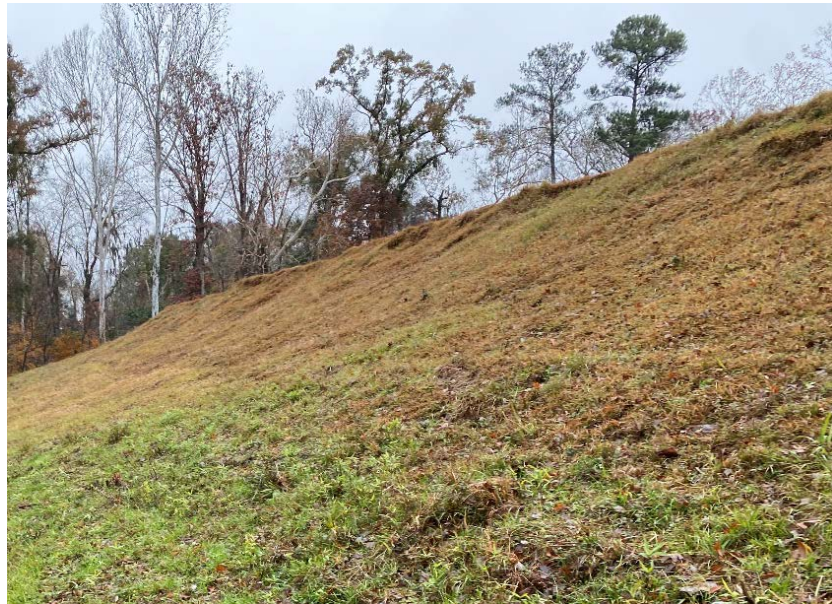
Photograph No. 06

1. Hummocky areas and minor soil erosion with missing grass cover was observed at several locations on both internal and external slopes of the AP embankments.
2. The latest mowing of the slopes was conducted in July 2020. Overall grass cover on the embankment slopes is acceptable, with grass heights

Description: Hummocky areas and minor surface erosion on the external slope of the west embankment

- **Recommendation No.1:** Continue to monitor the areas of minor erosion at both internal and external slopes during weekly inspections. If any changes are observed that are pointing to further degradation of the slopes, CCPC should repair these areas locally to prevent further erosion.
- **Recommendation No.2:** Continue to mow the external and internal slopes of the embankments and the outfall area to discourage overgrowth. Remove small volunteer trees as early as practical. Trees allowed to grow and develop root systems in the slopes of dams can create preferential seepage pathways and potential instability.
- **Recommendation No.3:** Continue to monitor the vicinity of monitoring well MW-D3 for wetness, signs of general slope instability, or embankment distress such as sloughs, tension cracks, bulges.

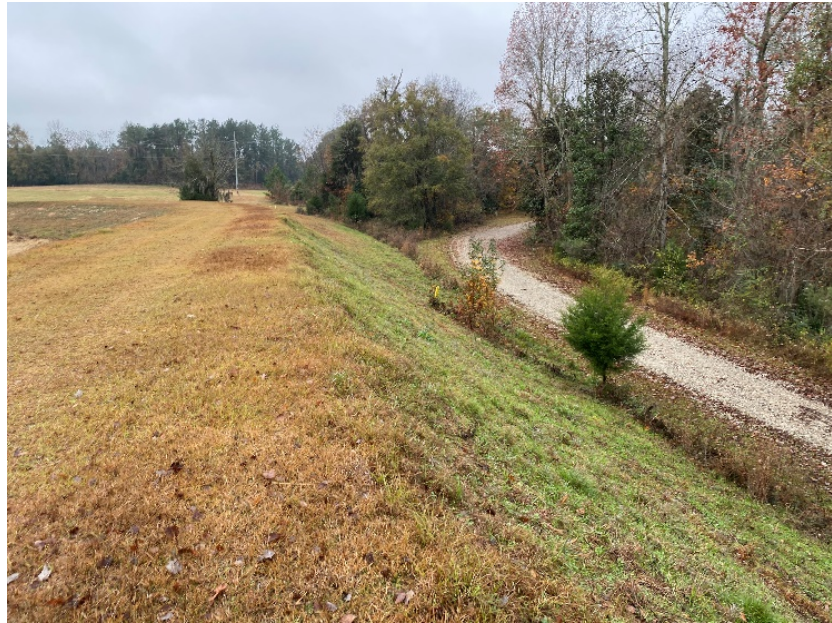
Photograph No. 07

3. Three short trees (<5 ft) were observed along the toe of the external slope of the west embankment during the inspection (Photograph No. 07). Following the inspection, CCPC removed the trees, which is documented on Photograph No. 08.

Description: External slope of the west embankment with short trees on the slope

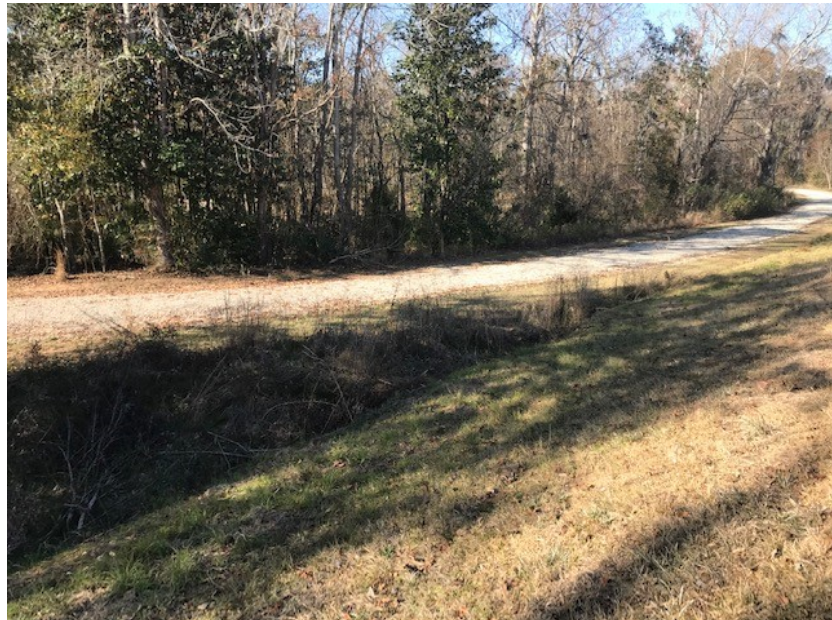
Photograph No. 08

Description: Documentation of Maintenance - External slope of the north embankment after the short trees in Photograph No. 07 were removed

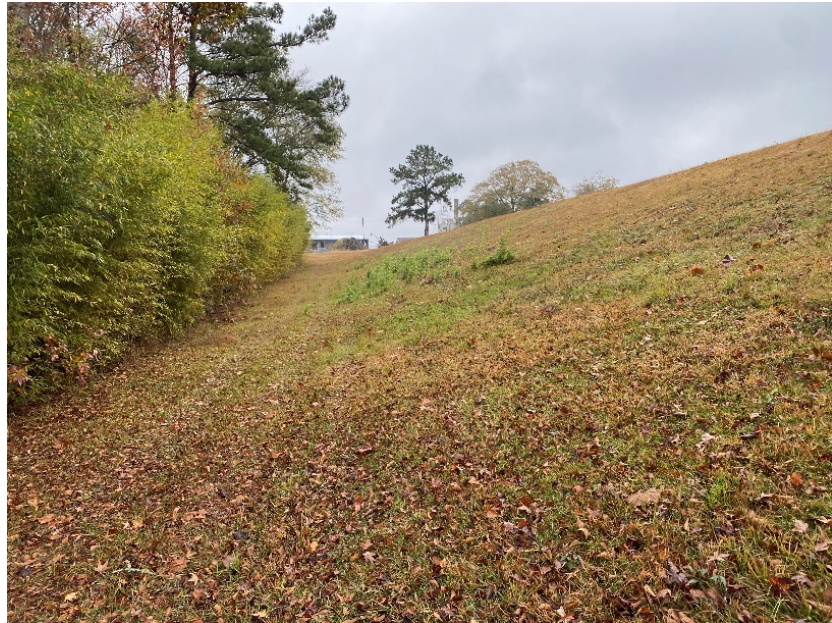
Photograph No. 09

generally less than six inches. A small area on the external slope of the Northern Dike had overgrown vegetation taller than 6-inches, which appeared to consist of bamboo saplings (Photograph No. 09). Following the inspection, CCPC mowed the overgrown vegetation, which is documented on Photograph No. 10.

Description: External slope of north embankment with bamboo saplings on the slope

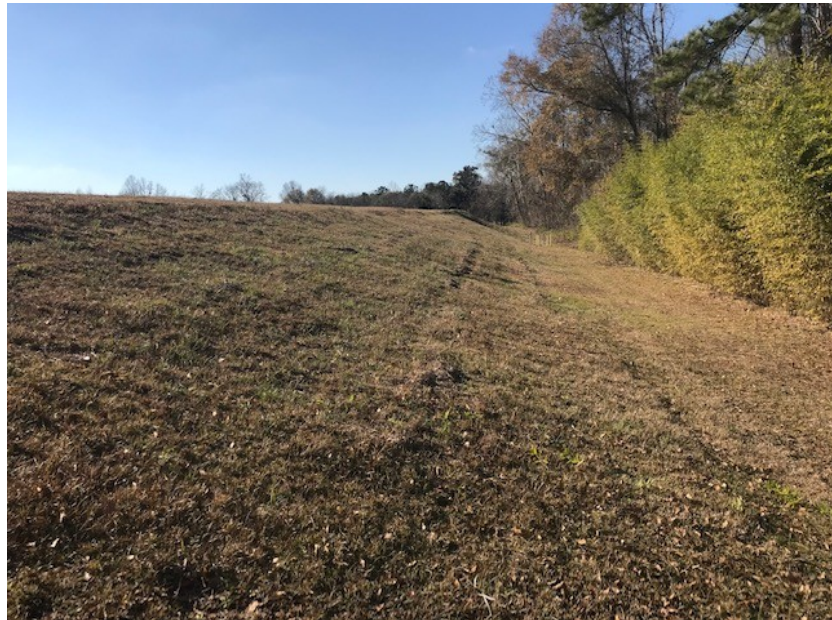
Photograph No. 10

Description: Documentation of Maintenance – External slope of north embankment after the bamboo saplings on Photograph No. 09 were removed

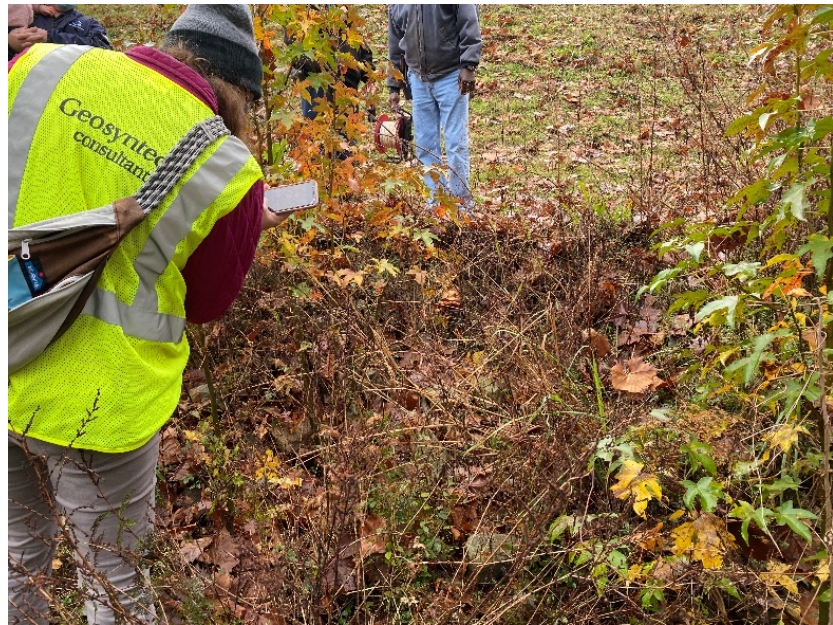
Photograph No. 11

4. The spillway outfall area was covered with overgrown vegetation which impeded visual inspection of the outlet pipe and would obstruct flow if discharge were to occur from the AP (Photograph No. 11). The inspectors carefully removed the vegetation locally and observed the outfall area to be dry. Following the inspection, CCPC trimmed the vegetation and cleared the area, which is documented on Photograph No. 12.

Description: Spillway outlet (installed with a protective grate for animal control) covered by overgrown vegetation; no flow/discharge observed

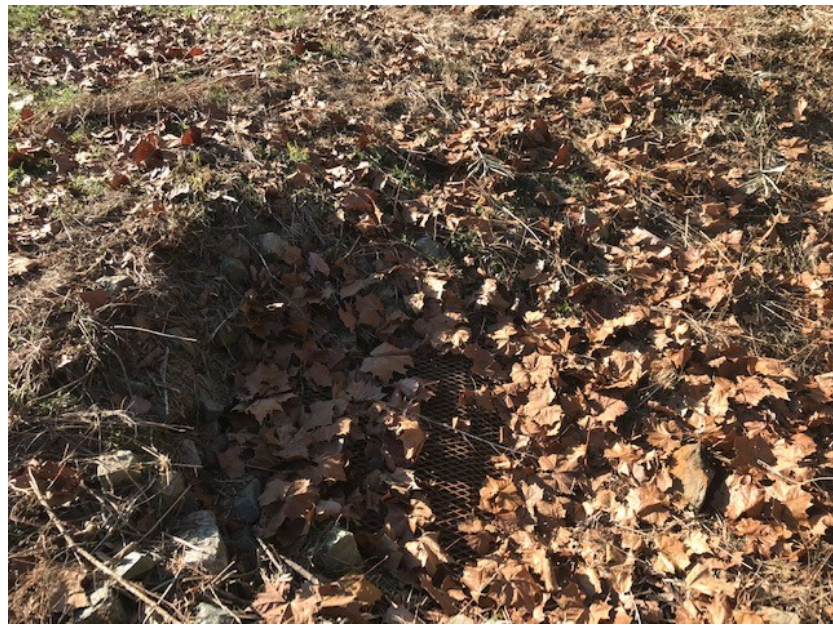
Photograph No. 12

Description: Documentation of Maintenance – Spillway outlet pipe after the overgrown vegetation on Photograph No. 11 were removed

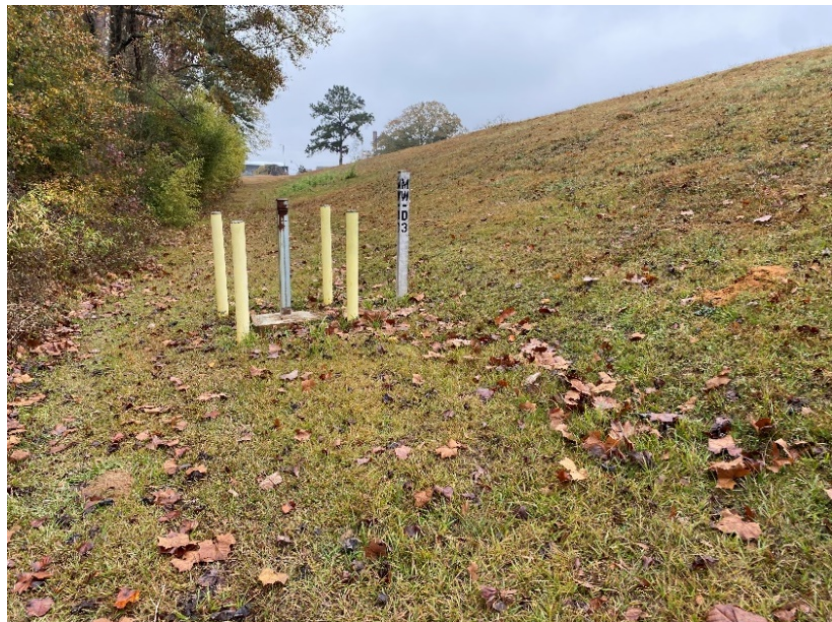
Photograph No. 14

5. Previous safety inspections reported a wet area in the vicinity of monitoring well MW-D3, near the toe of the north embankment [Rizzo, 2019; Geosyntec, 2020b]. However, this area appeared to be dry during this inspection (Photograph No. 14). Additionally, the groundwater level in monitoring well MW-D3 was measured to be approximately 3.5 ft below ground surface at the time of the inspection.

Description: External slope of north embankment; groundwater monitoring well MW-D3
