# ASSESSMENT OF DAM SAFETY OF COAL COMBUSTION SURFACE IMPOUNDMENTS – FINAL REPORT

**Crisp County Power  
Commission  
Plant Crisp  
Warwick, Georgia**

Prepared for  
*U.S. Environmental  
Protection Agency  
Washington, D.C.*

December 2013  
Revision 1, February 2014

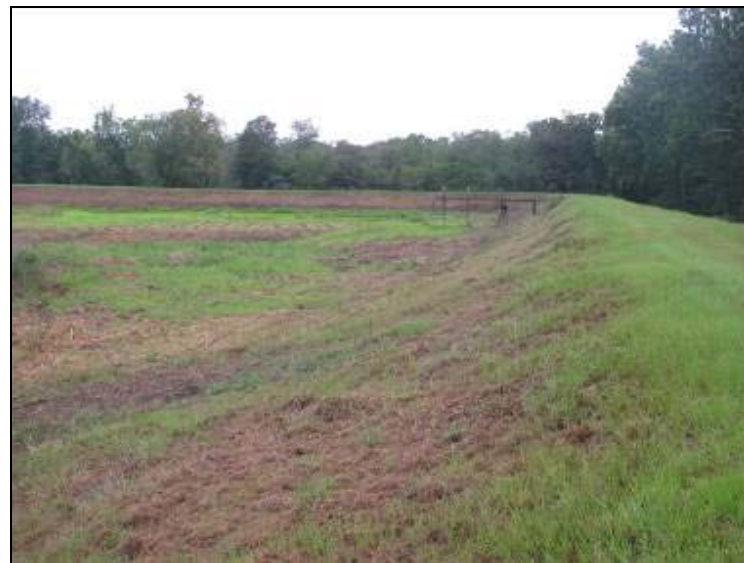
The interior slopes of the Ash Pond embankments appear to be in **FAIR** condition. The interior slopes are about 2H:1V at the north and west embankments, 3H:1V at the south embankment, and 5H:1V at the southeast embankment. Slopes shown on the drawings provided are 3H:1V. Interior slopes have a grass cover approximately 4 inches high (Photographs 4, 9, 10, 42, 43, 57, 60, 67, 71 and 72). Scarps and erosion rills (Photographs 50, 59, 61, 62, 66, 70 and 75) were observed along the interior slopes of the north, west, and south embankments. Several boulders (rocks with size greater than 12 inches) protruding from the face of the slope (Photographs 65 and 73) were observed on the north and south embankments. Near the southeast embankment, accumulated ash and debris were clearly visible (Photograph 53).

Photo 2: Ash Pond – North embankment interior slope, looking west.

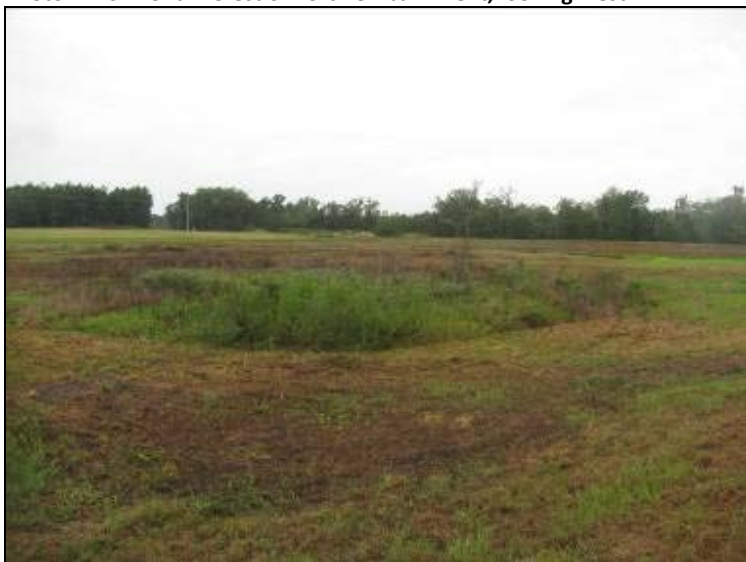
Photo 3: Ash Pond – North embankment interior slope, general view of pond surface area looking southwest.

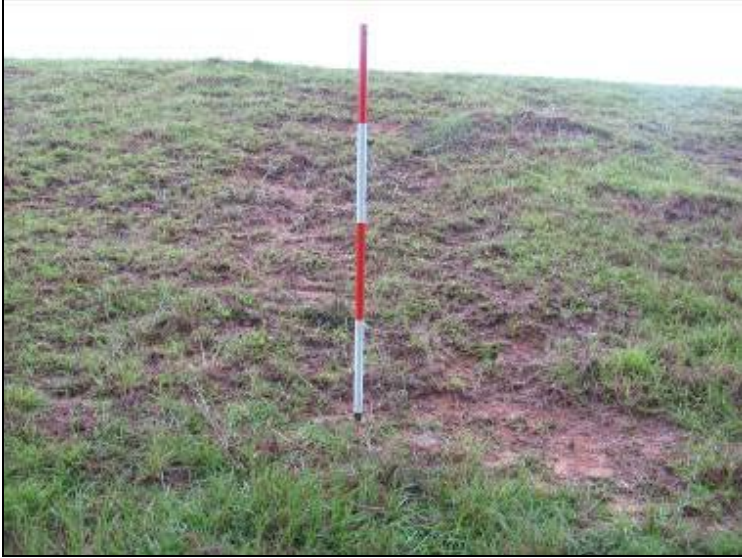
The exterior slopes appear to be in **FAIR** condition. The exterior slopes of the embankments are about 2H:1V at the north and west embankments, 5H:1V at the south embankment, and 4H:1V at the southeast embankment. The east portion of the north embankment has an approximate slope of 3H:1V with a slope break near the outlet structure to 2H:1V (Photograph 6). Slopes shown on the drawings provided are 3H:1V. The exterior slopes are covered with grass that was approximately 4 to 6 inches high at the time of the visual assessment (Photographs 14 to 17, 31, 32, 38, 39, 44 and 45). Surficial erosion rills and scarps were observed at the north embankment (Photographs 5, 7 and 8). An apparent 16-foot-long semicircular surficial slough (Photographs 21 to 23) and several minor sloughs and scarps near the crest (Photograph 18, 19, 20, and 24 to 27) were observed on the west embankment.

Photo 5: Ash Pond – North embankment exterior slope, minor surficial erosion looking south.

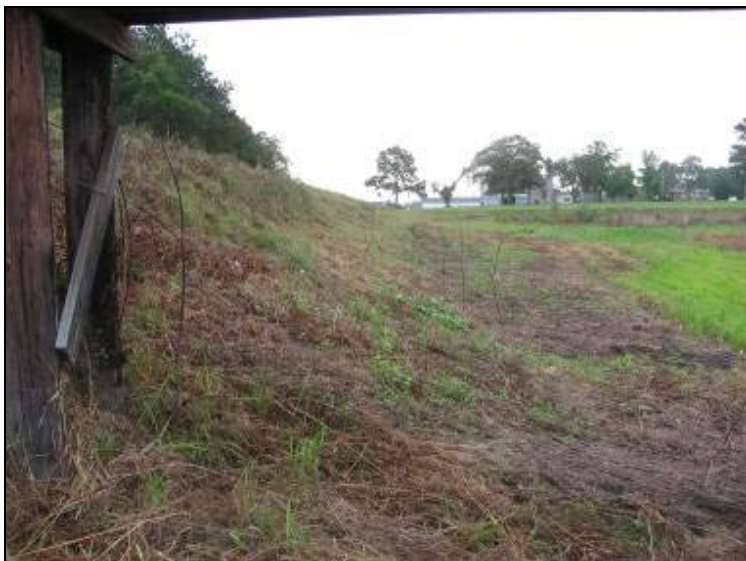
Photo 9: Ash Pond – North embankment interior slope, looking east.

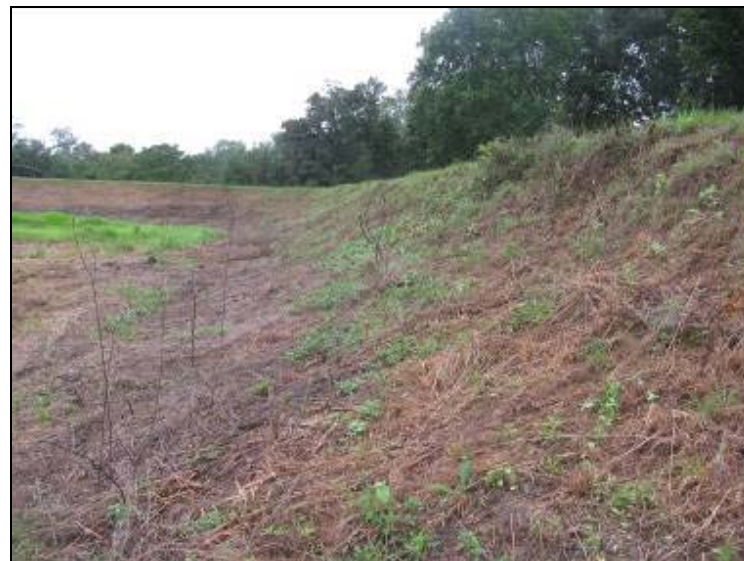
Photo 10: Ash Pond – North embankment interior slope, looking west.

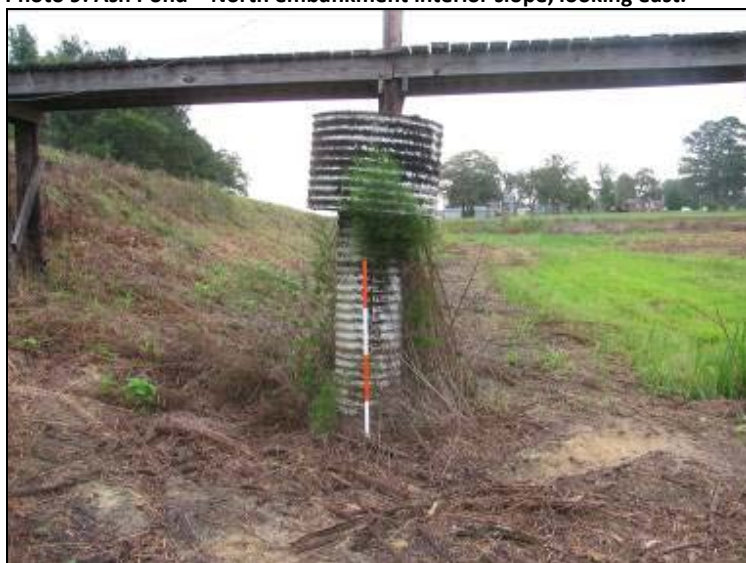
The outlet structure consists of an 18-inch-diameter corrugated metal riser pipe (CMP), with an approximate 2-foot-high by 36-inch-wide CMP trash-rack at the neck of the outlet pipe. This outlet is located near the central portion of the north embankment (Photographs 11, 12 and 64). Based on the drawings provided by the Crisp County Power Commission (Appendix A), we understand that this riser pipe connects into a 12-inch-diameter CMP and discharges near the toe of slope of the north embankment. CDM Smith was not able to locate the exit pipe due to the high vegetation at the apparent outfall/discharge location.

Photo 11: Ash Pond – North embankment interior slope, 18-inch outlet riser pipe, looking east.

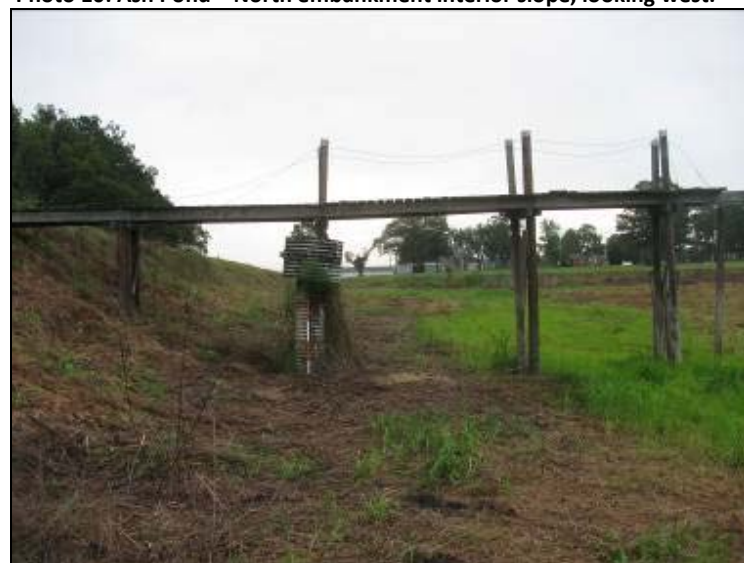
Photo 12: Ash Pond – North embankment interior slope, boardwalk and 18-inch outlet riser pipe looking east.

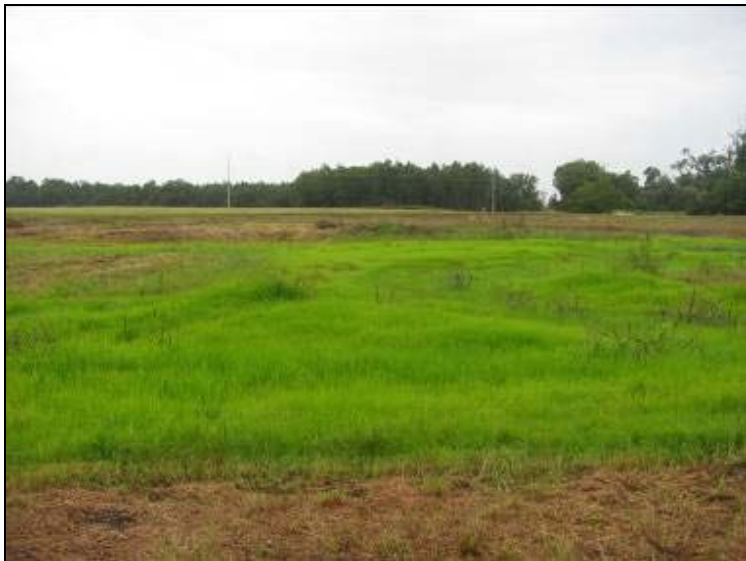
Photo 13: Ash Pond – General view of pond bottom surface, looking south.

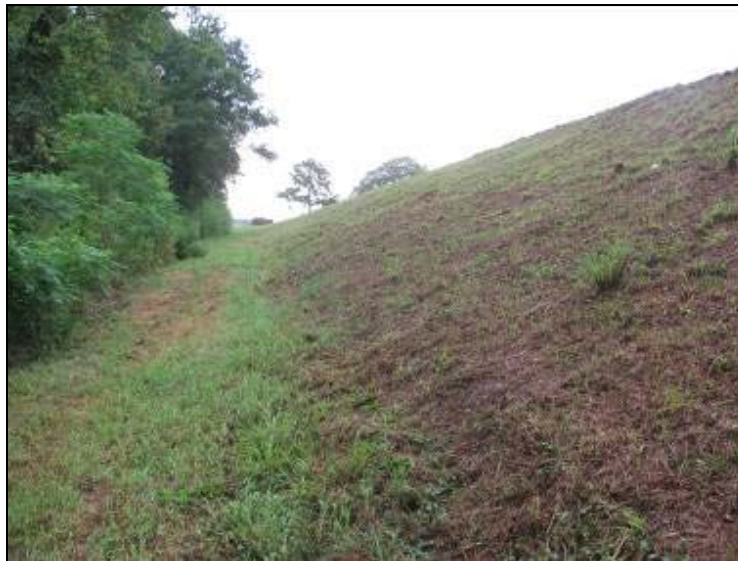
Photo 14: Ash Pond – North embankment exterior slope, looking east.

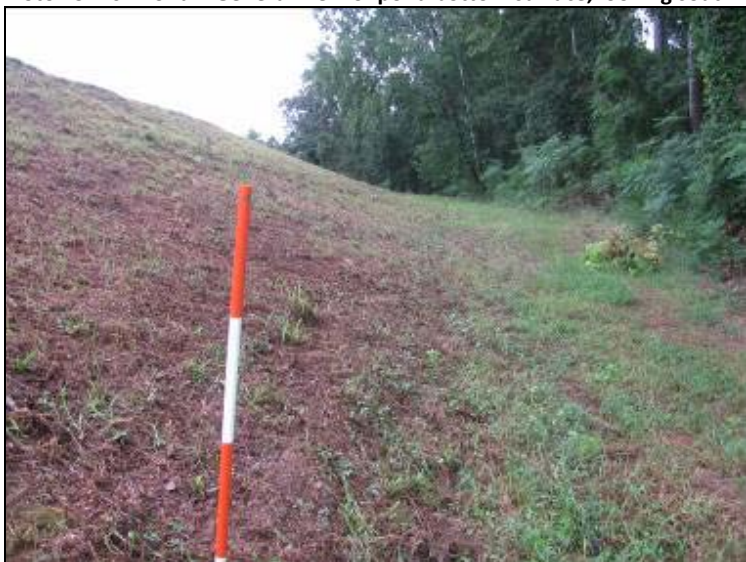
Photo 15: Ash Pond – North embankment exterior slope, looking west.

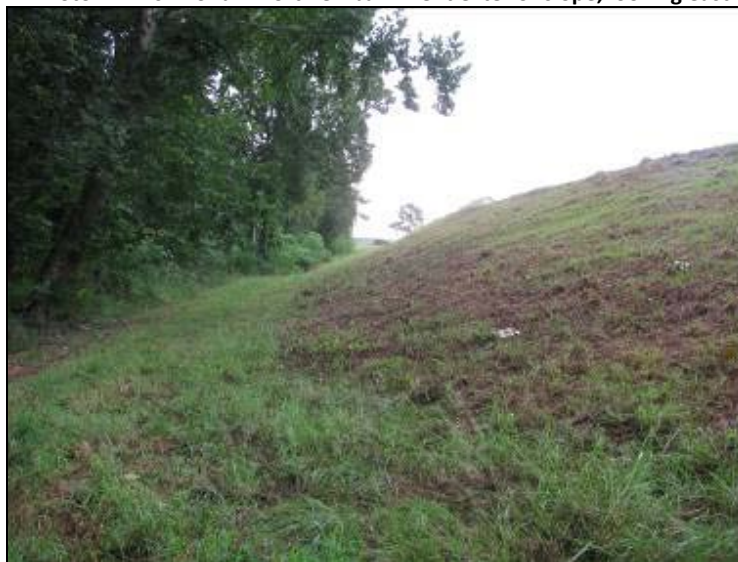
Photo 16: Ash Pond – North embankment exterior slope near northwest corner, looking east.

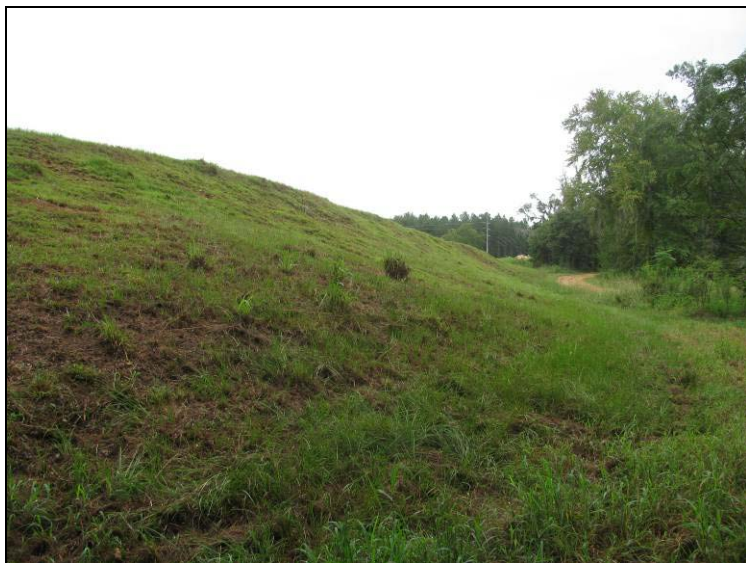
Photo 17: Ash Pond – West embankment exterior slope near northwest corner, looking west.

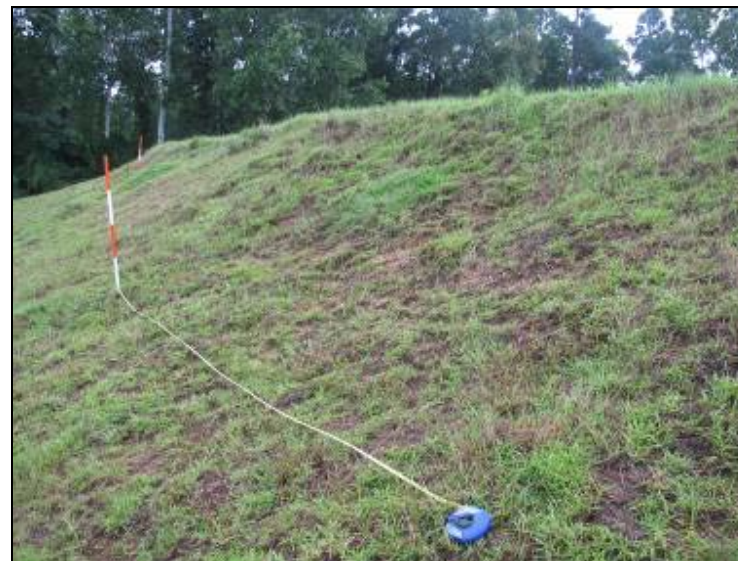
Photo 22: Ash Pond – West embankment exterior slope, apparent 16-foot long semi-circular sloughing, looking north.

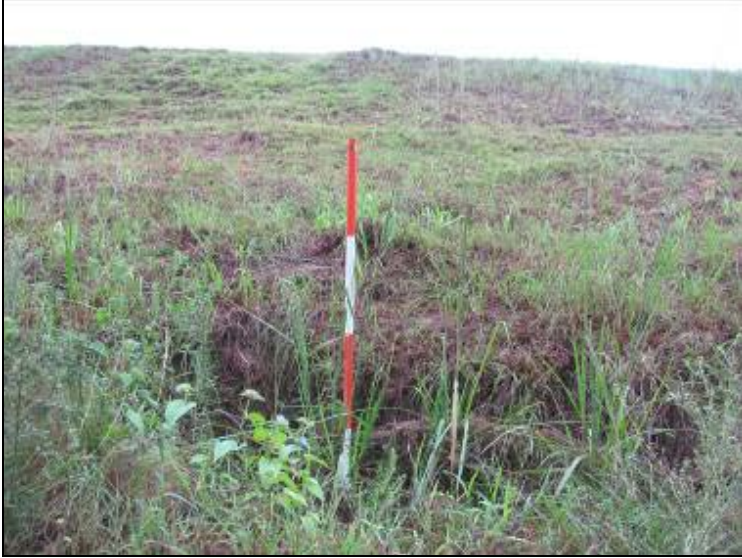
A runoff swale was cut into the toe of the slope of the west embankment (Photographs 29 to 31). It was reported by the Crisp County Power Commission representatives that the toe of slope of the west embankment extends beyond the plant property line.

Photo 29: Ash Pond – West embankment exterior slope, swale cut at toe of slope, looking east.

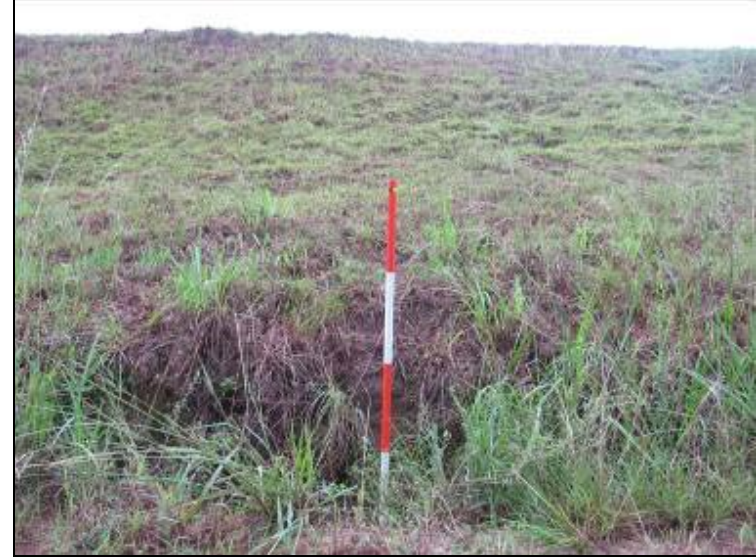
Photo 30: Ash Pond – West embankment exterior slope, swale cut at toe of slope, looking east.

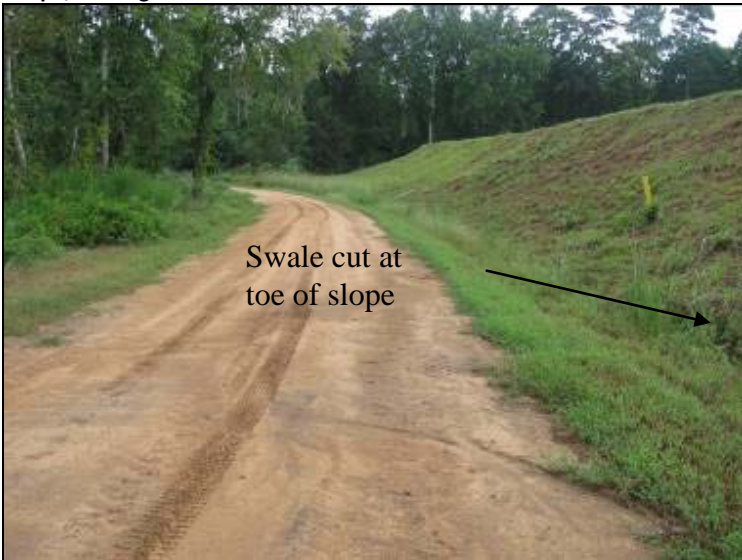
Photo 31: Ash Pond – West embankment exterior slope, toe of slope and road looking north.

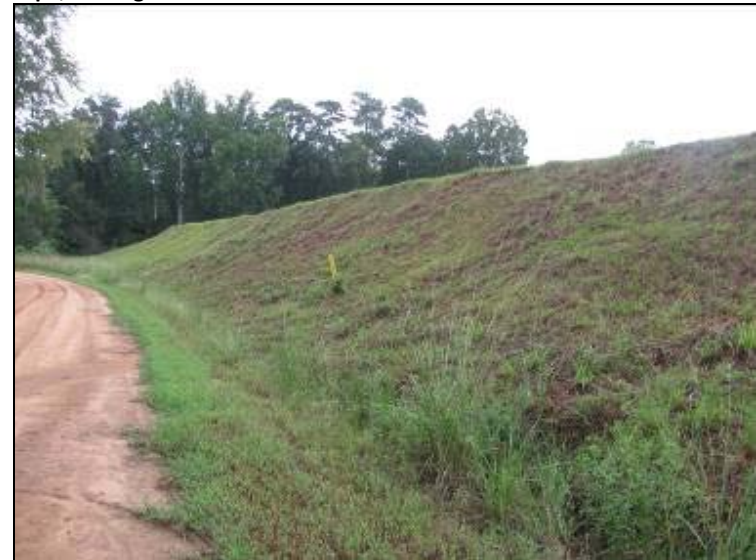
Photo 32: Ash Pond – West embankment exterior slope near southwest corner, looking north.

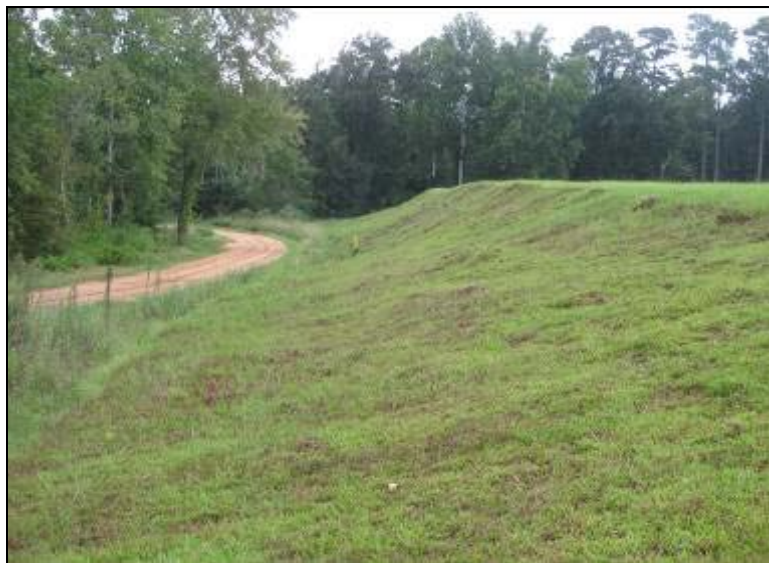
Photo 33: Ash Pond – West embankment exterior slope near southwest corner, looking north.

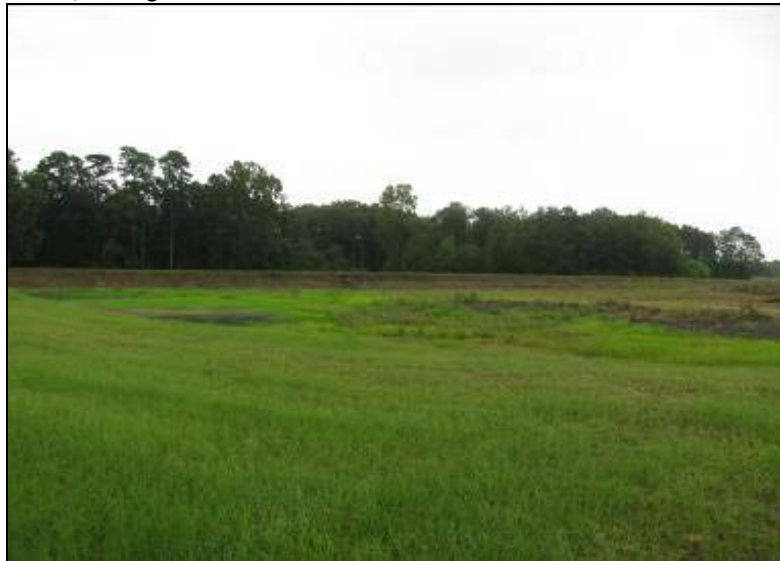
Photo 35: Ash Pond – General view of pond surface area looking northeast.

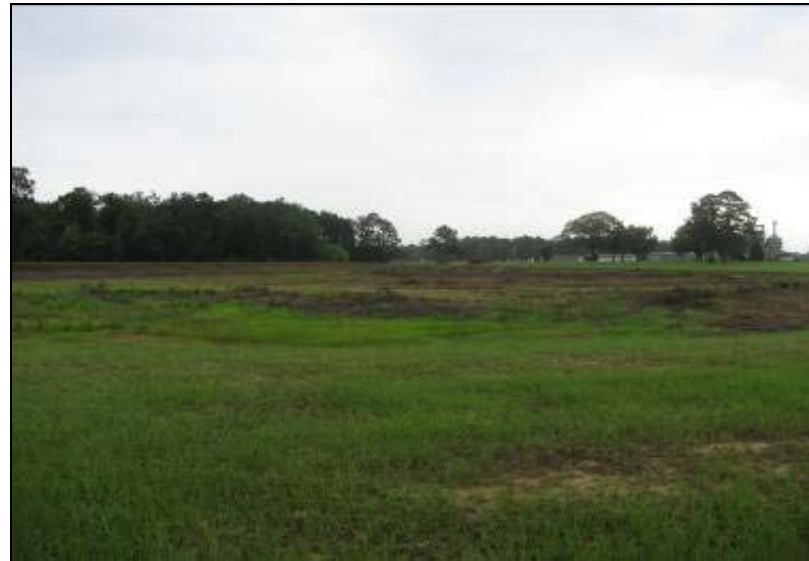
Photo 36: Ash Pond – General view of pond surface area looking northeast.

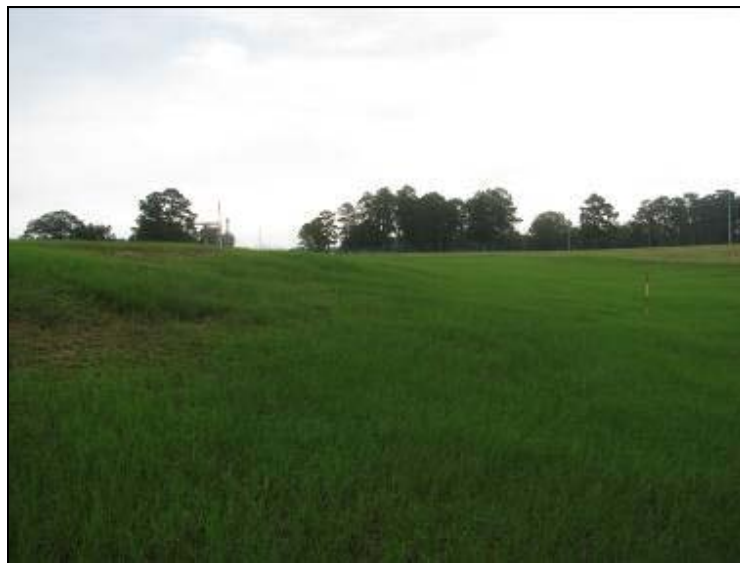
Photo 38: Ash Pond – South embankment exterior slope, looking east.

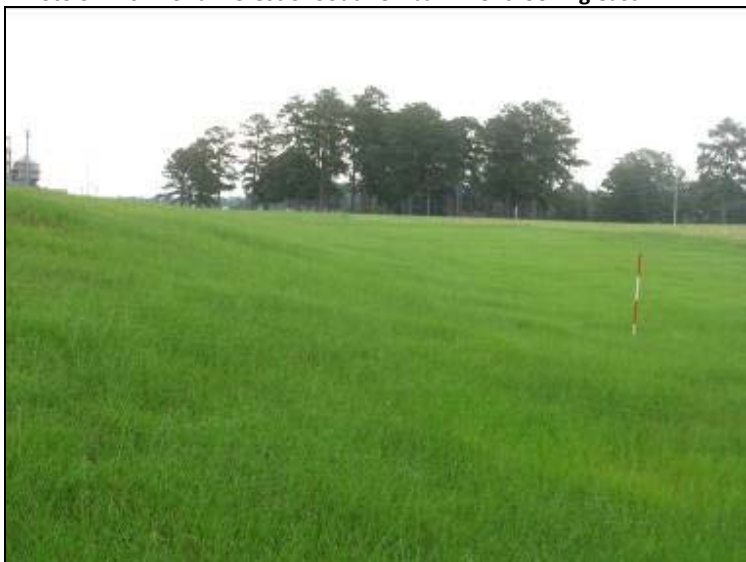
Photo 39: Ash Pond – South embankment exterior slope, looking east.

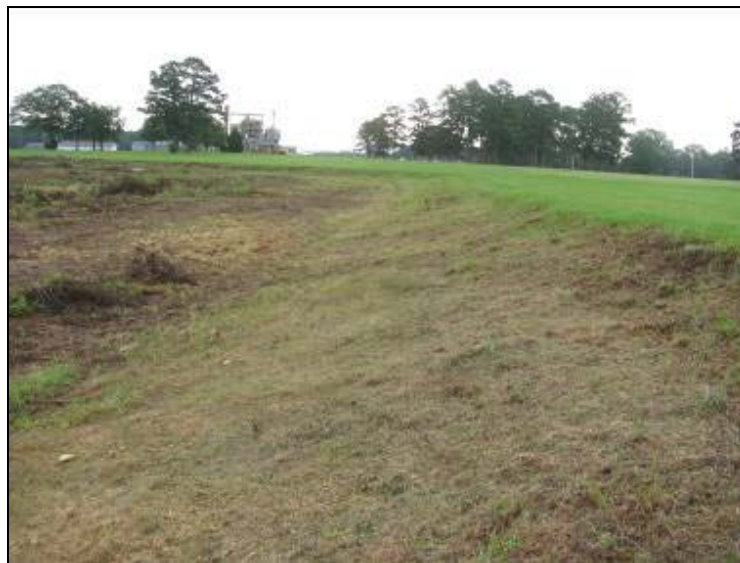
Photo 42: Ash Pond – South embankment interior slope, looking east.

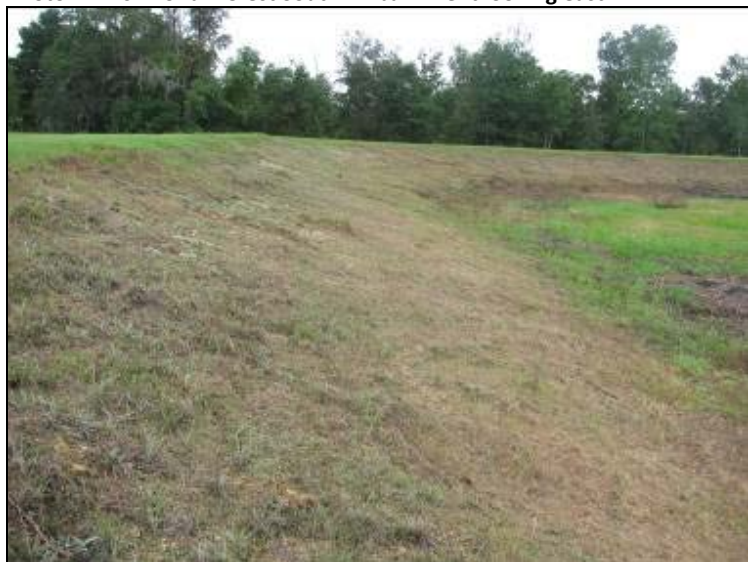
Photo 43: Ash Pond – South embankment interior slope, looking west.

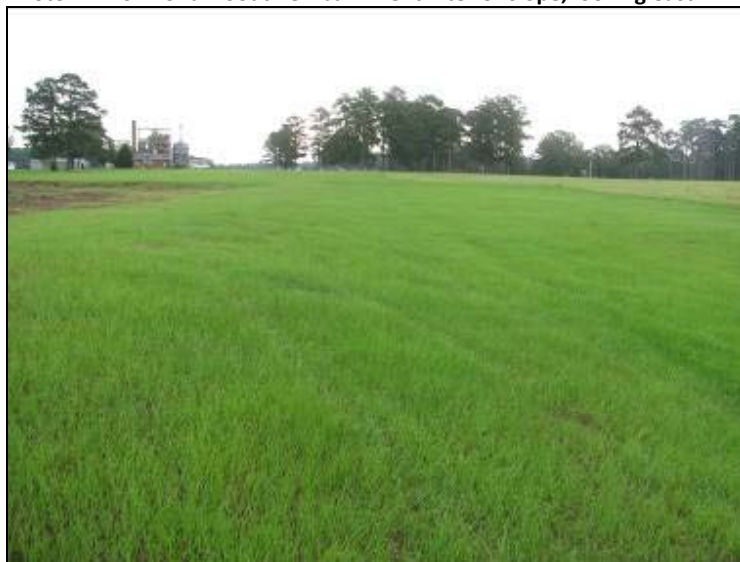
Photo 44: Ash Pond – South embankment exterior slope, looking east.

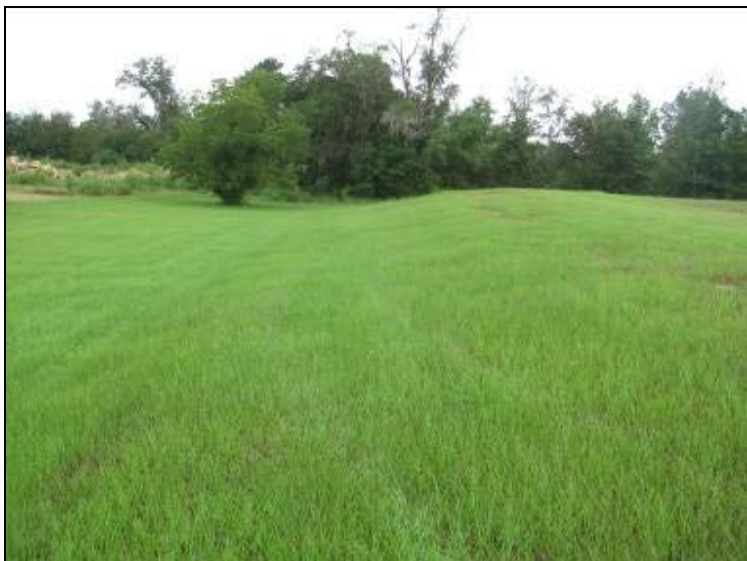
Photo 45: Ash Pond – South embankment exterior slope, looking west.

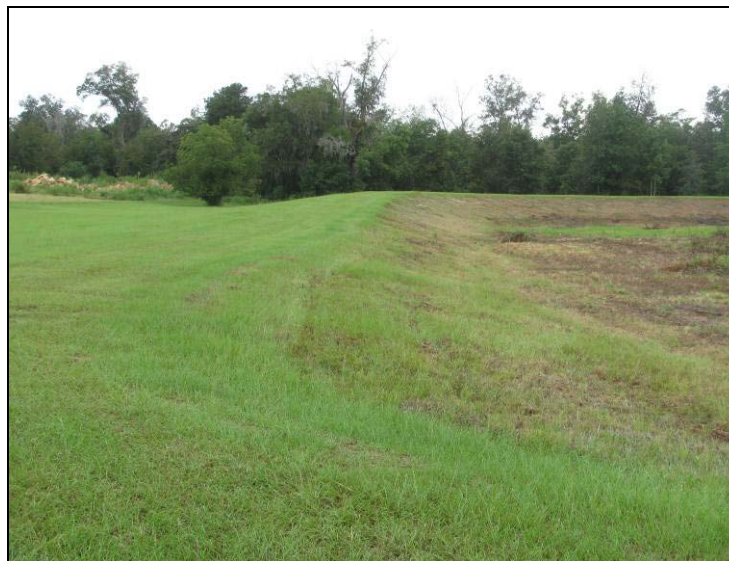
Photo 46: Ash Pond –Crest of South embankment near southeast corner looking west.

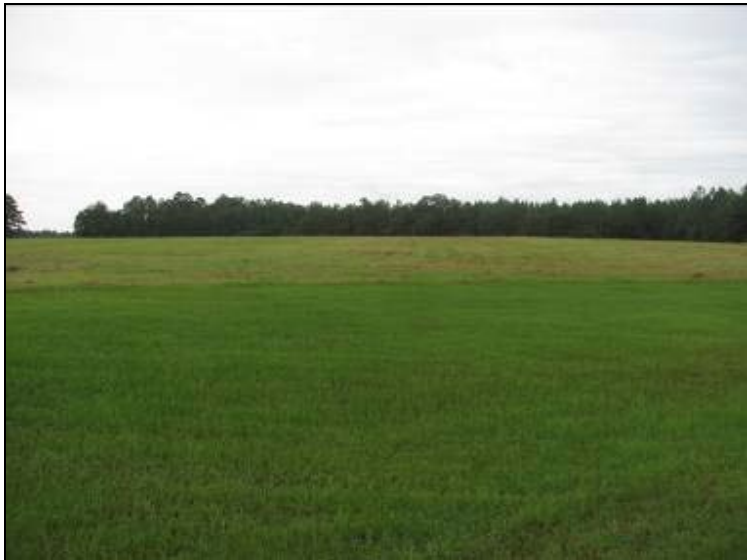
Photo 47: Ash Pond – General view of floodplain area south of Ash Pond, looking southeast.

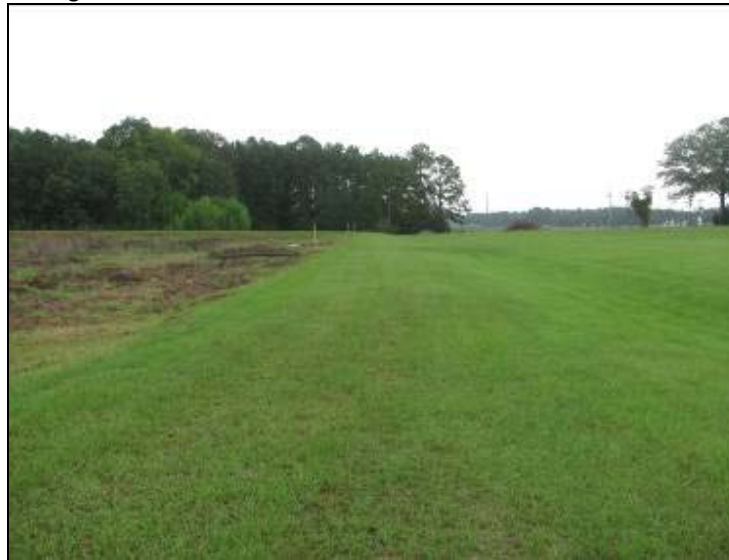
Photo 48: Ash Pond – Crest of southeast embankment near southeast corner, looking northeast.

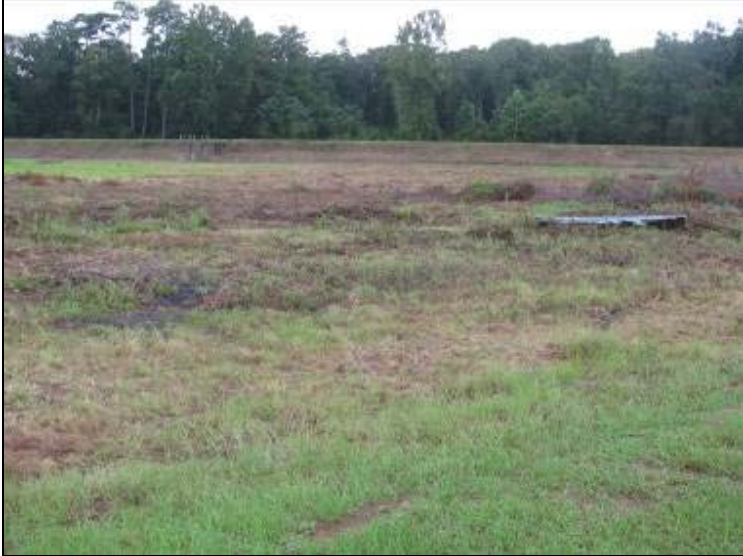
Photo 49: Ash Pond – General view of pond surface area near southeast corner, looking northwest.

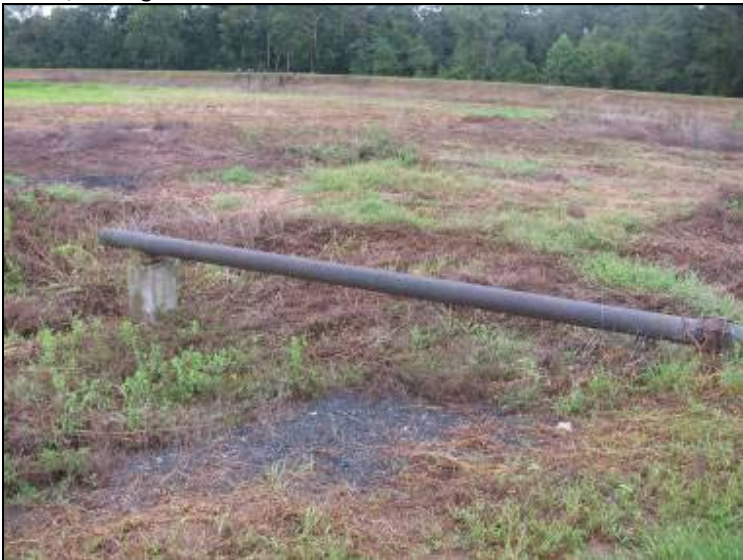
The Ash Pond has two inlet pipes located on the southeast embankment (Photographs 4, 51, and 55); one 8-inch-diameter polyvinyl chloride (PVC) pipe and one 7-inch-diameter ductile iron pipe (DIP). During the visual assessment, water from the plant was discharging through the PVC pipe (Photograph 63).

Photo 51: Ash Pond – Southeast embankment interior slope, 7-inch I.D. Ductile iron pipe looking northwest.

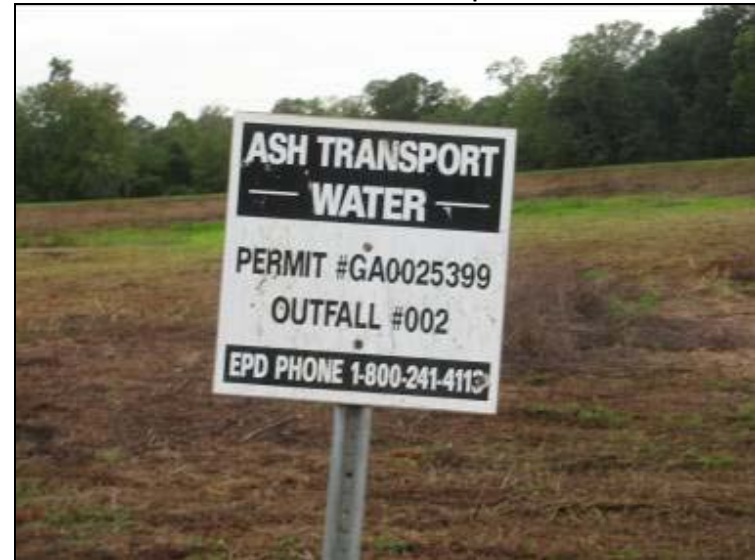
Photo 52: Ash Pond – Permit sign on southeast embankment, looking west.

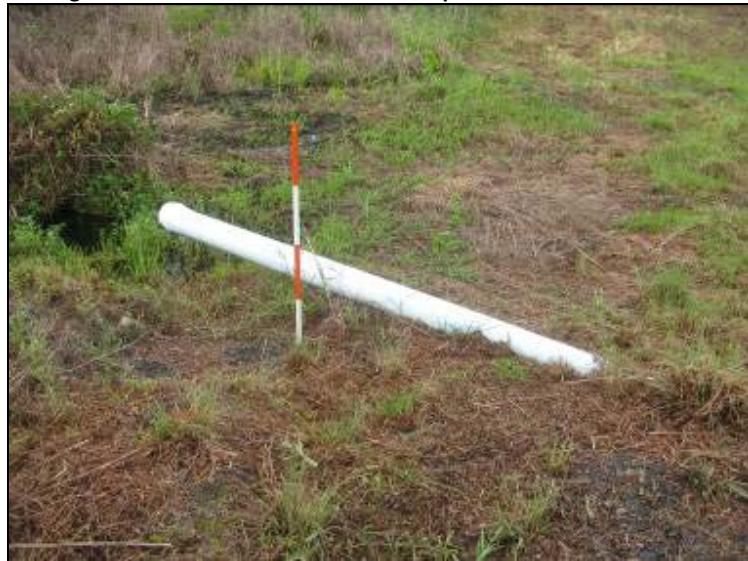
Photo 55: Ash Pond – Southeast embankment interior slope, 8-inch PVC inlet pipe, looking northwest.

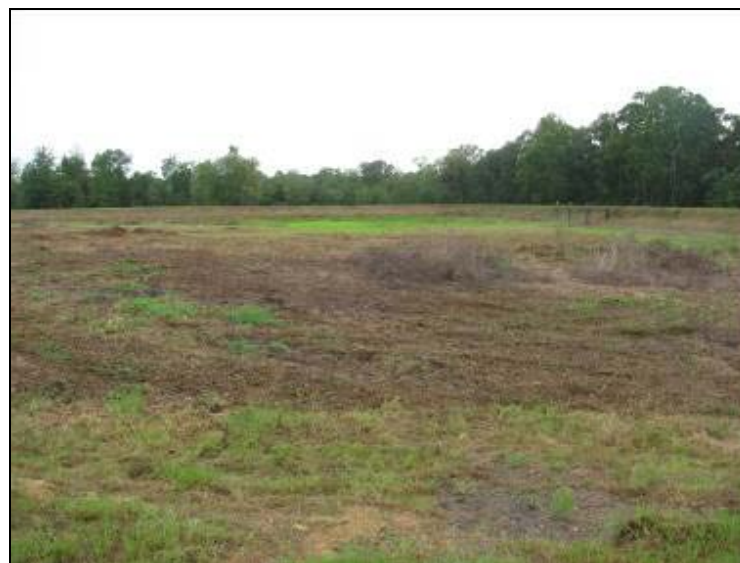
Photo 54: Ash Pond – General view of pond surface, looking west.

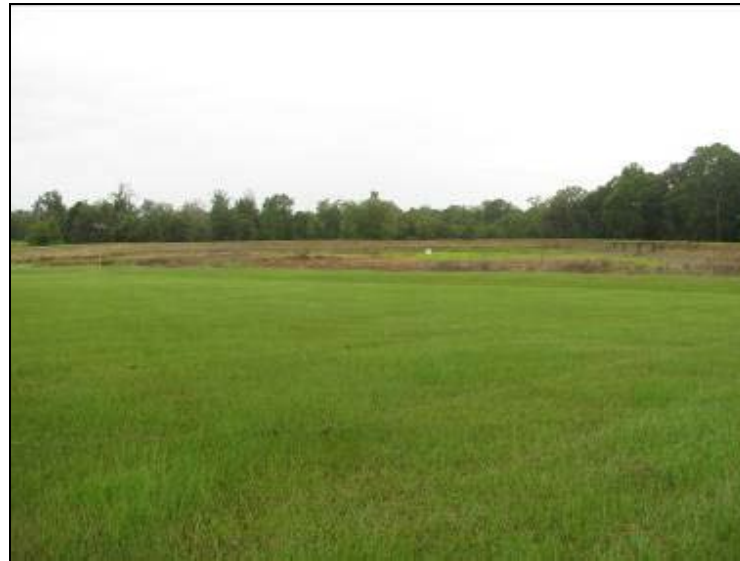
Photo 56: Ash Pond – General view of Ash pond, looking west.

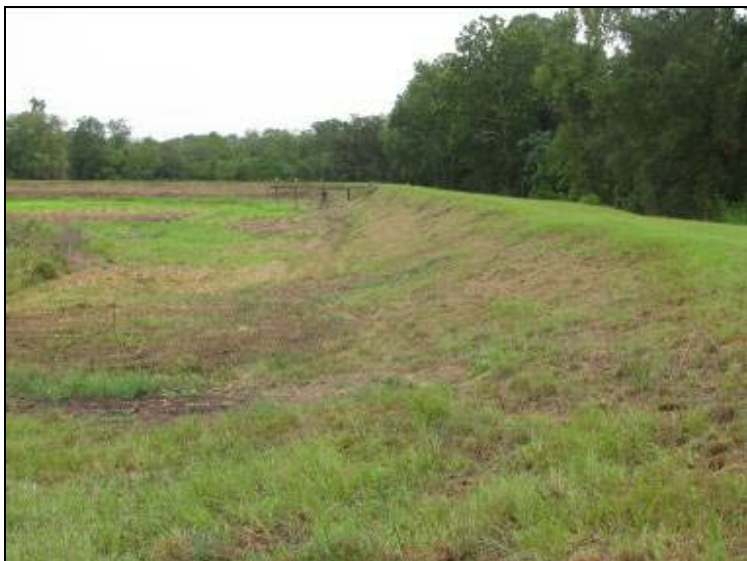
Photo 57: Ash Pond – North embankment interior slope near northeast corner, looking west.

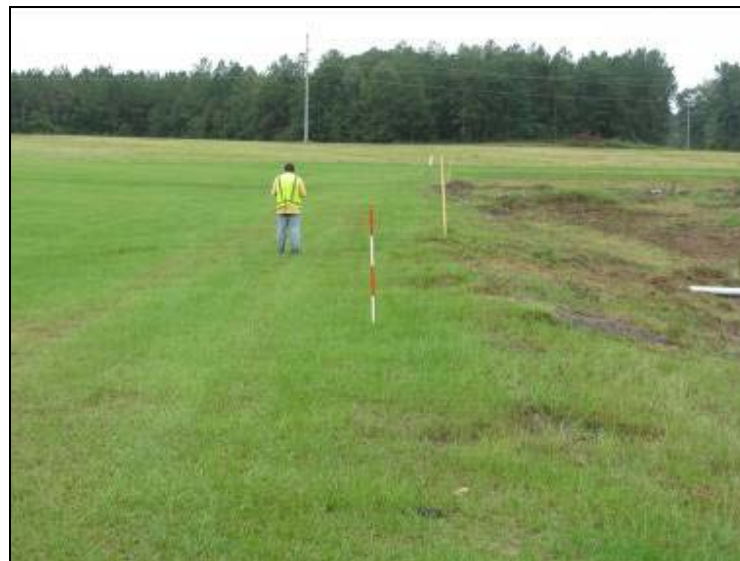
Photo 58: Ash Pond – Crest of southeast embankment near northeast corner, looking southwest.

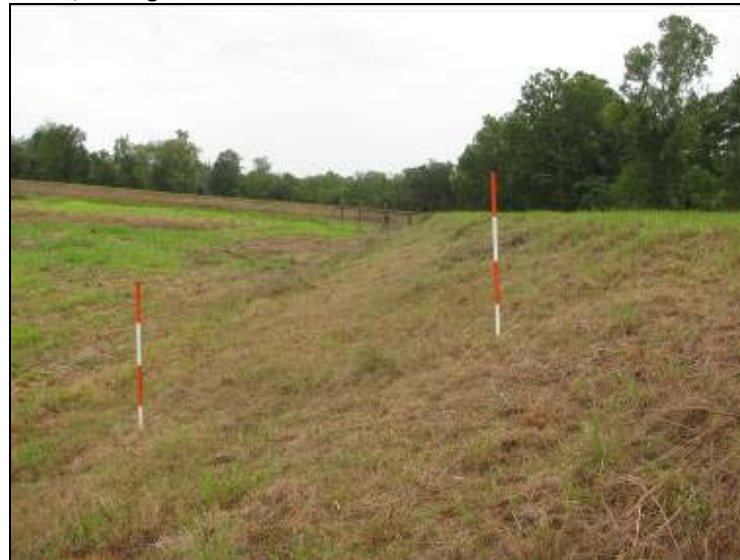
Photo 60: Ash Pond – North embankment interior slope, looking west.

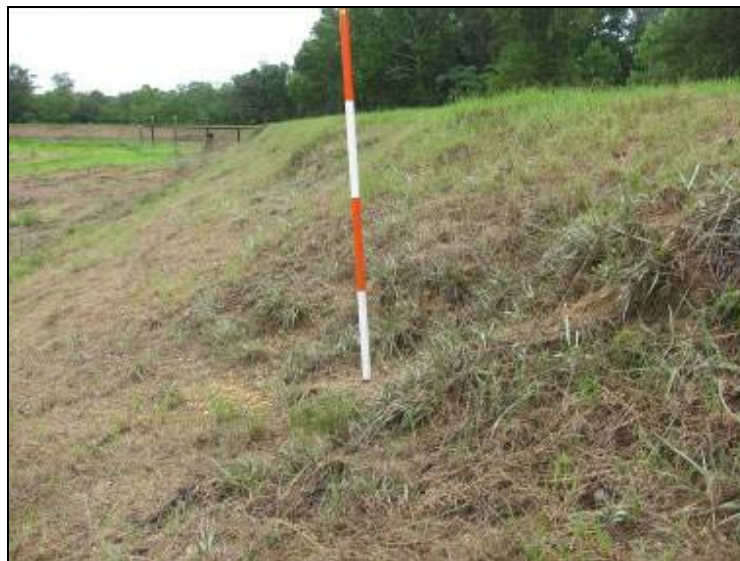
Photo 62: Ash Pond – North embankment interior slope surficial erosion, looking west.

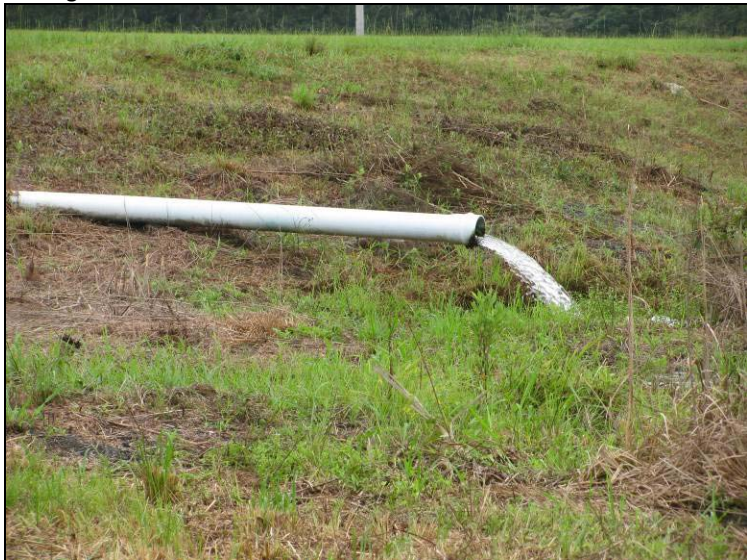
Photo 63: Ash Pond – 8-inch PVC inlet pipe on southeast embankment, looking south. Note: water flowing.

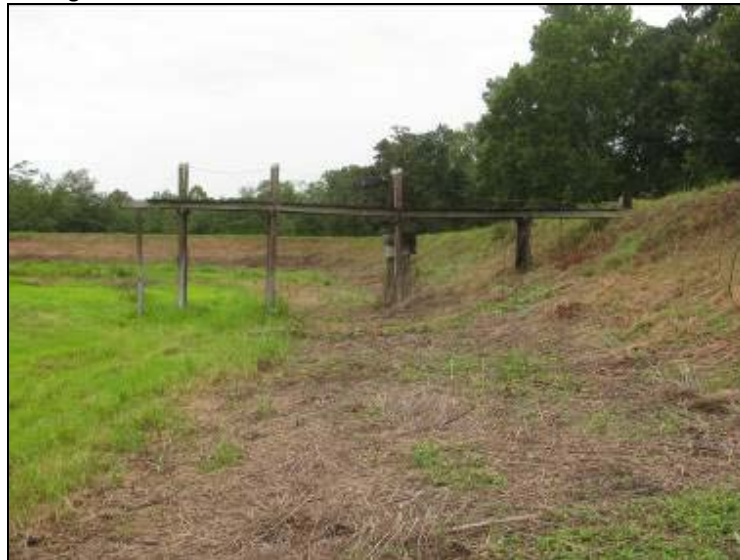
Photo 64: Ash Pond – North embankment interior slope, boardwalk and outlet 18-inch CMP riser pipe looking west.

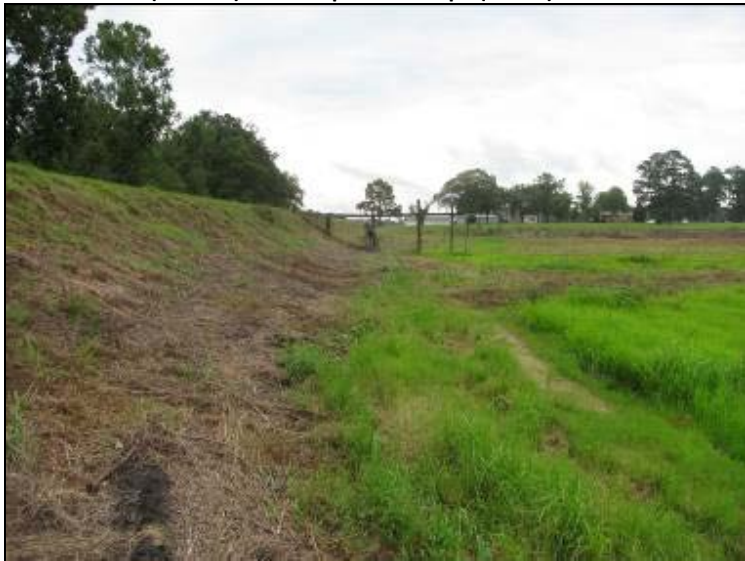
Photo 67: Ash Pond – North embankment interior slope, looking east.

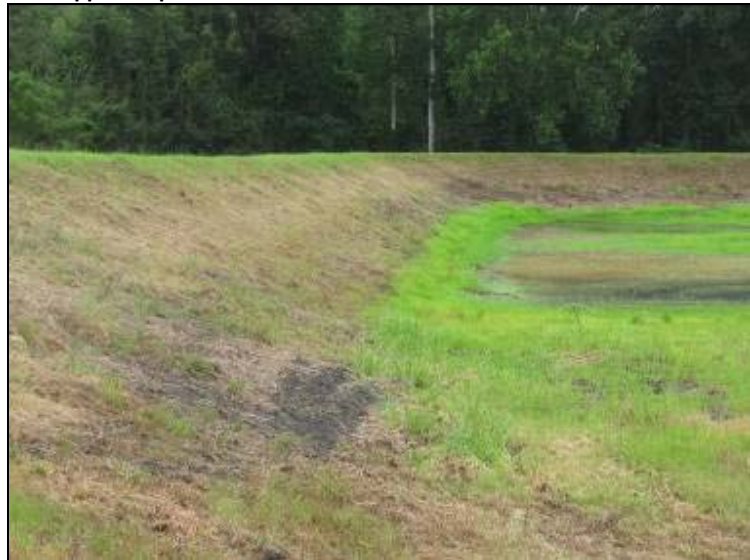
Photo 71: Ash Pond – West embankment interior slope, looking north.

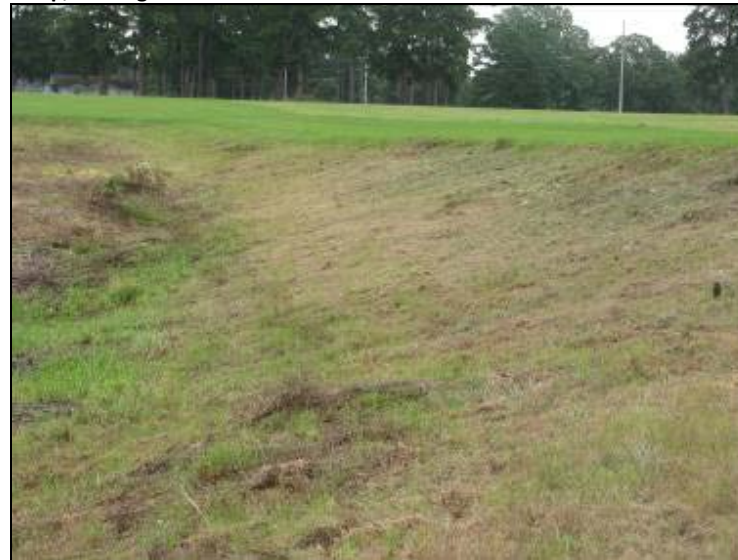
Photo 72: Ash Pond – South embankment interior slope, looking east.

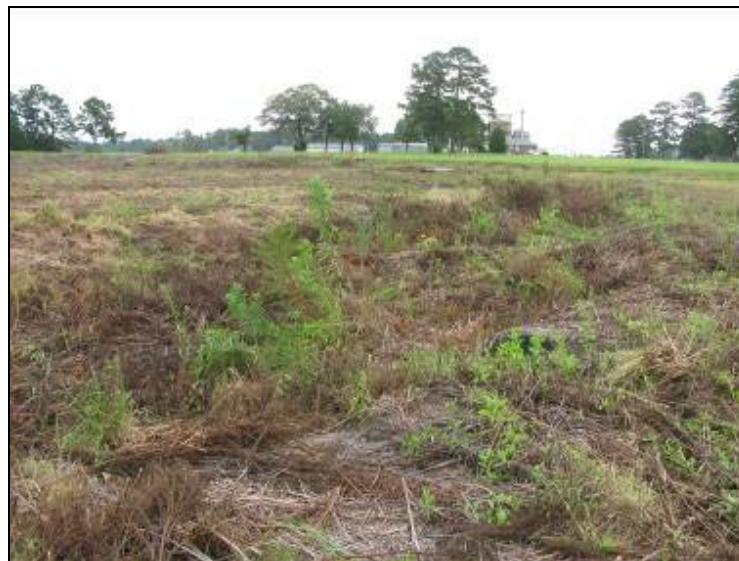
Photo 74: Ash Pond – Incised channel in the Ash deposited at bottom of pond, looking east.
