June 13, 2019
Project No. 17-5796BMr. Ronnie Miller
Manager of Production
Crisp County Power Commission
961 Power Dam Road
Warwick, GA 31796via email: rmiller@crispcountypower.com

**2019 DAM SAFETY INSPECTION REPORT
PLANT CRISP CCW IMPOUNDMENT
CRISP COUNTY POWER COMMISSION
PROJECT NO. 17-5796B**

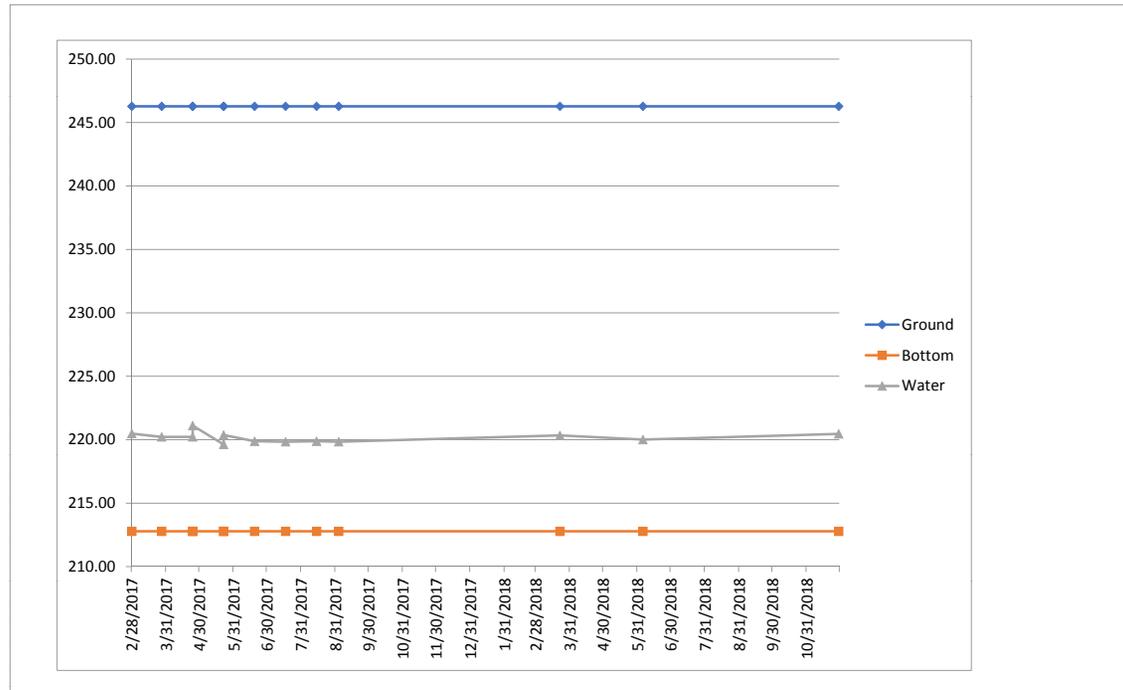
WELL MW-D3

A wet seepage area at the downstream toe near MW-D-3 was noted and photographed. There was standing water in tire ruts in this area. The last groundwater measurement prior to the site visit showed a ground water table within 1 foot+/- of the surface. Minimize vehicle traffic in this area as much as practical.

- **Recommendation 4** – Consider mitigating the seepage area MW-D3. This appears to be a relatively high traffic area that provides access to spillway and instrumentation. Recommend installing a hardstand area of gravel over geotextile.
